Artificial breaching of Bot River Estuary between 30 September and 01 October 2015

Post-breaching Report on behalf of the BREF Breaching Sub-subcommittee

submitted to DEA&DP in accordance with the approval granted
to the Overstrand Municipality to breach the Bot River Estuary artificially
(DEA&DP reference E12/2/4/7-E4/5-CJ2148/11)

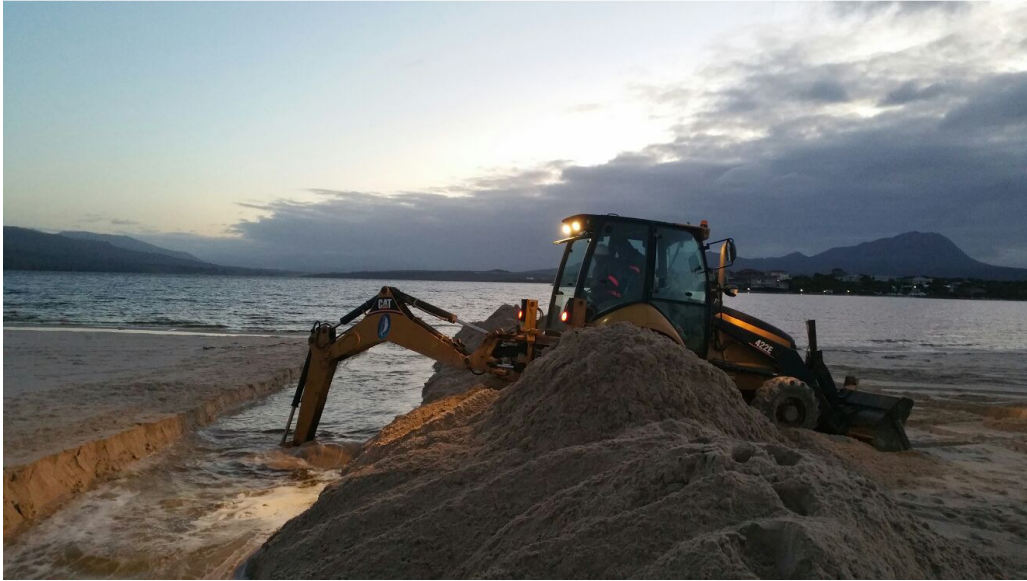
3. Sea conditions were relatively calm, and the weather was fine and windless. Since the footbridge from Meerensee to the berm had been submerged and damaged by the high water levels, law enforcement officials prevented members of the public from crossing it for safety reasons.
4. The final plug of sand was removed at 05:30 and high tide was at 05:08 allowing the first water to begin flowing as the tide was receding.

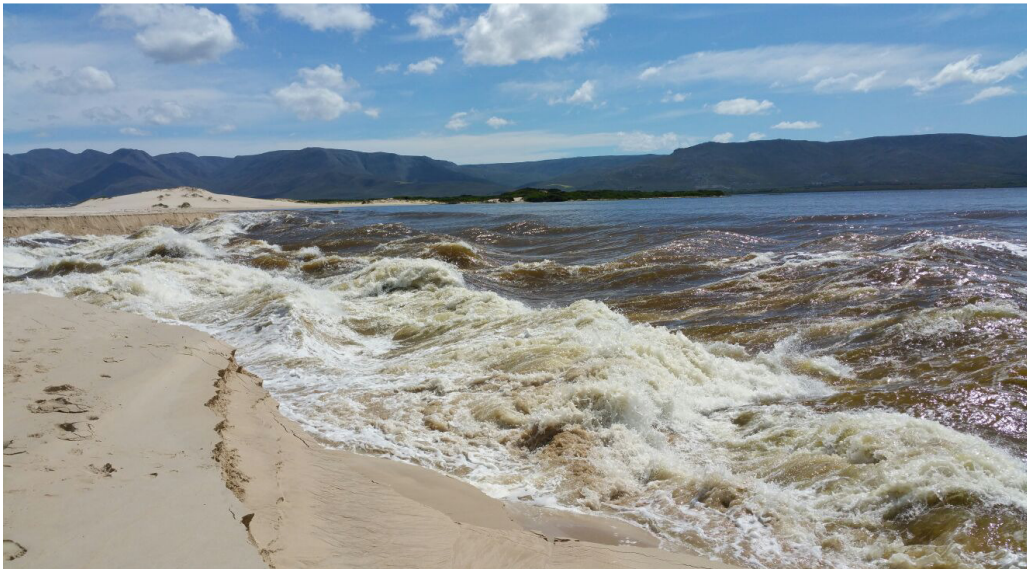
5. By morning the water level had dropped significantly and the footbridge was safe to use. Warning tape was erected well back from the steep embankments made by the outflow channel, and law enforcement officials were on site to ensure members of the public did not venture too close to the edge.
6. Peak outflow occurred between 10:30 and 11:00 on Thursday and by that time the width of the mouth was in excess of 100 m wide.
