*Public Participation document:*

# **Baardskeerdersbos**

Overstrand Heritage Landscape Group (OHLG):

Overstrand Municipality

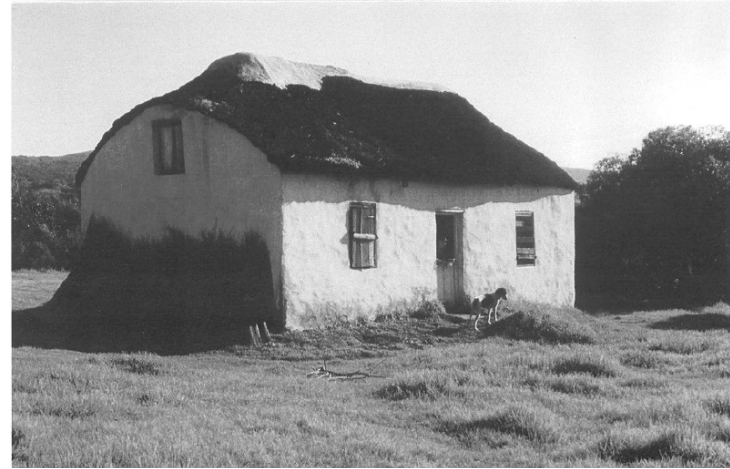
Figure 2: Baardskeerdersbos cottage (Willem Malherbe), from VASSA, Cape Folk Architecture Exhibition souvenir, Cape Town 2005, p.21. (Now probably demolished, was in area of erf 58-59 (B. Otto interview 07.07.2008) and shows up on aerial photo of 1938).

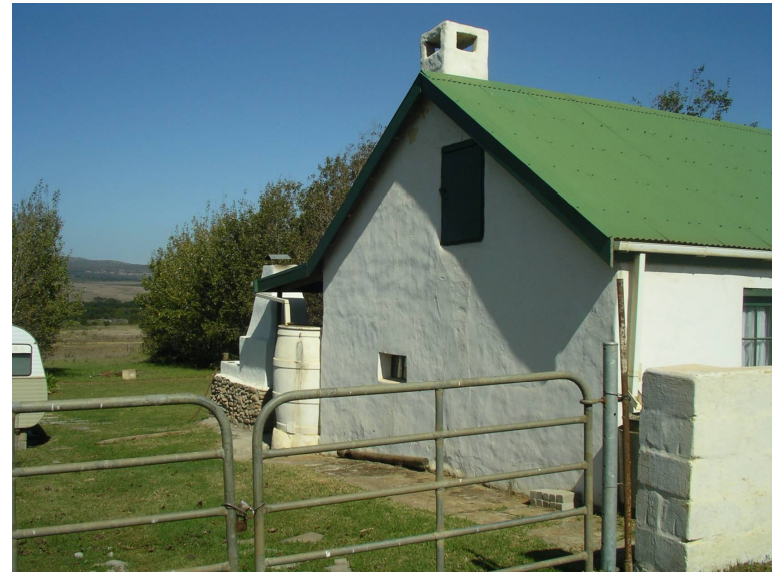
House in process of renovation. Stone foundation, poplar beams.  
**Materials:** Mud brick; corrugated iron  
**Associated landscape features:**

- Conserve
- Remedial action to enhance
- HWC permit of approval required for any demolition, alteration or change in planning status
- Retain historical fabric (predominantly building exterior)

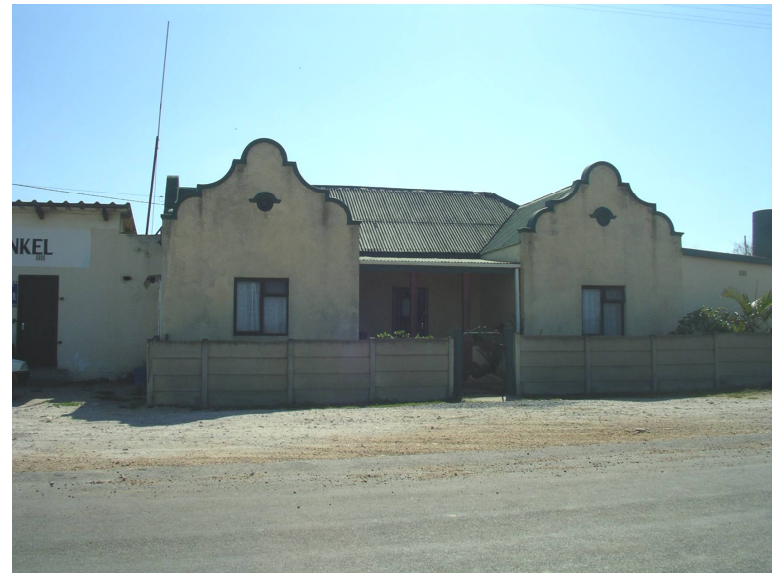
Manie se winkel and attached gabled house, early 20th c. The shop section may have an older core but has been much altered. The gabled house next door has an older core, with art deco gable additions. It has old vents, pre 1930s, windows have been replaced but some 19thc or Victorian doors remain. Built in U shape.

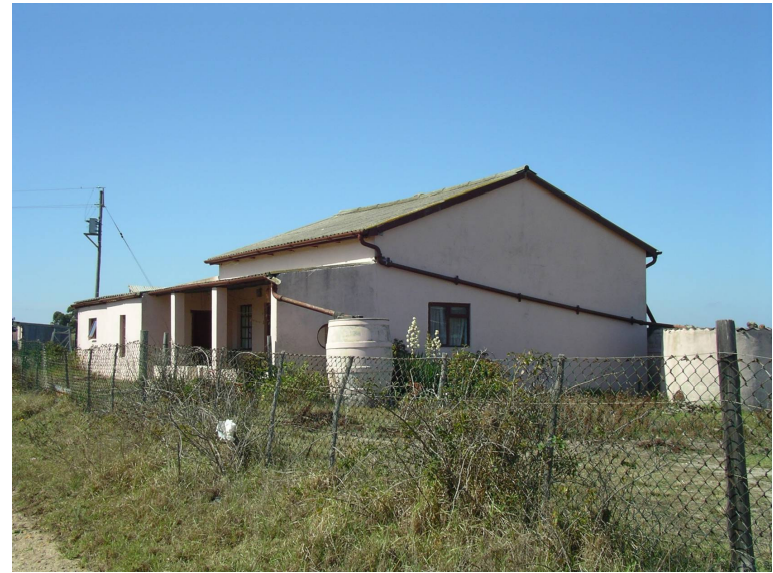
Katzenhuis. Much altered. Older core is early 20th century mud brick with reed ceiling. Brandsolder and peach pip floor was removed and replaced with cement. Owner says was similar to erf 56.  
Materials: Mud brick; corrugated iron  
Associated landscape features:

- Conserve wherever possible
- Retain historical fabric wherever possible (exterior only)

- Conserve and enhance contribution to overall character and streetscape (predominantly public/private interface)
- HWC permit of approval required for any demolition, alteration or change in planning status
- Demolition only to be considered if appropriate adaptive reuses cannot be established

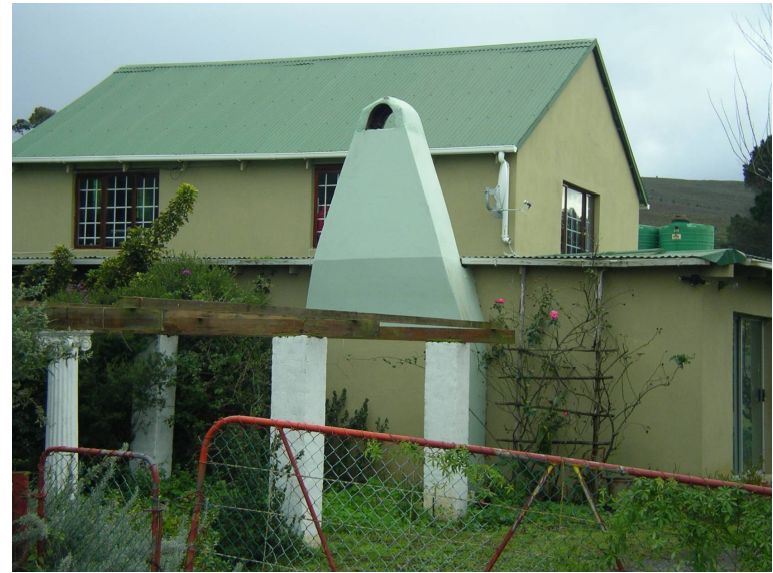
Mooiverbly, (currently owned by Groenewald), much renovated. According to Benade 2006, p.93 this was the residence of Oom Piet 'Lot' Groenewald, and was the site of the first official butchery in the town. Possibly mid-20th century but may have an older core. In front of the old graveyard.  
**Materials:** Brick; corrugated iron  
**Associated landscape features:**

According to Benade 2006, p.93 this was the residence of Oom Piet 'Lot' Groenewald, and was the site of the first official butchery in the town. Possibly mid-20th century but may have an older core. In front of the old graveyard.

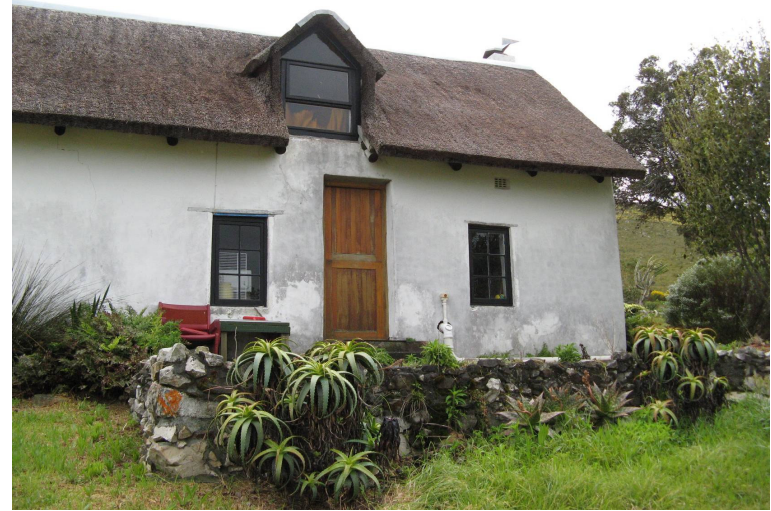
Cottage with fairly thick walls. Woodwork looks original, but extensively renovated.  
**Materials:** Mudbrick; Corrugated iron  
**Associated landscape features:** Grave of De Kock buried 1962 34 34' 13"S 19 36' 01"E  
Vacant labourers' cottage close to the road

**Original use:** Residential  
**Current use:** Cottage  
**Landscape type:** Continuing  
**Design/Style:** Vernacular  
**Construction date:** Late 19th/early 20th century  
**Historical period in which constructed:**  
**Theme:**

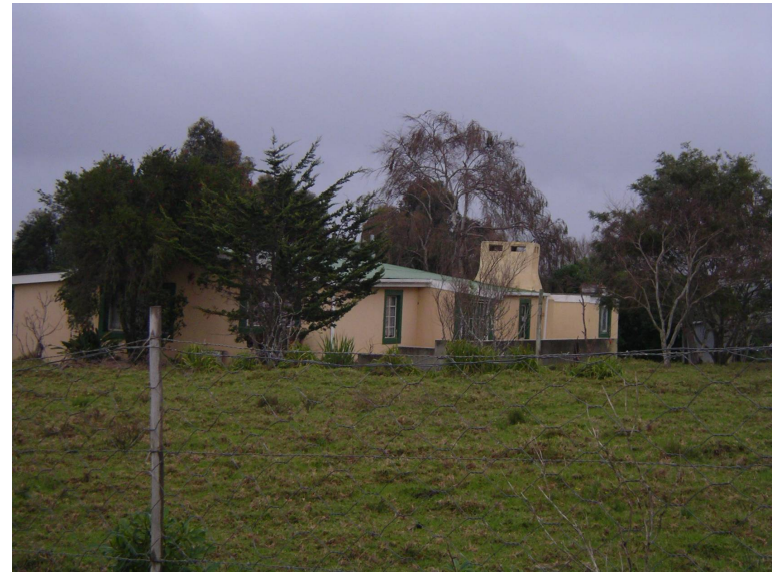
Cottage at back of plot with cinderblock repairs: corrugated iron roof, but old chimney stock. The chimney may be remnant of labourer's cottage.

- Demolition could be considered
- HWC permit of approval required for demolition
