ONRUS ESTUARY

Final Draft

**Including Reassessment of 2002 proposed
Rehabilitation and draft Situation Analysis**

May 2015

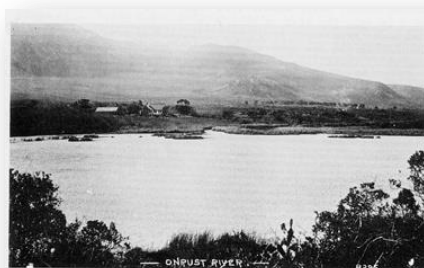
Figure 2.1: 1921 and 1979 photographs of Onrus Lagoon

FIG. 10: Onrus Lagoon 1921, photographed from "Sleepy Lagoon", Protea Street. The wide lagoon is fringed with a narrow *Phragmites* bed. Islands in the lagoon are vegetated with a *Scirpus* species. (Photograph by courtesy of Mr Swigler.)

The 1983 report describes the changes in the lagoon since 1921(Heineken & Damstra, 1983). It shows the pristine state with large open water areas in a photograph of 1921 compared with extensive reed growth in 1976 (see Figure 2.1).

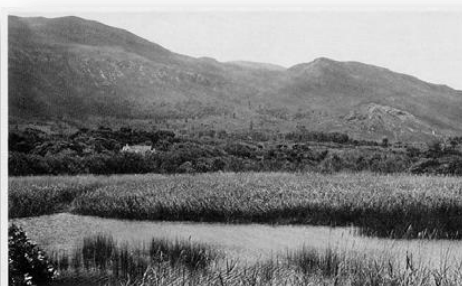
FIG. 12: Photograph illustrating the extensive reed growth that has taken place since 1921 (ECRU, 79-12-06)

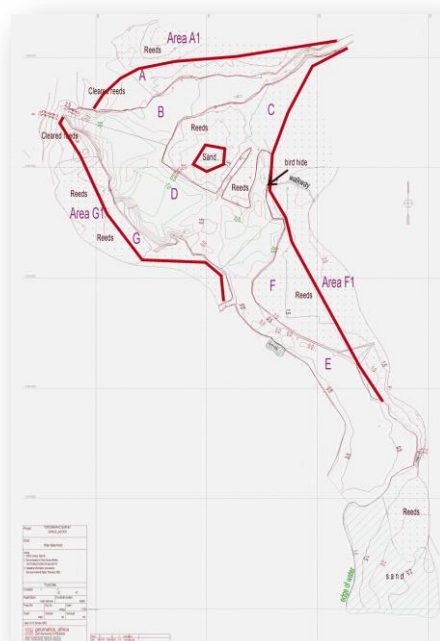
The proposed area to be dredged is shown between the red lines in Figure 2.8. A small island will also be maintained as shown. The surveyed area and calculated volumes have been split into separate areas so that should a different area be selected for dredging fairly accurate assumptions on new volumes would be possible by adding prorata volumes of each area. Similarly as recommended by CSIR (1993), the volumes have been calculated for removal of material to a level of –1m MSL. The areas and volumes for each area are shown in Table 2 below:

Figure 2.8: Area to be dredged

Areas A, C, F and G are covered by reeds giving a volume with reeds of about 20 000m³ material with roots (assuming a root depth of 1m). The remainder would be clean sand (no roots). The area of reeds that would remain should the recommendation be implemented is shown in Table 3 below:

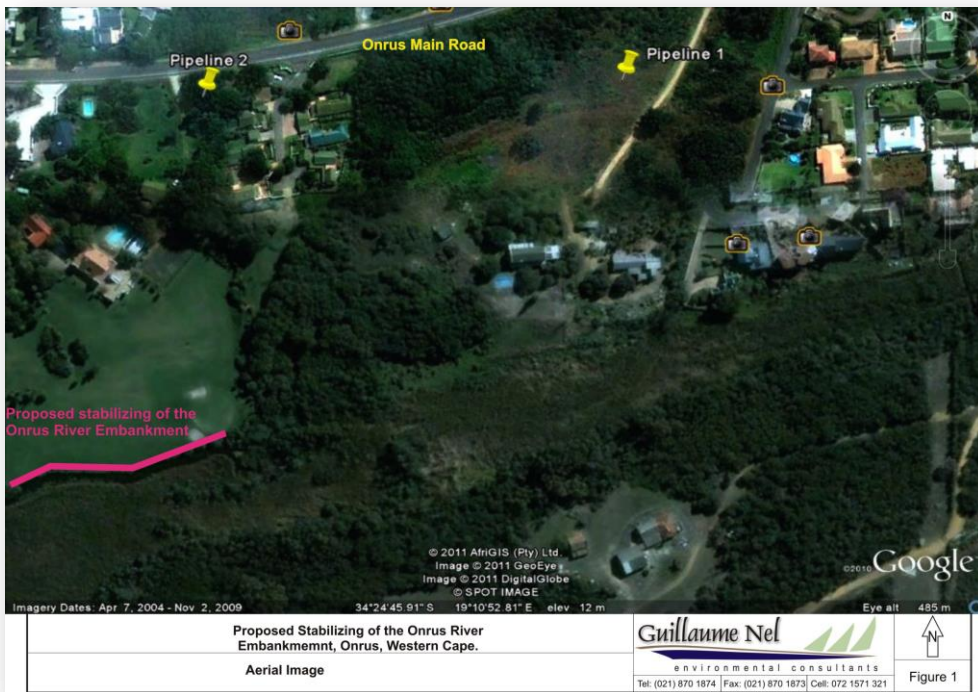
The preferred option as approved for stormwater retention ponds is shown in Figure 2.13 and for embankment stabilisation as shown in Figure 2.14.

Figure 2.14: Proposed embankment stabilisation

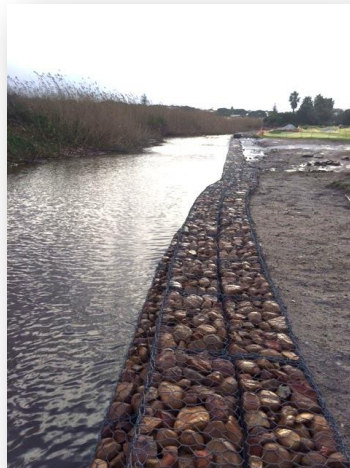
The proposed embankment stabilisation is being implemented at present as shown in Figure 2.14a.

Figure 2.14a: Completed bank stabilisation

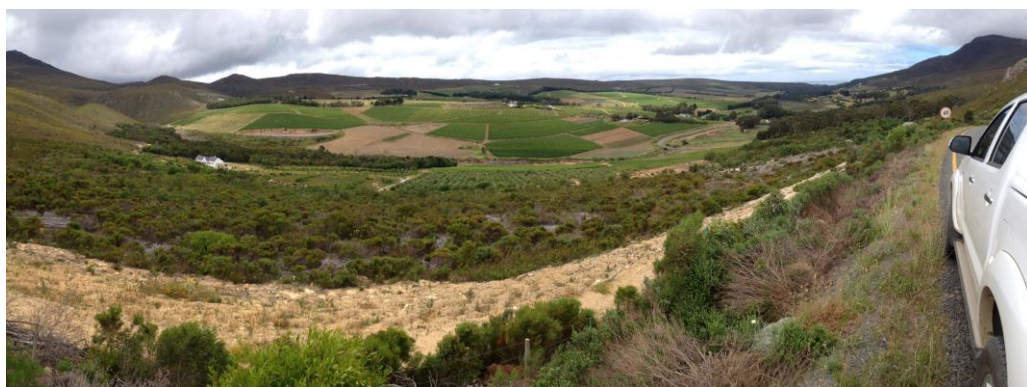
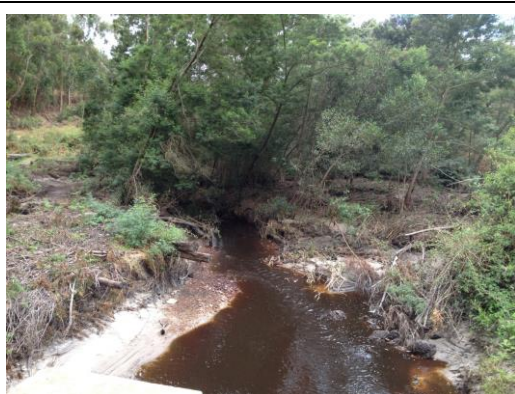
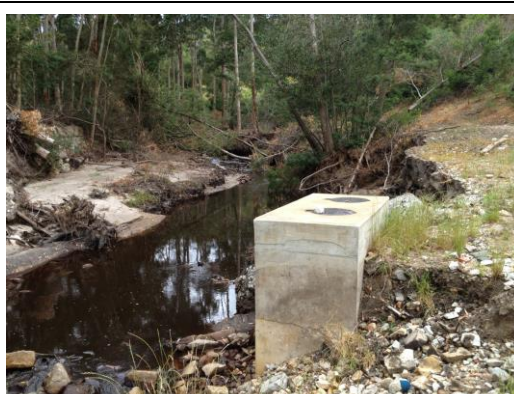
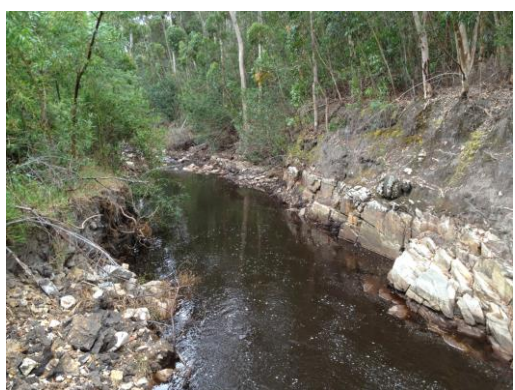
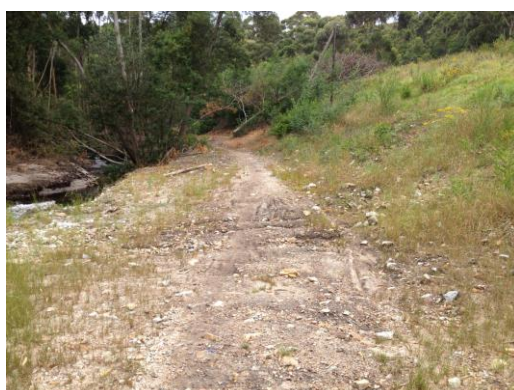
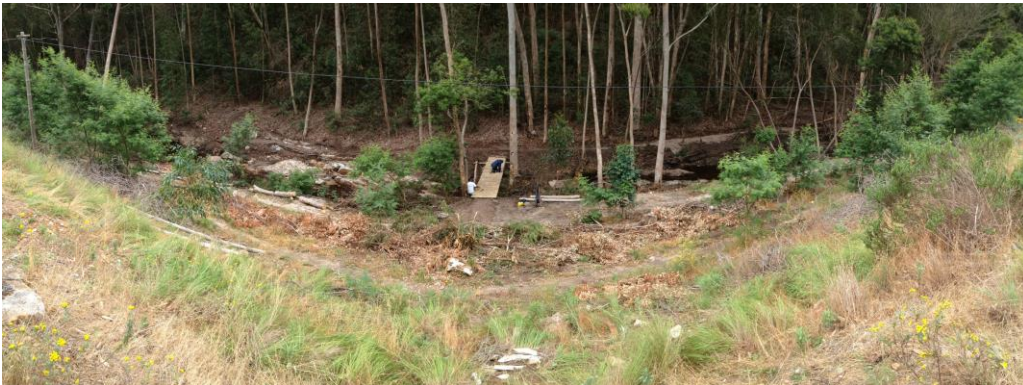
- The river is mostly contained along its edges, mostly due to either an adjacent road, rocky substrate, trees or cultivated lands (see below photos 2139, 2145, 2147-2149, 2151, 2153, 2156);
- Little erosion was observed, this is most likely due to the above; and
- High flow velocities were observed throughout the system, except in the area below the dam where the river widens; and
- It seemed likely that a natural sand trap is located downstream of the Onrus Bridge, in and just upstream of the estuary (see photo 2160). The main reason for this conclusion is that it seems the slope flattens below the bridge thereby decreasing flow velocities. In addition the comparative surveys of 2002 and 2014 show increased sedimentation in the upper reaches of the estuary.

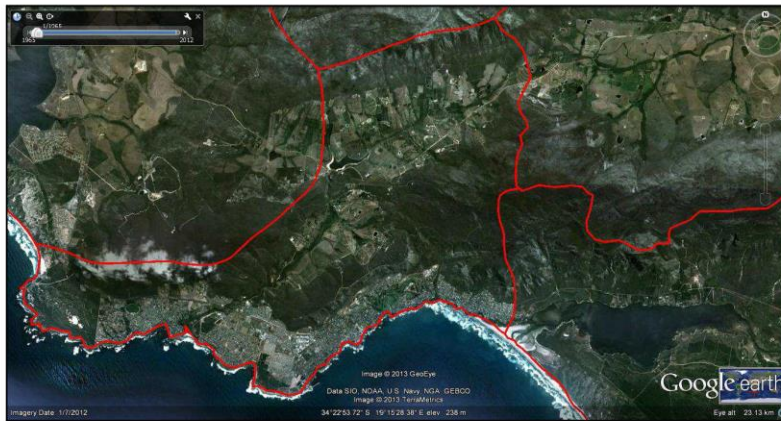
Figure 2.1: The Onrus River catchment

The Onrus River catchment (G40H) covers an area of only 59 km² and lies entirely within the Overstrand municipal boundary. The catchment is bordered by the southern slopes of the Babilonstoringberge and the northern slopes of Kleinrivierberge, both part of the Cape Fold Belt formed as a result of continental collision some 250 million years ago. Lying between these two mountain ridges is the Hemel en Aarde Valley, through which the Onrus River flows.

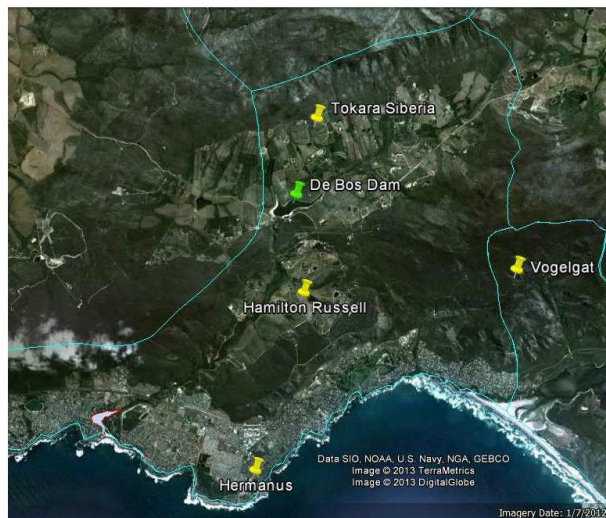
Figure 2.5: The location of the weather stations and De Bos Dam relative to the catchment boundary and Onrus Lagoon.

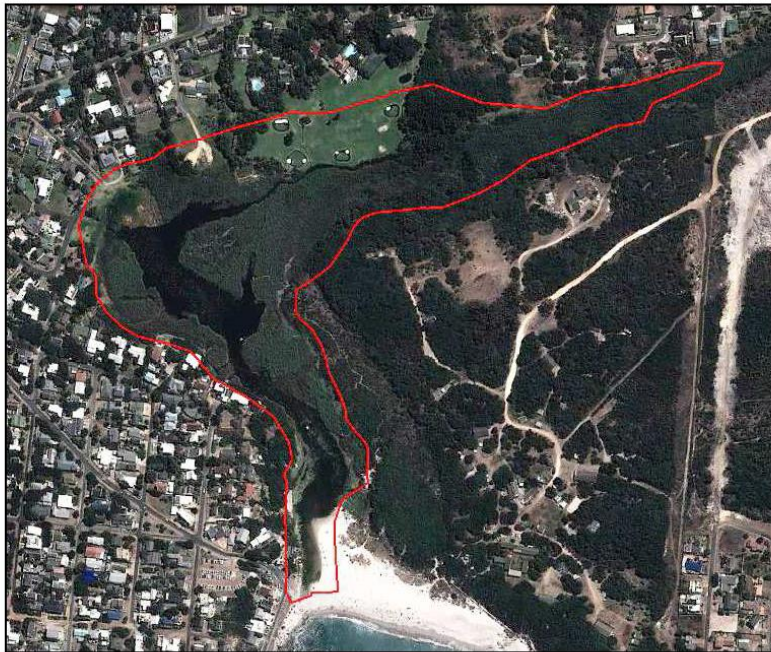
The boundary of Onrus Lagoon, according to the National Estuaries Layer, is shown in Figure 3.1. This is a very small system, covering an area of just over 15 ha.

Figure 3.1: The estuarine boundary of Onrus Lagoon. The distance between the estuary mouth and the northern shore is approximately 600 m.

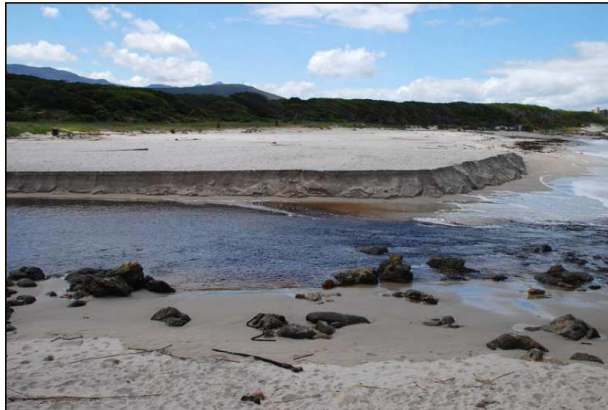
Figure 3.4: The estuary mouth on 23 October 2012, following the natural breaching on 19 October. Seawater can be seen surging up the breaching channel.

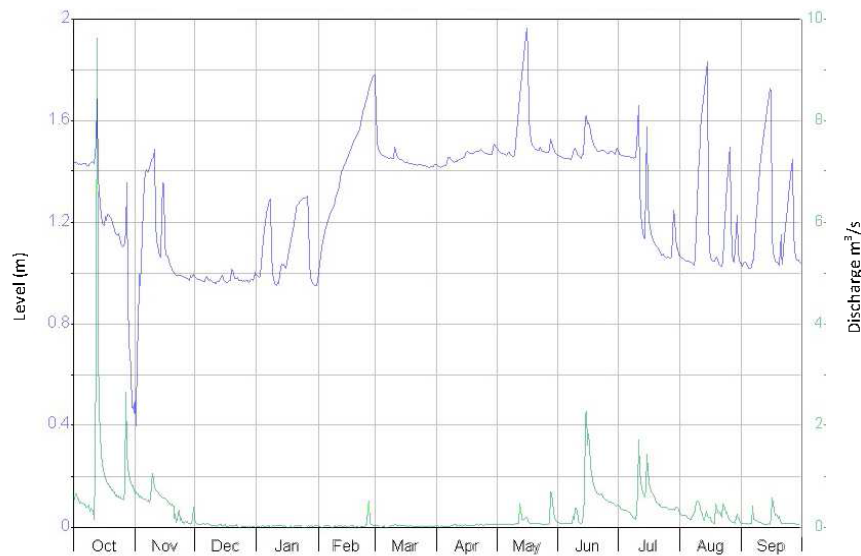
An overlay of graphs depicting river flow above De Bos Dam (green line) and water level in Onrus Lagoon (blue line) for the period October 2009 - September 2010 shows how the estuary responds to rainfall events and seasonal flow (Figure 3.6). Although this river flow is largely retained by the De Bos Dam, it can be expected that the flow pattern approximates that of streams flowing into the Onrus River below the dam. The estuary was relatively full in October, before a flood event caused the sandbar to break open. The water level dropped significantly as the estuary drained, but the mouth closed within about a week and the water level rose again to the pre-breaching level. The overflow channel then opened, which maintains the water level at approximately 1 m depth. At the end of January the overflow channel closed and the water level rose. Evaporation and seepage through the sandbar maintained the water level at about 1.45 m depth. It remained at this high level until the onset of winter rains, and hence higher flows, in June and July re-opened the overflow channel.

Figure 3.6: River flow (green line) and estuary water level (blue line) for a one-year period starting October 2009, shows how Onrus Lagoon responds to rainfall events. Graphs courtesy of Dept Water Affairs.

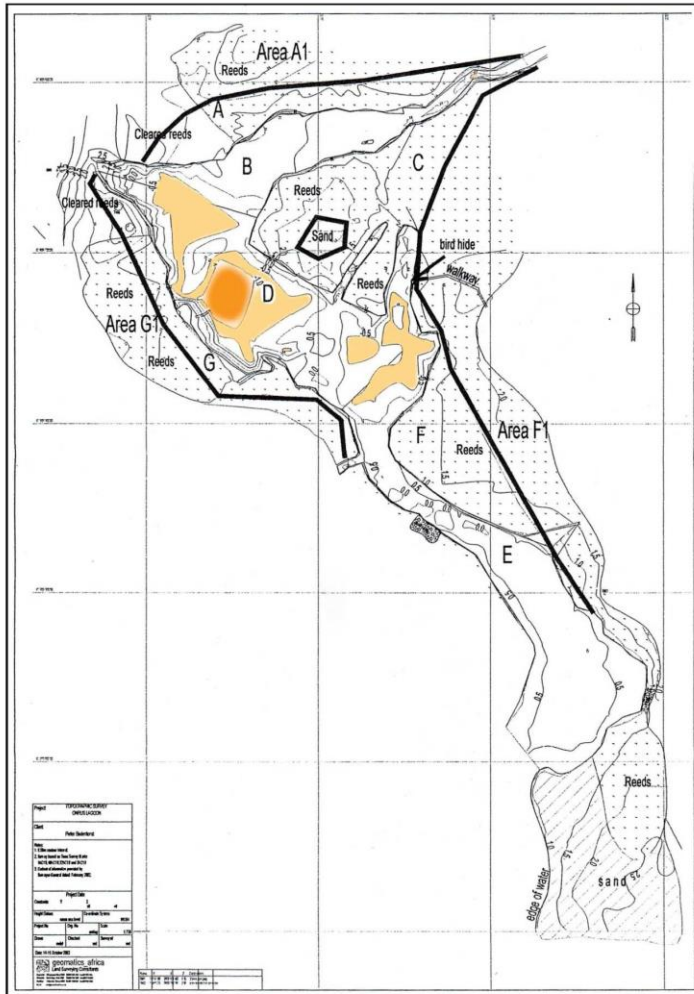
Figure 3.7: Bathymetry of Onrus Lagoon, according to the 2002 survey. The coloured areas are the deepest parts of the estuary, dark orange being -1 m MSL and light orange -0.5 m MSL (adapted from Badenhorst 2002).

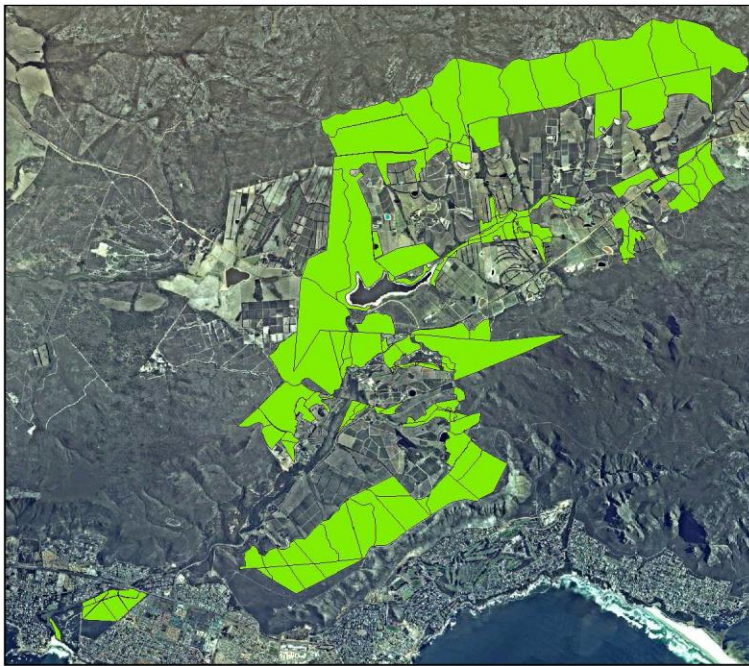
Figure 4.1: Alien-clearing by Overstrand Working for Water during the past five years.

Working for Water first became involved in alien-clearing in the Onrus River catchment with the launch of the Greater Hermanus Water Conservation Programme in November 1996. Activities initially focused on the upper reaches of the catchment as a means of increasing runoff into the De Bos Dam, but in the past few years clearing has taken place in the lower catchment too (Figure 4.1).

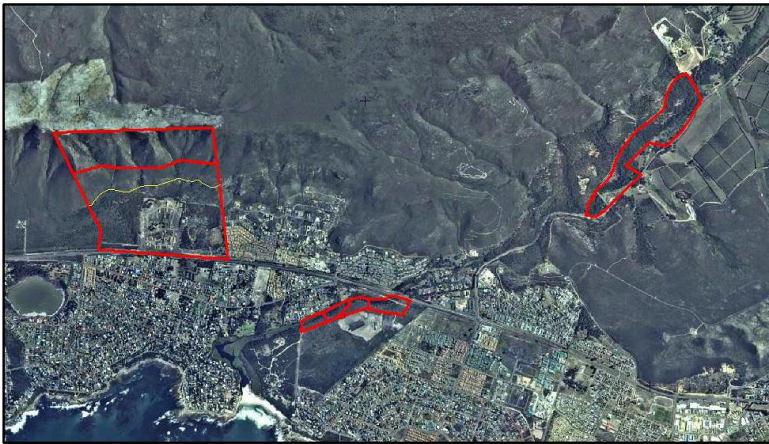
Figure 4.2: Alien-clearing work to be completed by mid 2015.

More recently, a new project has been initiated to increase these efforts. The project will be funded by the Working for Water Programme to clear on private property within the project boundaries, and by the Overstrand Municipality from the Environmental Management Services budget to clear on municipal properties. The areas to be cleared are the Habonim property on the eastern bank of the river and the riparian zone below the R43 bridge, the river course south of Camphill, and the mountainside above the suburb of Berghof (Figure 4.2).

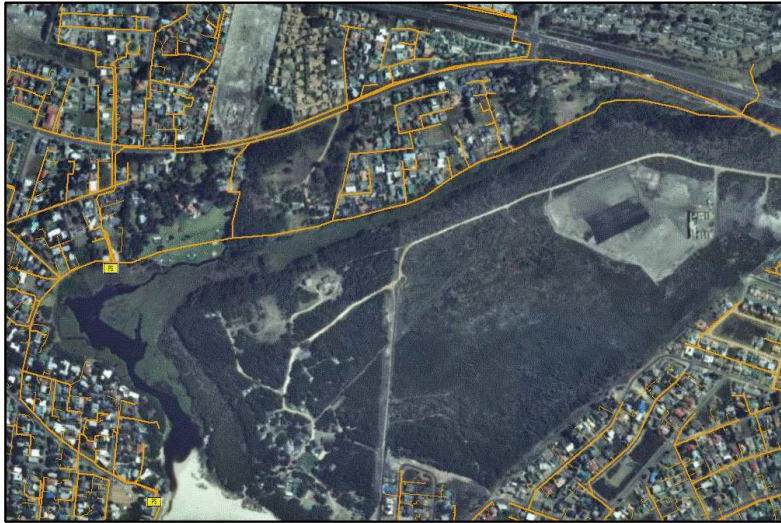
Originally the pipeline consisted of a combination of 160 mm uPVC structured wall and 200 mm and 250 mm uPVC pressure pipes, with brick and concrete ring manholes. Following numerous incidents of sewage pollution of the river and estuary, V3 Consulting Engineers were contracted in 2000 to investigate the problem. A survey and visual and camera inspections were conducted, and the pipeline was found to be in a poor physical condition, with several dips, bends and holes, as well as root ingress and leaks. The consultants noted that the flow used in the design was too high, and some of the design gradients were flatter than those generally recommended by the 'Red Book' (Guidelines for Human Settlement Planning and Design), i.e. at least 1:300 for a 200 mm pipe and 1:400 for a 250 mm pipe. The low summer flows, in combination with the line's flat gradients and low points, caused fat to accumulate against the pipe wall. They recommended that regular cleaning and dosing be undertaken, but not jet-cleaning as this would damage the pipe walls. The 160 mm uPVC pipe was particularly prone to damage, and was considered unsuitable. The section of pipe from Kidbrooke Place had no more fat accumulation than other areas, but it was recommended that the fat trap at the Kidbrooke restaurant be re-commissioned.

Figure 4.3: Municipal sewerage infrastructure in the vicinity of Onrus Lagoon.

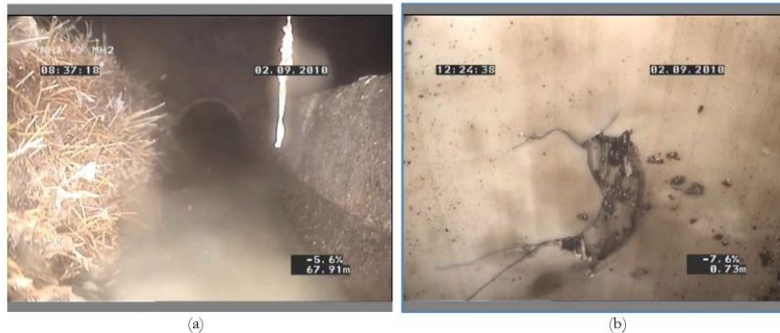
Figure 4.4: CCTV camera footage from 2010 reveals (a) root ingress and (b) fractures in the Kidbrooke sewerage line.

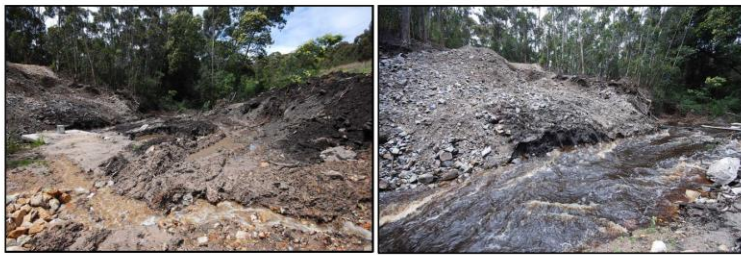
Figure 4.9: Construction work for the Hemel en Aarde groundwater development project may have increased the sediment load in the Onrus River.

The earlier CSIR reports noted that bridge and road construction in the vicinity of the Onrus River might have contributed to sedimentation of the estuary in the past. During the public participation process for the Hemel en Aarde groundwater development EIA, Cape Nature expressed concern about the risk of erosion during pipeline construction, and suggested that construction take place manually and outside the wet winter season where aquatic features are present. The Comments and Responses Report noted that this would be possible providing environmental authorisation was received in time to do the work during the summer months, so it had been included in the Environmental Management Plan. The site where the pipeline would cross the Onrus River near the Preekstoel water treatment works was identified in the Basic Assessment Report as an area of particular concern, due to the steep slopes here. The photos below, taken after heavy rain in October 2012 resulted in the De Bos Dam overflowing, indicate that the recommendations were not adhered to. The slope has since been stabilised.
