**THE ONRUS RIVER WETLANDS
(HEMEL EN AARDE VALLEY, WESTERN CAPE, SOUTH AFRICA)**

WETLAND ASSESSMENT

October 2025

LIZ DAY
CONSULTING

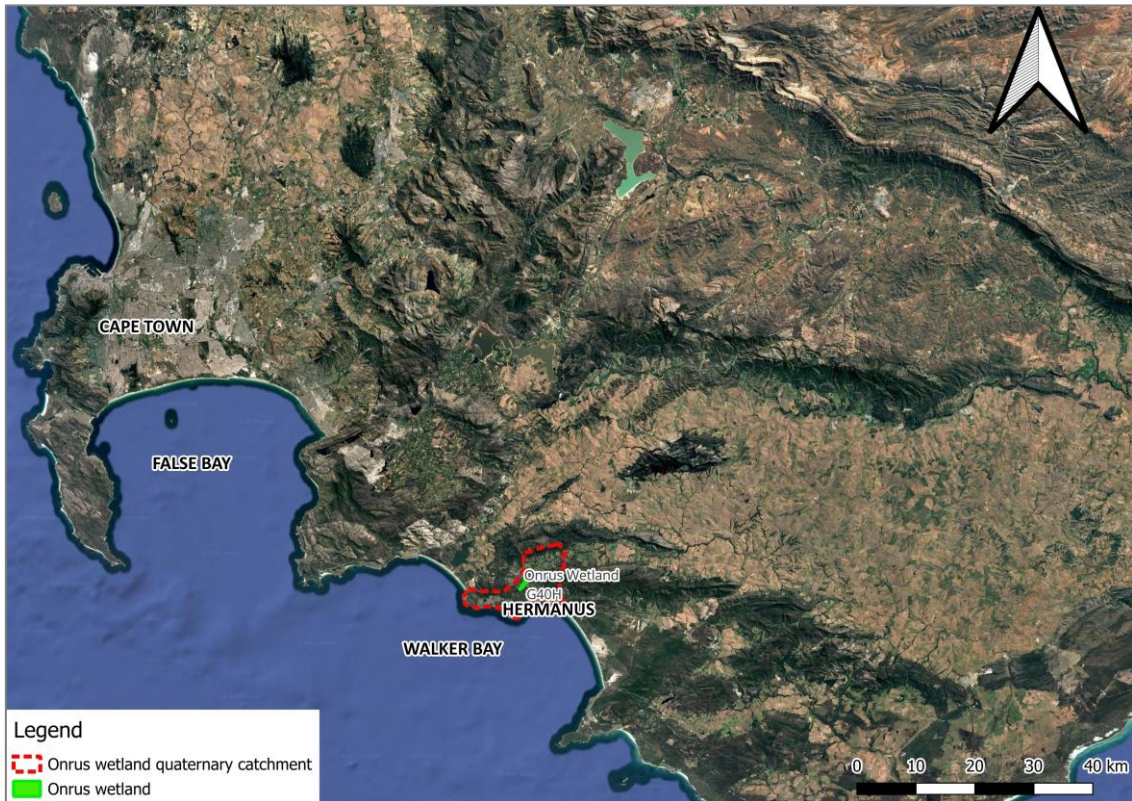
Location of the Onrus River and Onrus wetland in the Western Cape, South Africa

Figure 1.1 shows the extent of the Onrus River Catchment as a whole, and its location within the Western Cape of South Africa. **Figure 1.2** shows the location of the Onrus Wetland itself, nested within this catchment.

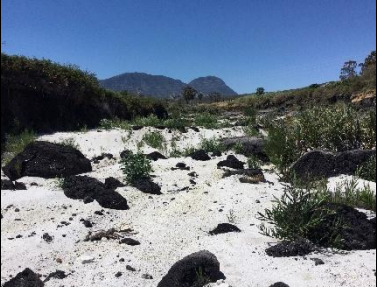
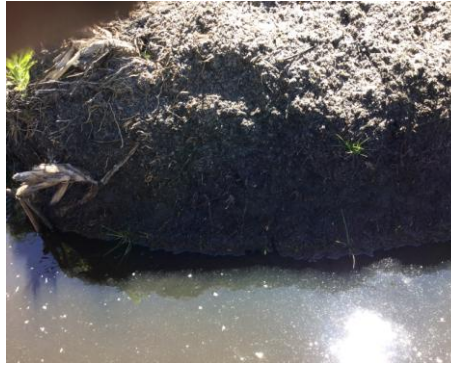
Figure 2.1
Examples of different soil conditions selected for sampling and analysis for TOC and HC analyses in the Onrus Wetland, January to March 2025.

<p style="text-align: center;">Coarse, sandy soils</p>	<p style="text-align: center;">Infiltrimeter on exposed organic soils</p>	<p style="text-align: center;">Mainly unexposed soils – these were accessed by augering at least 40cm into the soil mass</p>

Actual infiltrimeter measurements involved filling the infiltrimeter's mariotte chamber with river water and placing the stainless-steel disk underlying the instrument on an area of flat, undisturbed

surface of the selected soil, ensuring good contact between the two surfaces. The time taken for a known volume of water to infiltrate the soil was measured, using multiple measurements at intervals of 5 – 30 seconds, depending on the rate of infiltration. These measurements were repeated using 95% ethanol instead of water, to provide a measure of soil water repellence, based on Lichner et al. (2007)'s proposed index of soil water repellence, based on the respective sorptivities of 95% ethanol and water in soils. The excel models provided by METER were used to convert measured data into hydraulic conductivity and soil water repellence data, using Van Genuchten parameters for soil texture classes.

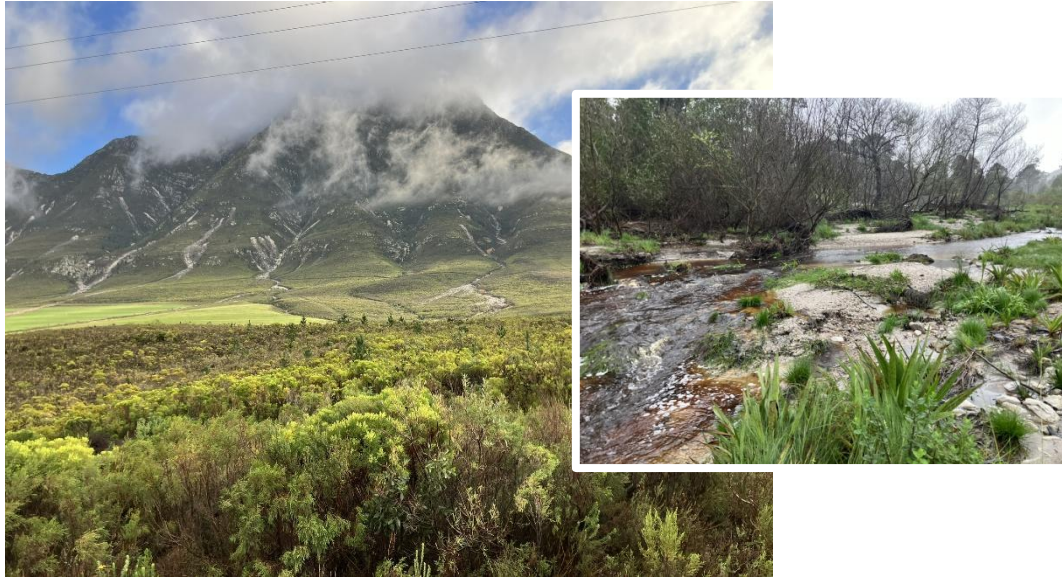
Figure 3.2

Major sediment flows down the Babilonstoring Mountains following major storms in 2023. Inset: Sediment accumulation in the upper reaches of the Onrus River, resulting in large-scale habitat disturbance

However, as noted in SRK (2024), the steep slopes on both sides of the Onrus River valley make the system susceptible to rapid hydrological responses and extreme events. This is borne out by the images in Figure 3.2, which show that, notwithstanding the hard rock formations of the upper catchment, major storms in 2023 resulted in the formation of multiple debris flows off even relatively intact mountain slopes, contributing large sediment loads into the Onrus River via its mountain tributaries (see **Figure 3.2**).

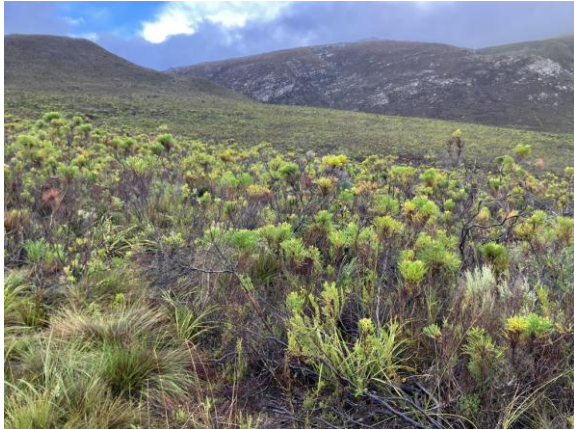
Photo 3A
Wetland seeps in the upper Onrus River catchment

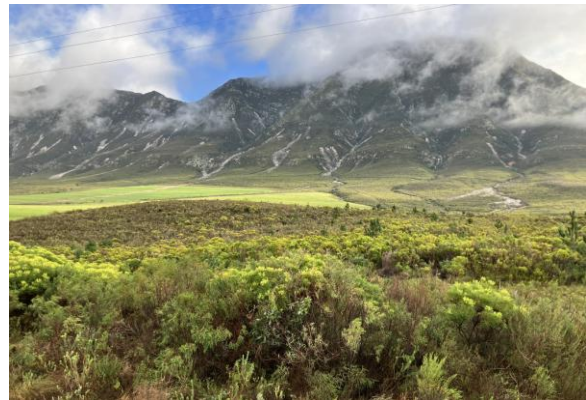
Photo 3B
Sediment debris trails into the Onrus River following severe storms in 2023

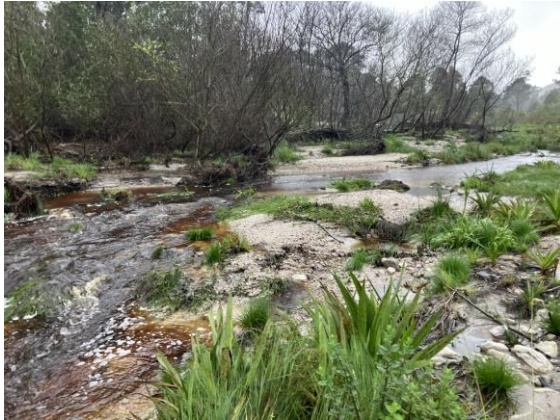
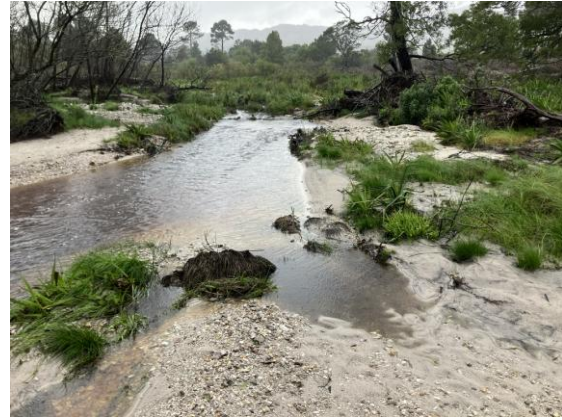
Photo 3C
Sedimentation of the upper Onrus River as a result of erosion in the upstream mountain catchment

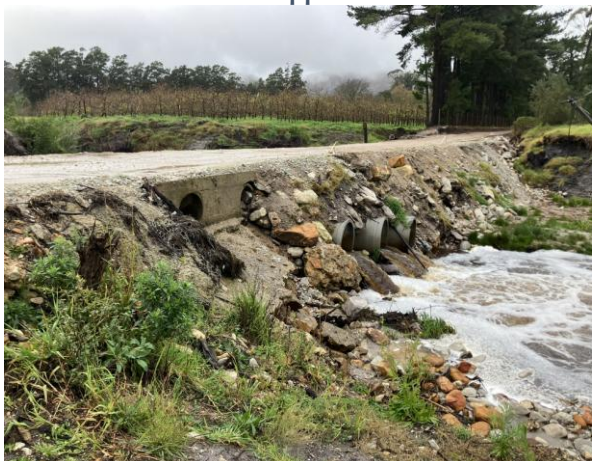
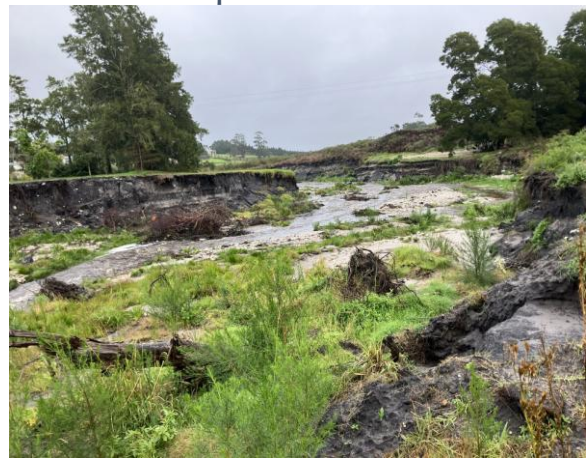
Photo 3D
Large, low-lying culverts in the Onrus River (upper reaches) create concentrated flows into the downstream system, triggering channel incision and resultant loss of valley bottom wetlands, including possible peatlands

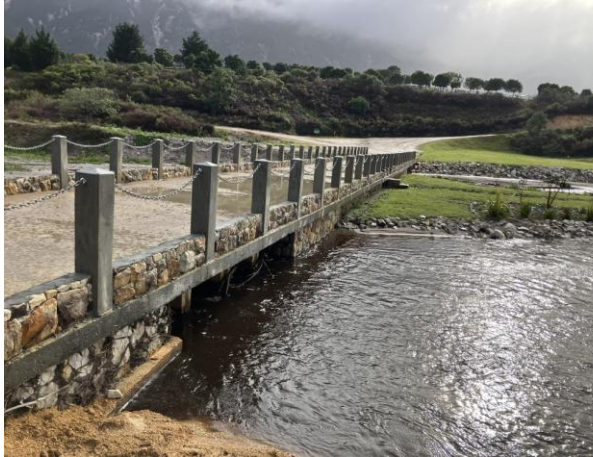
Photo 3E
Upstream view of Onrus River, being entrained through narrow culvert

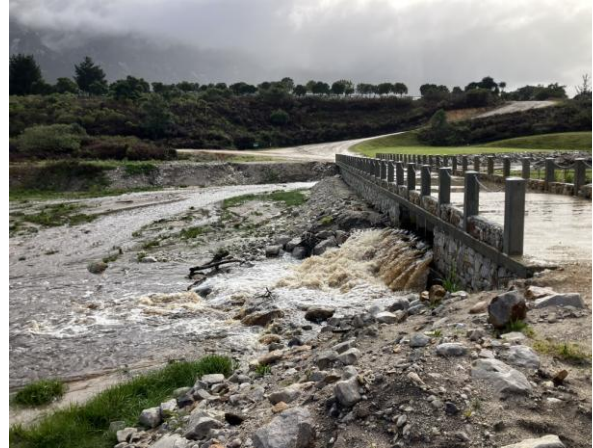
Photo 3F
Downstream view of Onrus River, with concentrated flows through narrow culverts that precipitate downstream erosion and channel incision

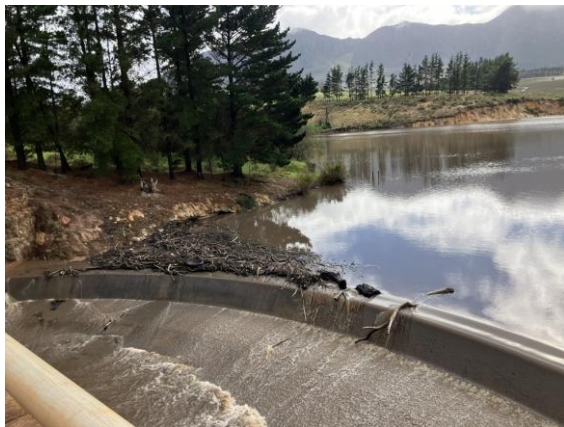
Photo 3G
Spillway at De Bos Dam

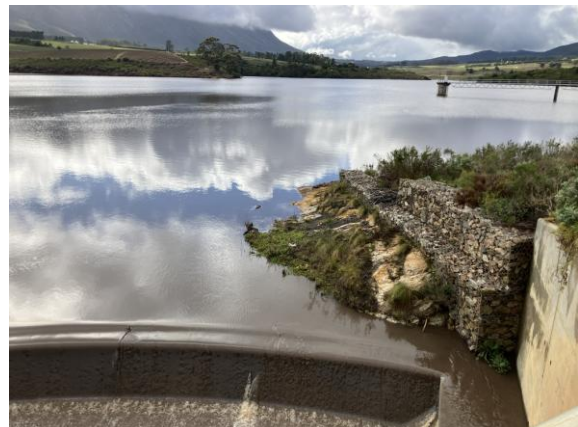
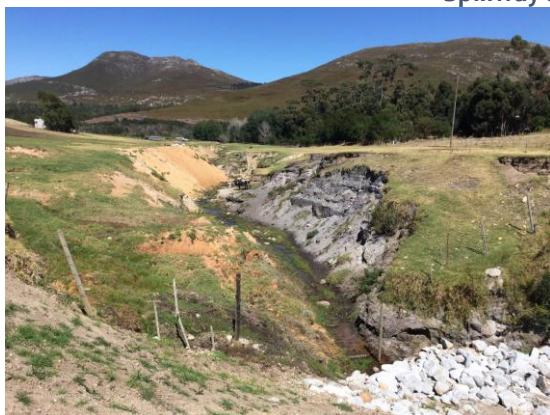
Photo 3H
Unstable, incised flows into the Onrus River from the un-named tributary, passing under the Hemel en Aarde Road

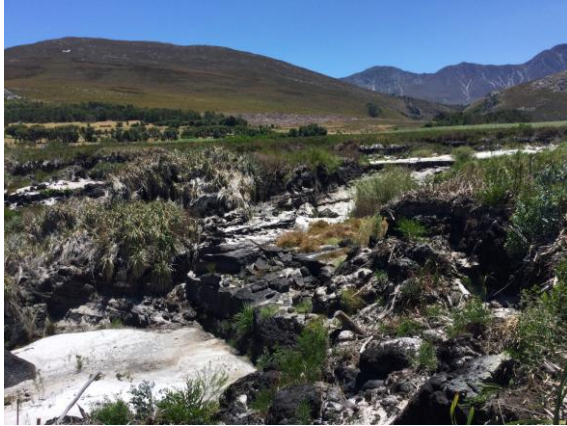
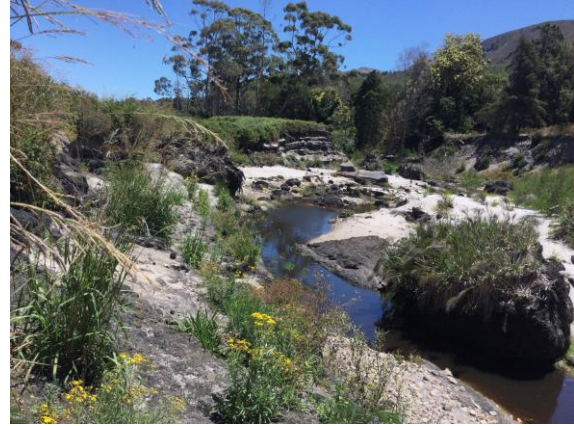
Photos 3J

Degraded Onrus Wetland, showing channel incision and exposure of organic soils

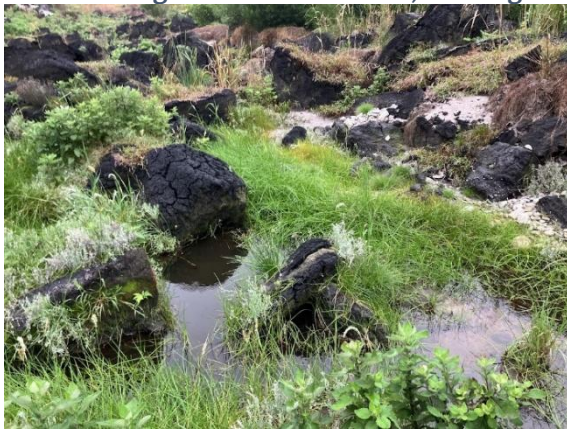
Photo 3K

Establishment of (mainly) indigenous wetland vegetation in incised channel in remnant Onrus wetland

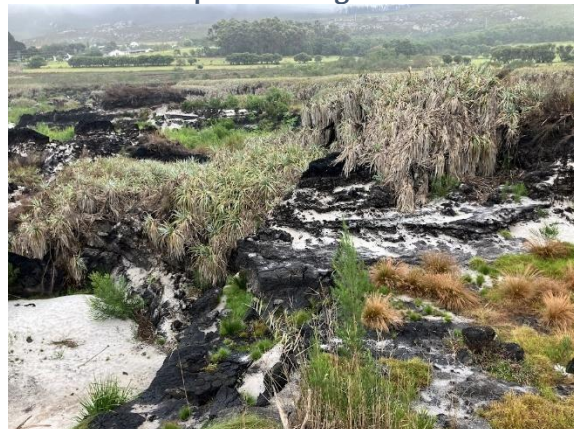
Photos 3L

Dessicated stands of Palmiet vegetation in the Onrus Wetlands, on remnant blocks of decomposing organic soils / peat, with the water table clearly well below the level accessible by these plants,

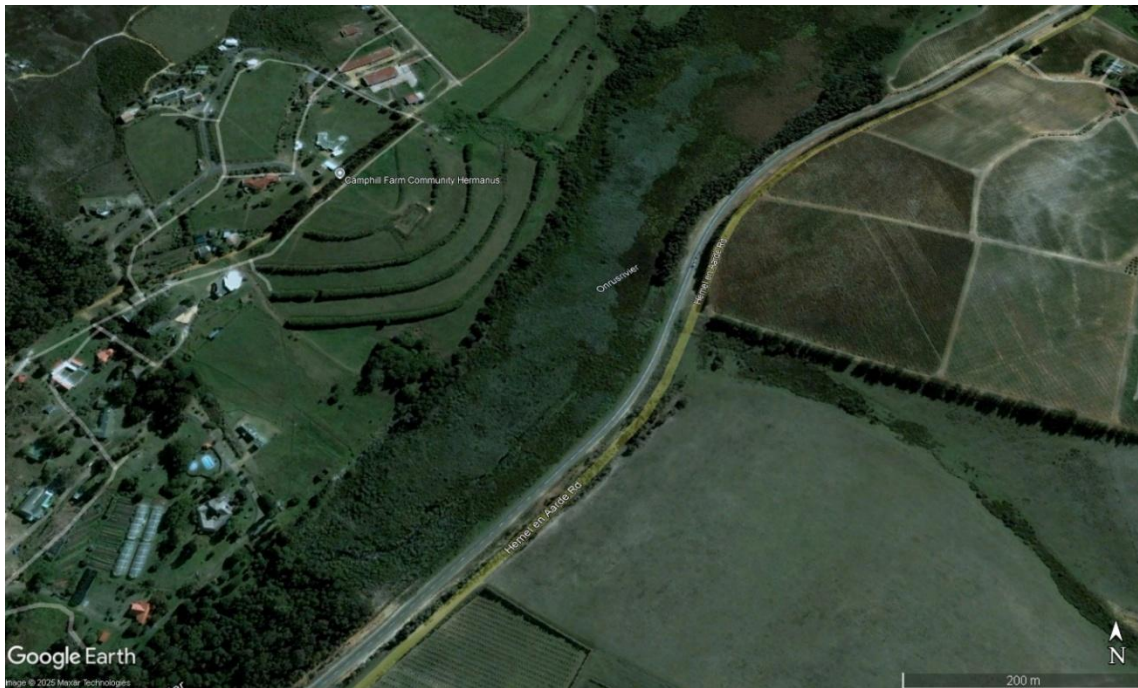
Figure 4.2

2004 image of the Onrus Wetland, with (assumed) erosion channel arrowed and extensive alien vegetation established downstream

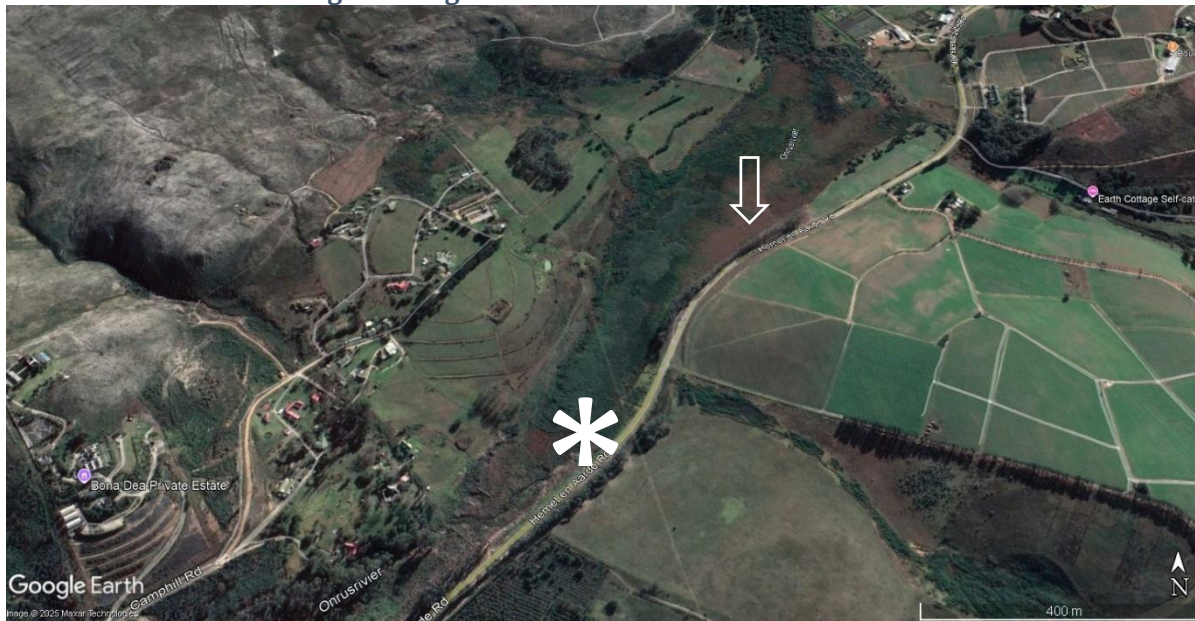
Figure 4.5
2020 image, showing post-fire wetland damage (note discoloured desiccated wetland vegetation, arrowed) and apparent upstream end of incised channel (asterisked).

- **Fires** in the wetland in 2019 resulted in large-scale damage to the peatland, with an estimated 9 ha of wetland surface burning, resulting in some 90 000 m³ peatland being burned and some 330 000 m³ being desiccated, amounting to an estimated total carbon loss of 4 680 t and emissions of 17 176 t of carbon dioxide (data from Grundling et al 2021). The fires were exacerbated by wetland desiccation, linked to gully formation, alien invasion and reduced upstream inflows into the system. The extent of wetland burned triggered reduced water holding capacity in ash-laden sediments and created compromised zones along long sections of the wetland (**Figure 2.6**).

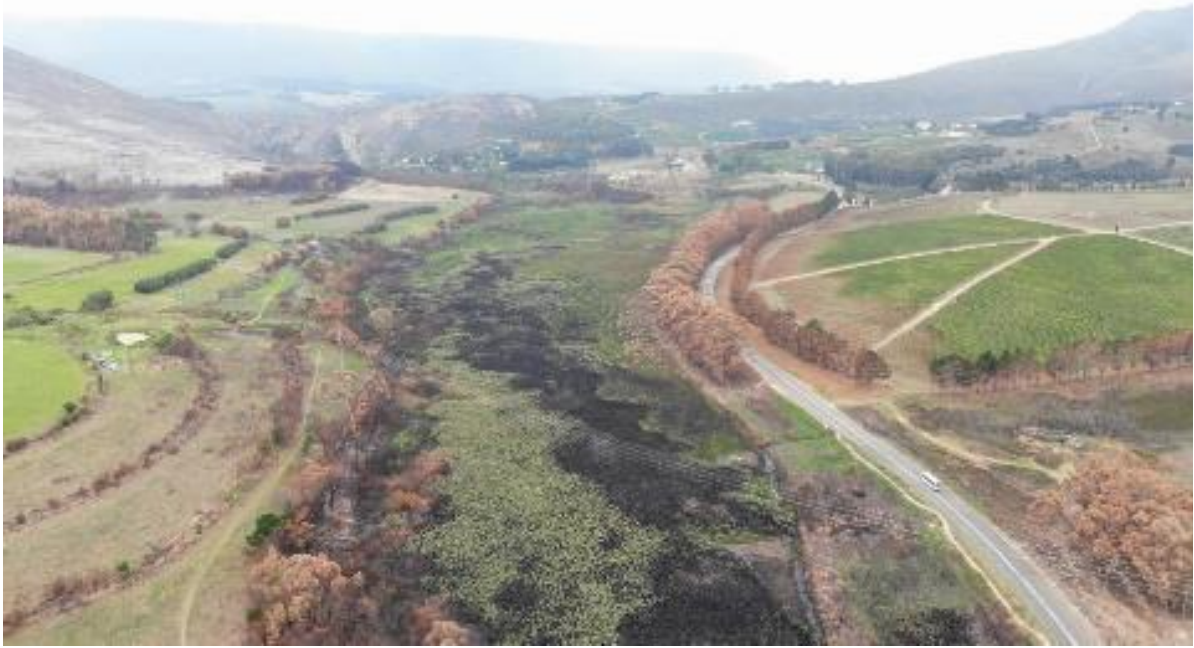
Figure 4.6

The burned Onrus Wetland peat fire of 2019, showing extensive burned pathways along the length of the lower wetland (Photo from Le Roux et al 2023, credited to Onrus Municipality)

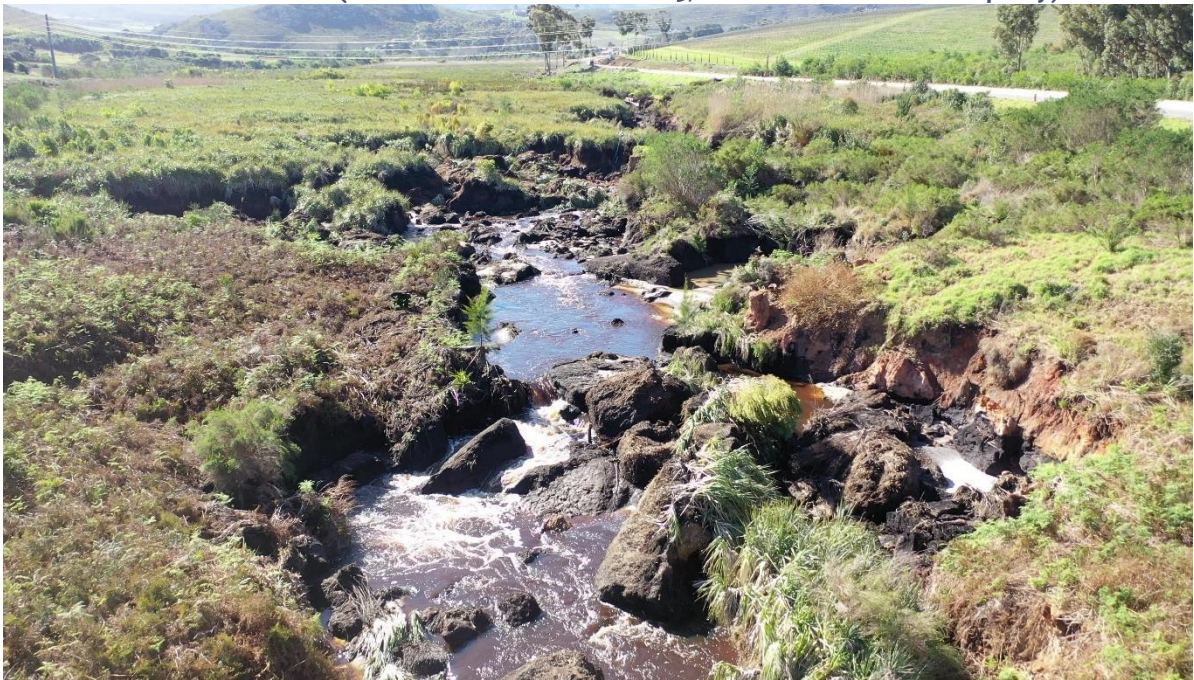
Figure 4.7

2023 image of the headcut incision in the Onrus River wetland (photo after King 2025)

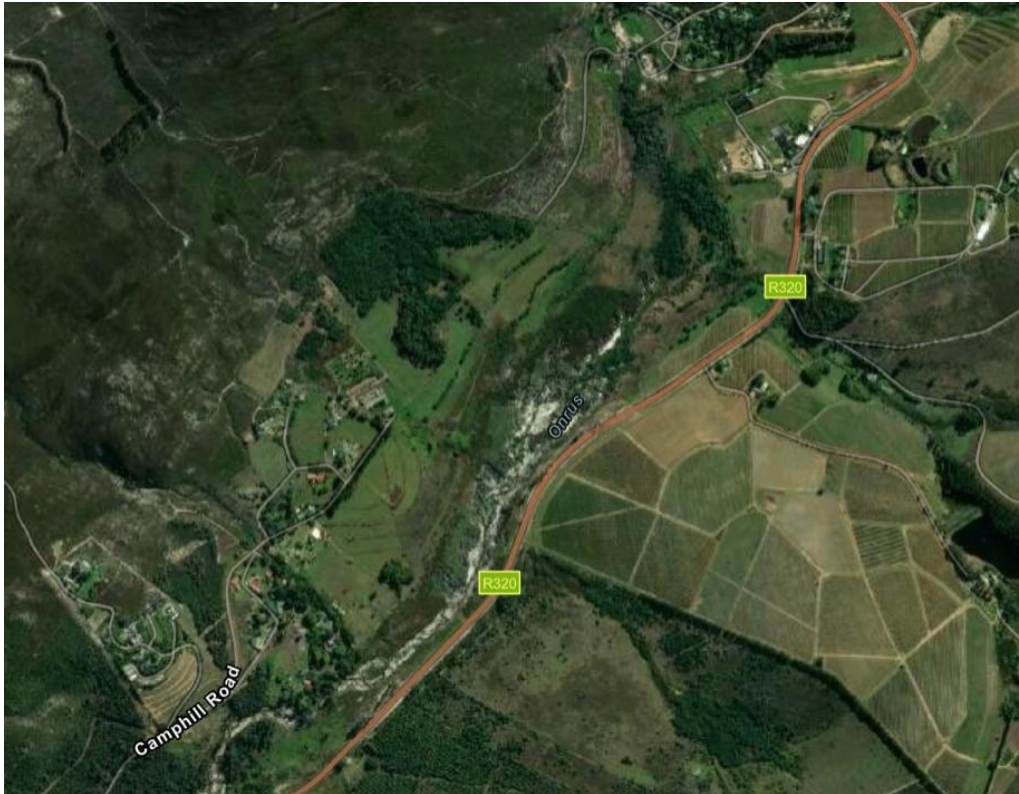
Figure 4.8
2025 image of the Onrus Wetland (image from Cape Farm Mapper) showing largescale erosion post the 2023 and 2024 floods.

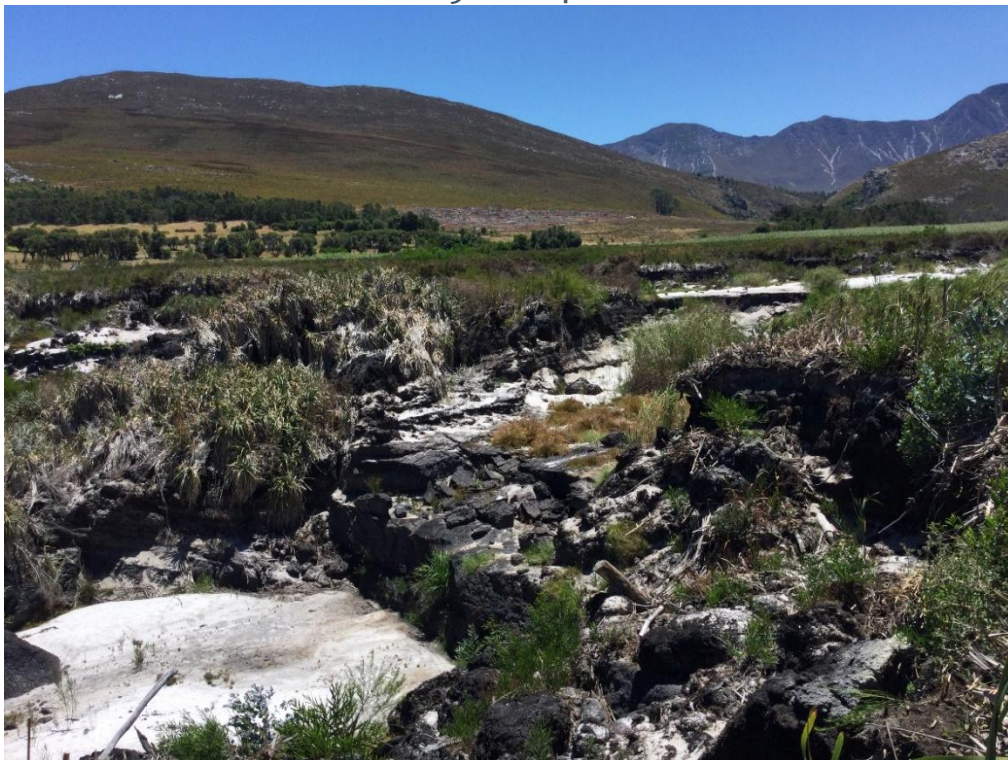
Figure 4.9
Extensive droughting of palmiet wetland as a result of gully erosion, leading to water table draw-down.

- Le Roux et al (2023) noted that the Onrus Wetland upslope of the eroded eastern gully in 2023 was “in pristine condition”. **By the time of the 2024 and 2025 assessments informing the present study, no parts of the wetland could be considered pristine; no intact peat could be found for analysis or mapping; all palmiet vegetation was in a state of desiccation, other than where it had been transported in blocks of peat by floods, and deposited in the incised, wetted channel. Figures 4.9-4.12 illustrate some of these issues.**

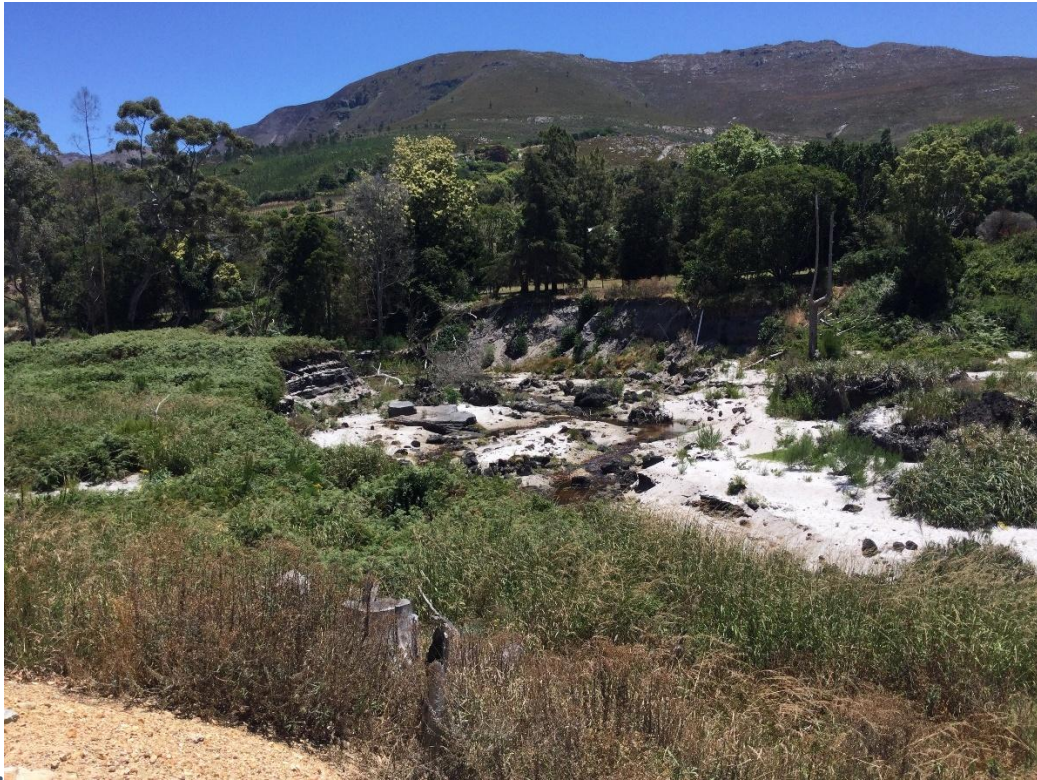
Figure 4.10

Largescale erosion in lower Onrus wetland, showing deposition of inorganic sediments, carried into the wetland from eroded areas upstream, including sediment from debris flows off mountain slopes under flood conditions

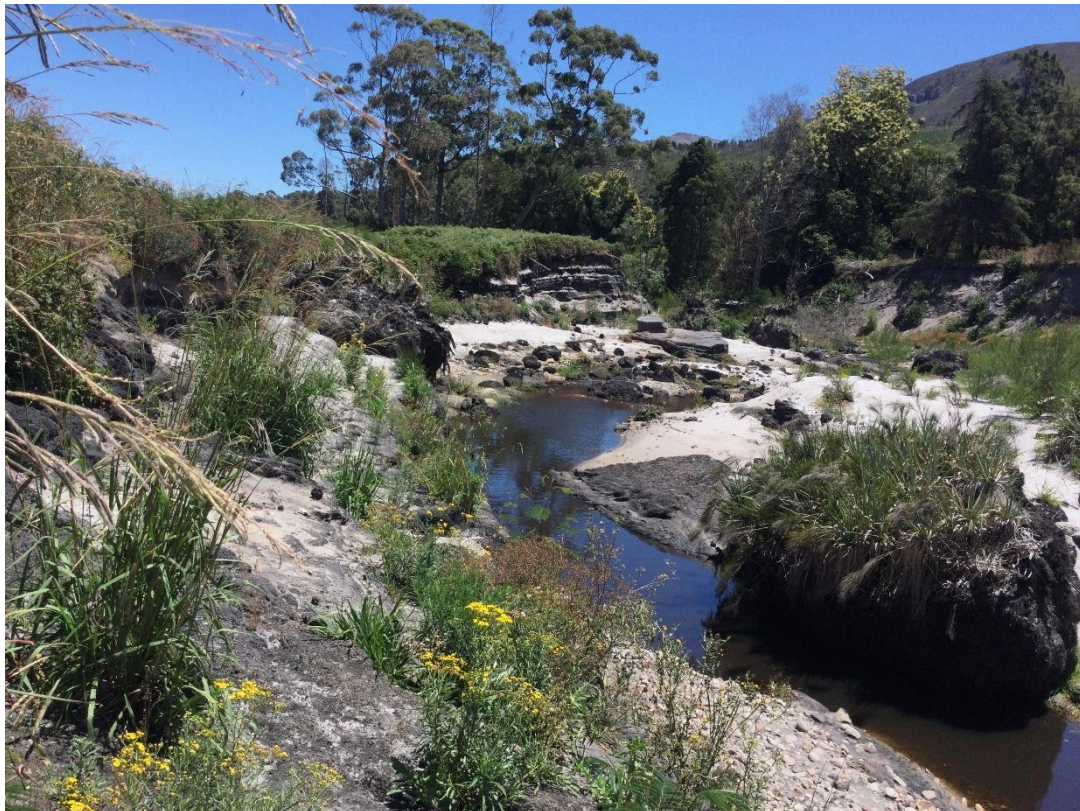
Figure 4.11

Largescale gully erosion, with the photo showing peat blocks transported from upstream and now establishing in some cases in the wetted channel, albeit under desiccating conditions.

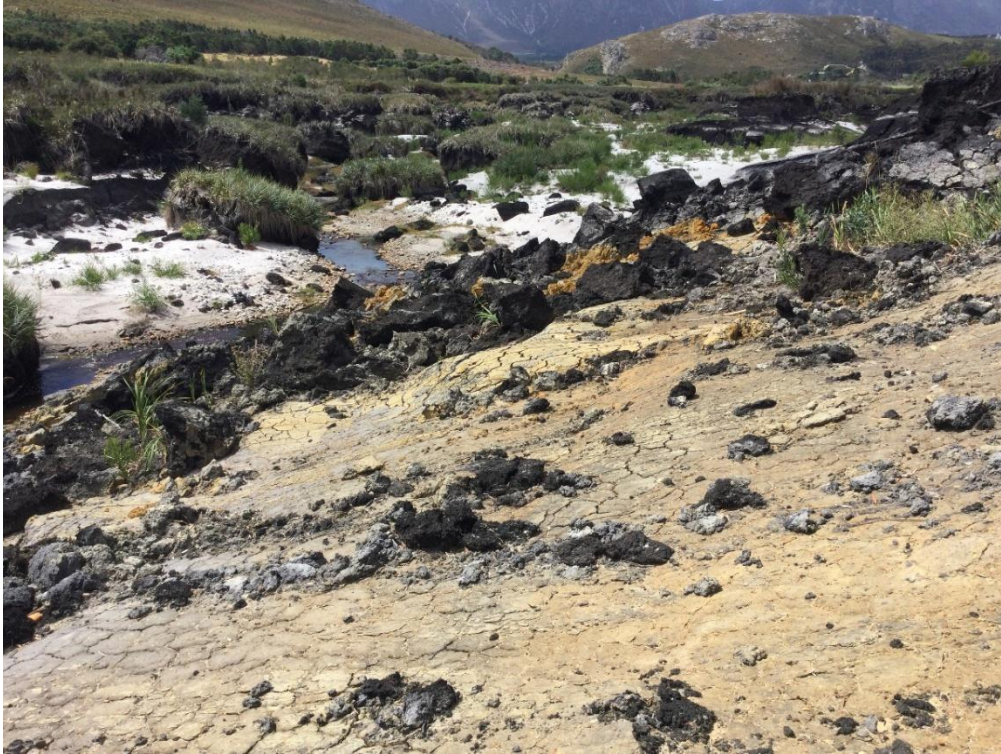
Figure 4.12

Post-flood area where peat layers have slid off underlying clay – Le Roux et al (2023) suggest clay layers here are a relic of past road construction activities, as they are underlain by more peat

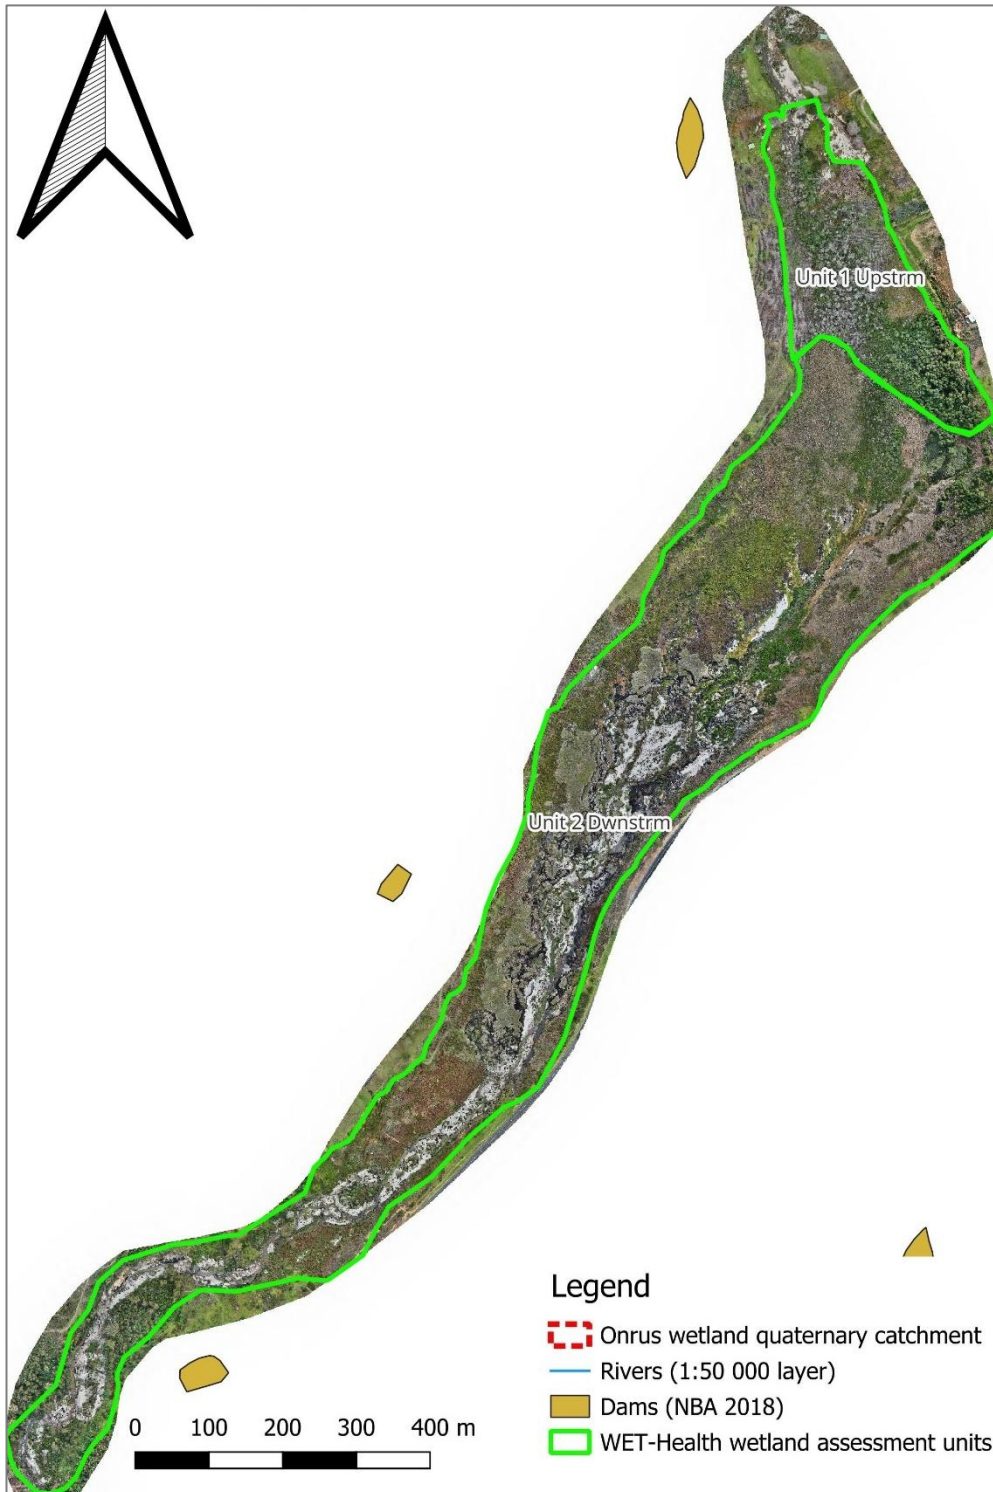
Figure 4.13

Wetland assessment units used in the WET Health assessment. Wetland mapping onto LIDAR image.

The mapped wetland was coarsely divided into two units of analysis, namely Unit 1, including the upper reaches of the wetland from Volmoed downstream, and Unit 2, which comprised the majority of the wetland area, and was defined by wetland visibly affected by headcut erosion / channel incision as shown in the 2025 drone imagery accessed for this study. Droughting of palmiet beds and visible channel incision were used as primary indicators, informed by ground-truthing and on-site observations. **Figure 4.13** shows the relative extent of the two assessment units, noting that their delineation is coarse and, moreover, additional incision and wetland droughting may well have occurred since the images were created.
