# Ecological Health Assessment of the Onrus Estuary

**November 2024**

Citation: Clark B.M, M. Jackson, J. Dawson, M. Armitage, M., A. De Villiers & E. Gammon.  
2024. Ecological Health Assessment of the Onrus Estuary. Report no. 2180/3 prepared by  
Anchor Environmental Consultants (Pty) Ltd for Overstrand Municipality. 67 pp.

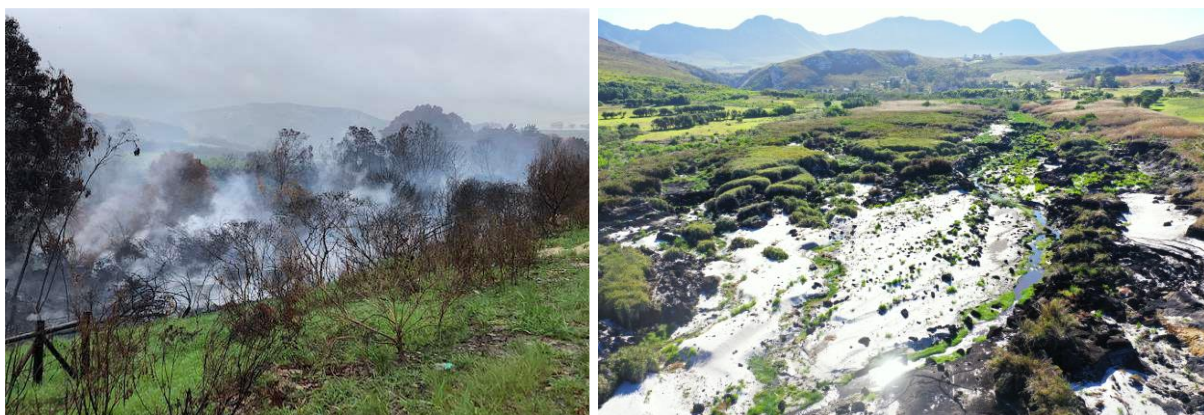
Figure 1-2. Fire in the Onrus wetland (2019) and the wetland after the flood in September 2023.

The Onrus Estuary has recently been severely negatively affected by a 1:100 year flood that occurred in the Onrus catchment in September 2023. This flood resulted in an enormous quantity of sediment being deposited in the estuary which has fundamentally altered hydrodynamic and ecological functioning of the system. Much of the sediment that was deposited in the estuary originated from a major wetland system (the Onrus Wetland) some 4 km upstream of the estuary. This wetland system is in a poor state of health having been subject to a long history of abuse. It has been drained for agricultural purposes for the past 70 years, and has experienced significant sediment losses and geomorphological changes as a result of natural and accelerated erosion (Grundling et al 2019). The peat which underlies the wetland has become desiccated, and alien invasive plant species have started to colonise degraded parts of the wetlands. An uncontrolled veld fire ignited the desiccated peat in the wetland in 2019 which further destabilised the system, laying the ground for the massive loss of sediment, peat and vegetation from the wetland in 2023 (Figure 1-2).

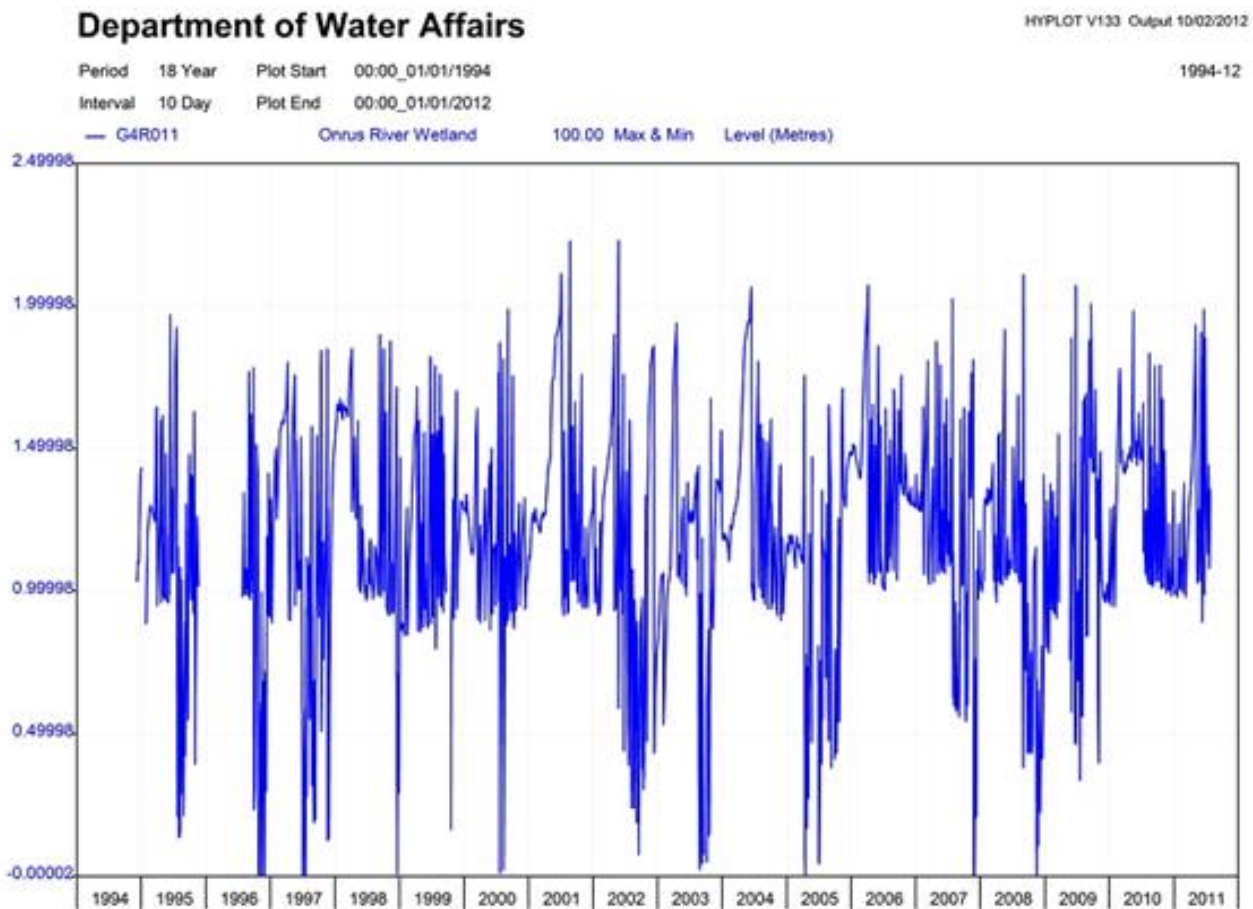
Figure 3-2. Water level in the Onrus Lagoon for the period 1994-2011, indicating occasions when the estuary drained after breaching of the sandbar (Source: Onrus Lagoon water level gauge G4T011, Department of Water and Sanitation). Location of the gauge is indicated on Figure 3-3.

There is some historic data on water level variation in the Onrus Estuary for the period 1994 - 2011 (Figure 3-2). The estuary drained at least a dozen times over this period which suggests that the sandbar at the estuary mouth was still regularly breached when floods were large enough. These open mouth periods tended to last for a few weeks to months based on data from the flow gauging station located within the estuary (Figure 3-2 and Figure 3-3).

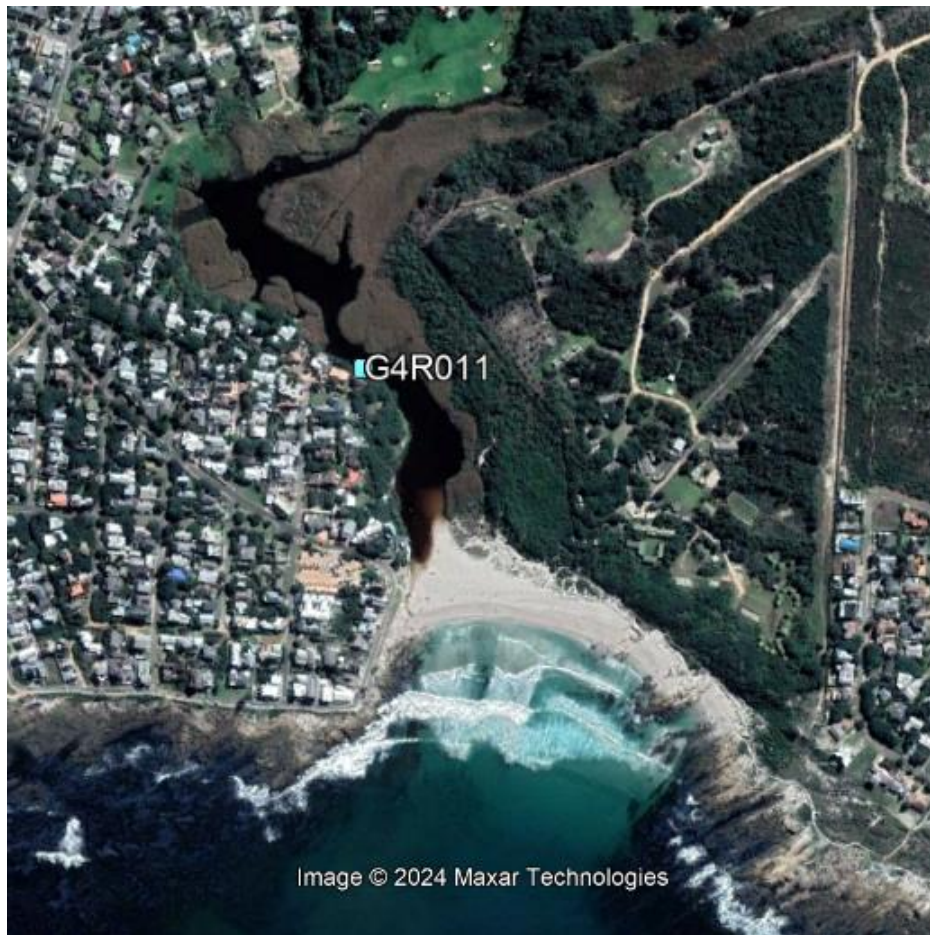
Figure 3-3. Location of the water level gauge (G4R011) in the Onrus Estuary.

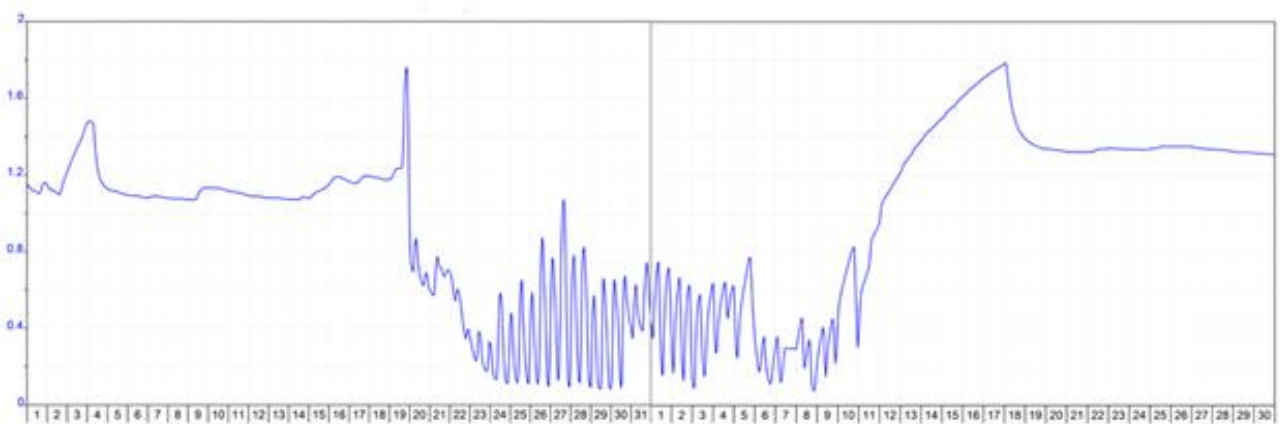
Figure 3-4. Data from the Onrus Lagoon water level gauge plotted for one-hour intervals for the period 1 October to 30 November 2012. The lagoon breached naturally on 19 October 2012 following heavy rainfalls. (Source: DWS).

It is likely though that De Bos Dam has attenuated flood flows to some extent and also the frequency at which the sandbar (berm) is breached. Lower flows are also likely to have resulted in the mouth closing sooner after breaching than prior to the commissioning of the dam (Van Niekerk and Turpie 2012). This is evident when considering the natural mouth breach that occurred on 19 October 2012 following heavy rainfalls. First the water level increased, then the lagoon drained, after which tidal fluctuations were evident for a short period (three weeks) before the mouth closed once more ( Figure 3-4and Figure 3-5).

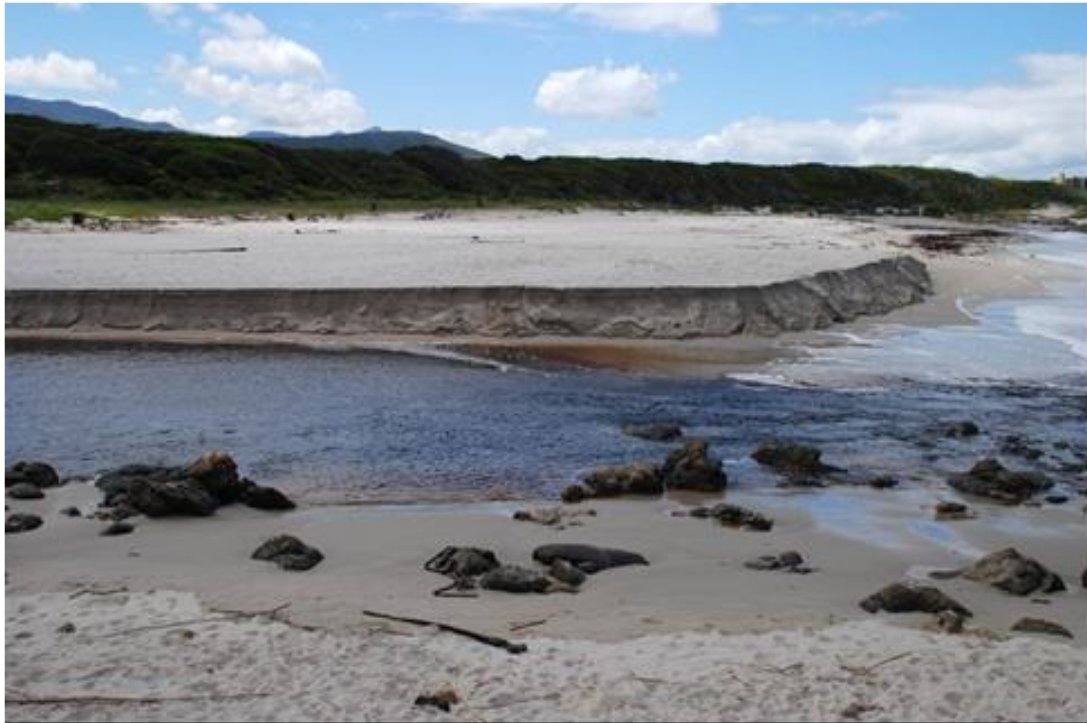
Figure 3-5. The estuary mouth on 23 October 2012, following the natural breaching on 19 October.

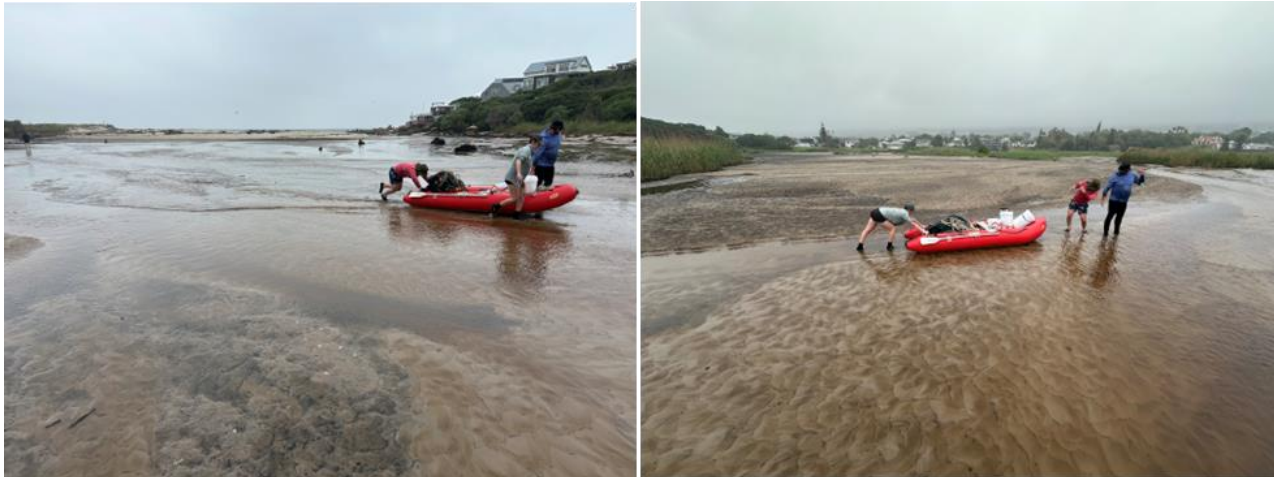
Figure 3-9. Extensive sedimentation in the Onrus Estuary following the floods in September 2023 have all but eliminated open water and deeper channel habitat in the estuary to the extent that it is no longer even possible to navigate with a small inflatable boat on the estuary.

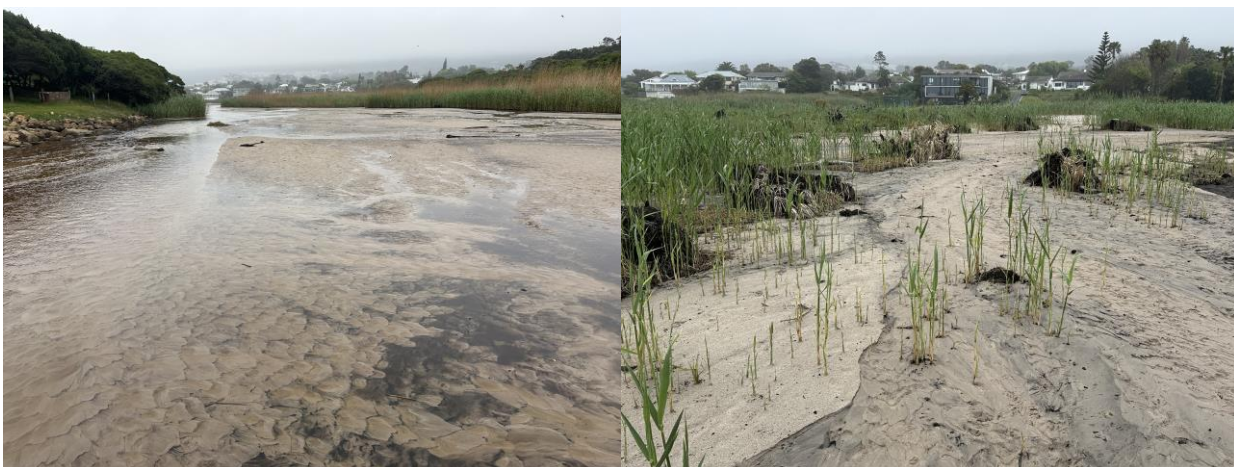
Figure 4-5. Extensive infilling of the Onrus estuary channel and other open water areas means that it is now ripe for invasion by *Phragmites australis*.

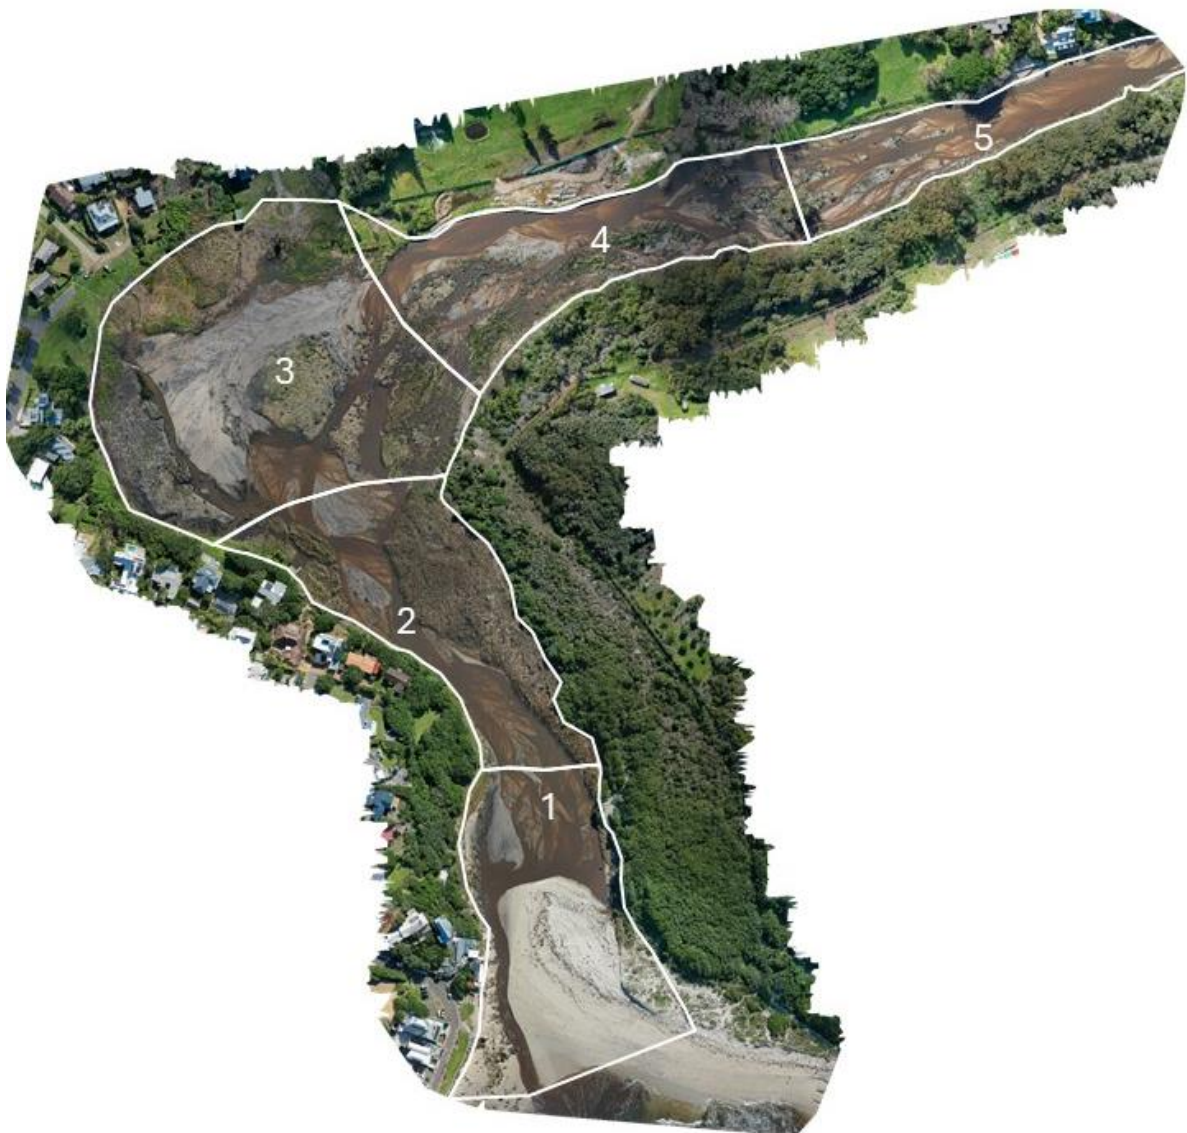
Figure 4-9. Waterbird counting areas on the Onrus Estuary.

A survey of the estuary in 2024 was conducted as part of this study. Waterbirds present on the estuary were counted in five discrete areas encompassing the full extent of the estuary functional zone (Figure 4-9). A total of 39 water birds from nine species were recorded (Table 4-18). This is very similar to the numbers of birds recorded by Underhill & Cooper (1983) but is very much more depauperate than the bird fauna recorded by Damstra (1980). This suggests that bird number and species composition has changed quite dramatically since the 1970s but possibly not as much since the 1980s. Alternatively, the survey by Underhill & Cooper (1983) may have been conducted under suboptimal conditions. Low numbers of waders and absence of wading birds on the estuary is consistent with the poor (or absence of any) tidal exchange and low invertebrate and fish biomass in the estuary.
