MAINTENANCE MANAGEMENT PLAN FOR THE ONRUS ESTUARY, HERMANUS

Citation: Armitage, MPA, Jackson, MJ, Swart, C, & Clark, BM. 2024. Maintenance Management Plan for the Onrus Estuary, Hermanus. Report no. 2180/2 prepared by Anchor Environmental Consultants (Pty) Ltd for Overstrand Local Municipality 151 pp.

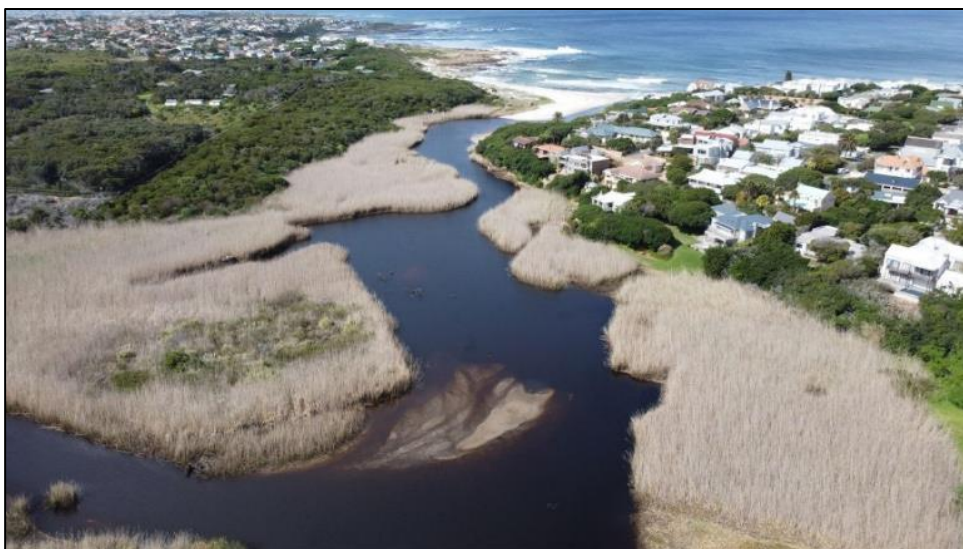
Figure 3.3. Aerial view of the Onrus Estuary before the 2023 floods (Onrus River Estuary Forum (O.R.E.F, No Date)).

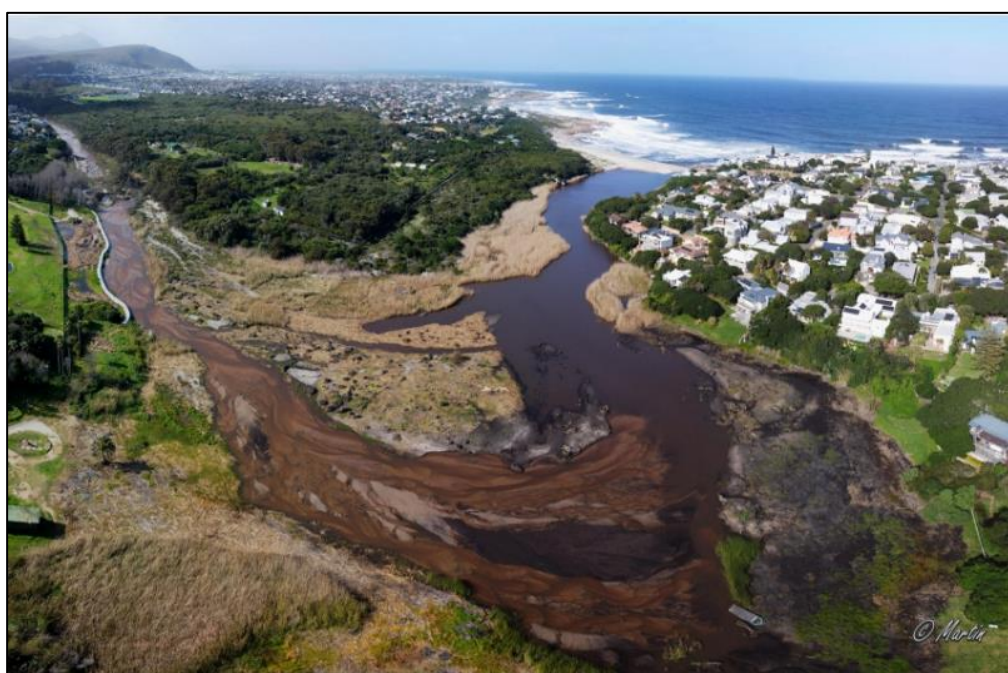
Figure 3.4. Aerial photograph of the Onrus Estuary following the September 2023 floods.

The situation changed dramatically following the September 2023 “Heritage Day” flood event. This flood—which is estimated to have exceeded the 1/100 year flood recurrence interval due to its intensity—resulted in substantial erosion of the Palmiet Peat Wetlands located upstream (Table 3.1). These floods had significant estuarine impacts, and resulted in the infilling of the entire estuarine channel with sediment, with an excess of 1 metre of vertical sediment deposition occurring in most of the central channel since the 2021 survey, with deposition exceeding 2 metres in some areas (Table 3.1, Figure 3.8, and Figure 3.9). This led to almost the entire central estuarine bed area being infilled with sediment, with only a small channel present between the western bend and the mouth. The floods also resulted in the washing away and/ or burying of much of the Phragmites reedbeds, as well as erosion and destruction to property on the western edge of the estuary (Figure 3.4).

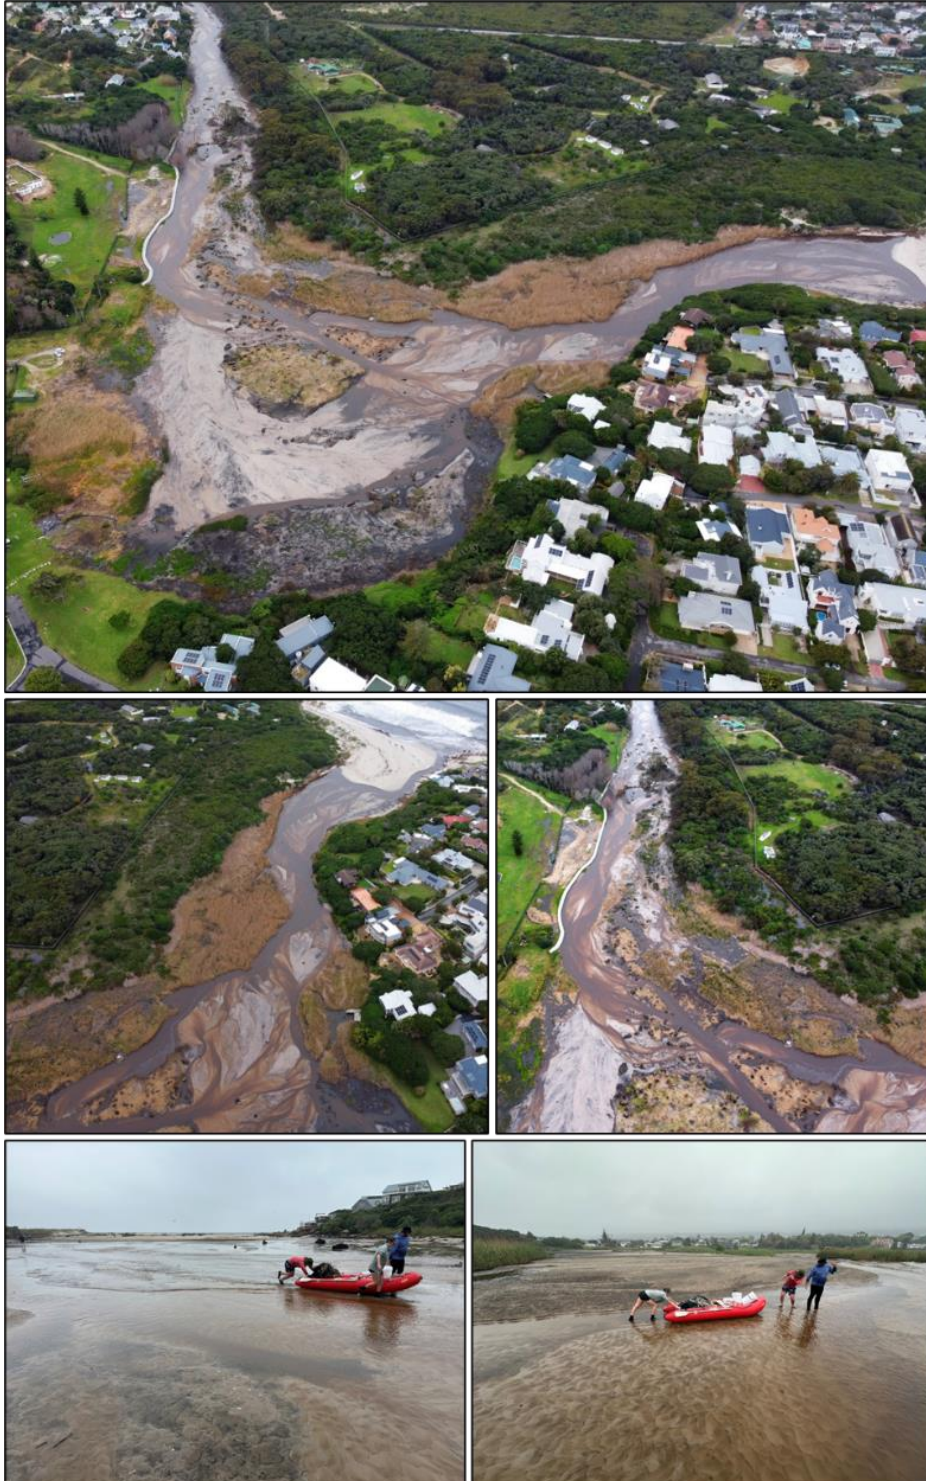
Figure 3.5. Top and Middle: Aerial drone photography of the Onrus Estuary captured in July 2024 (King 2024). Bottom: Images captured during the October 2024 Ecological Health Survey showing the extensive sedimentation and absence of an estuarine water body.

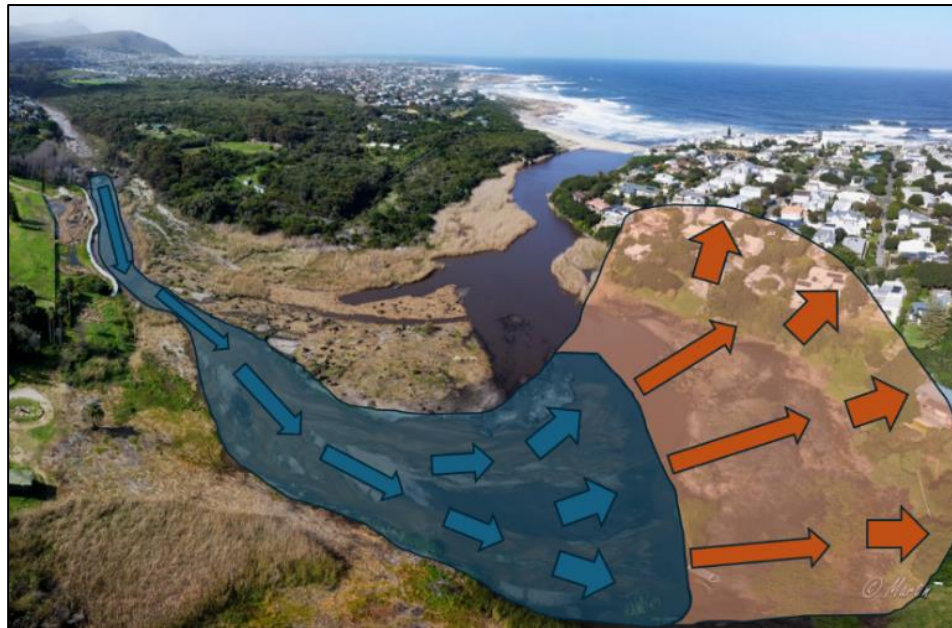
Figure 3.11. Blue: movement of sediment and floodwaters into the estuary during the September 2023 floods. Orange: anticipated flooding and sediment deposition within the Town of Onrus during future flood events should current conditions persist.

The above condition is greatly concerning, as future floods—even those of much lesser magnitude than those in 2023—can be expected to wash directly into the estuary with great velocity. These floodwaters will then directly overtop along the western estuarine bend due to the absence of a sizeable receiving basin and energy-dampening vegetation and (represented visually in Figure 3.11 below) and will likely flood the town of Onrus. Such flooding has the potential to damage residential properties and place residents at risk of drowning. Furthermore, local infrastructure will also be threatened—and potentially compromised—with the Onrus Main Sewage Pump Station (located to the west of the bend, and just out of shot in Figure 3.11) being particularly at risk. Should the pump station be compromised due to flooding, there would be a breakdown in sanitation infrastructure. This will likely result in sewage spills, both at the pump station itself, as well as from the surrounding sewage reticulation network which is dependent upon it. Such spills represent a threat to both human and ecological health due to pollution with bacteria, ammonia, and other nutrients. Finally, such a flood event will likely deposit large volumes of sediment in the town itself, therefore leading to an additional maintenance/ cleanup burden for local service providers and residents.

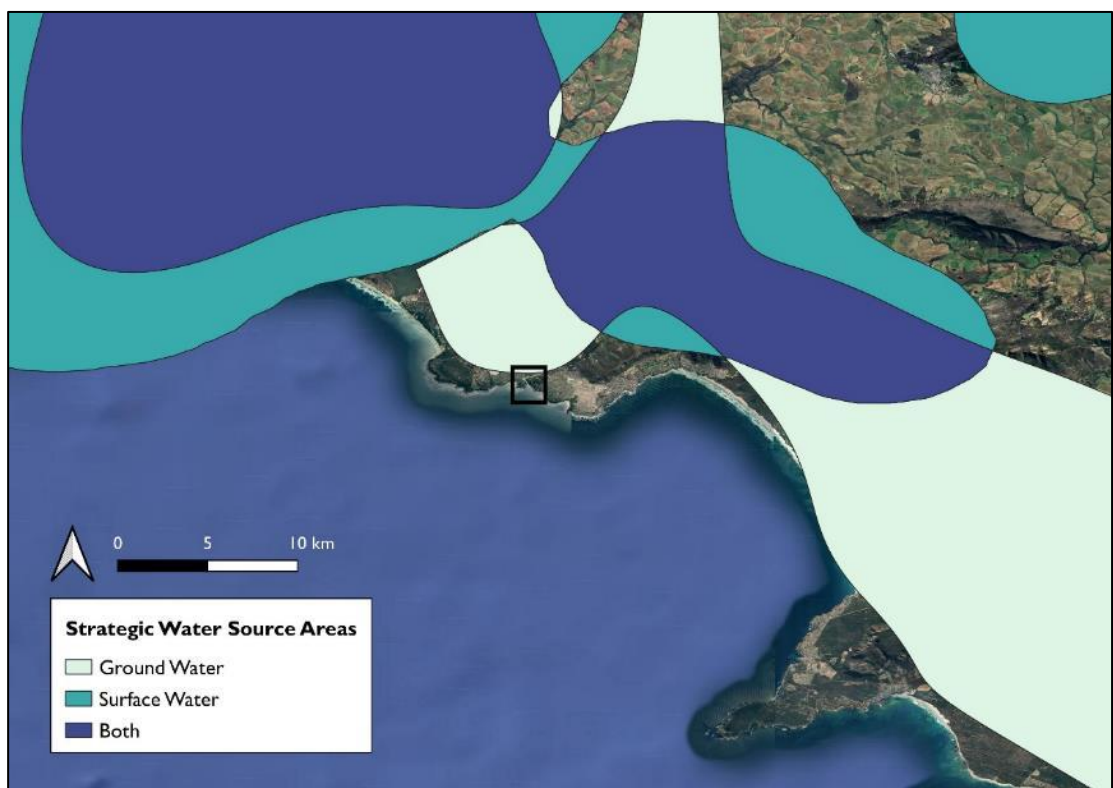
Figure 3.21. The Onrus Area in relation to delineated Strategic Water Source Areas.

The Onrus Estuary falls to the south of a Strategic Water Source Area (SWSA), specifically a groundwater source (Figure 3.21). These areas are important as the groundwater which forms here is a nationally important resource and the area has a high groundwater recharge potential (Le Maitre et al. 2018). The Onrus Estuary itself is fed by both surface water and ground water SWSAs located to the northeast of the estuary. However, given that the lower Onrus River and Estuary are located at the downstream end of all the above-mentioned sources, the

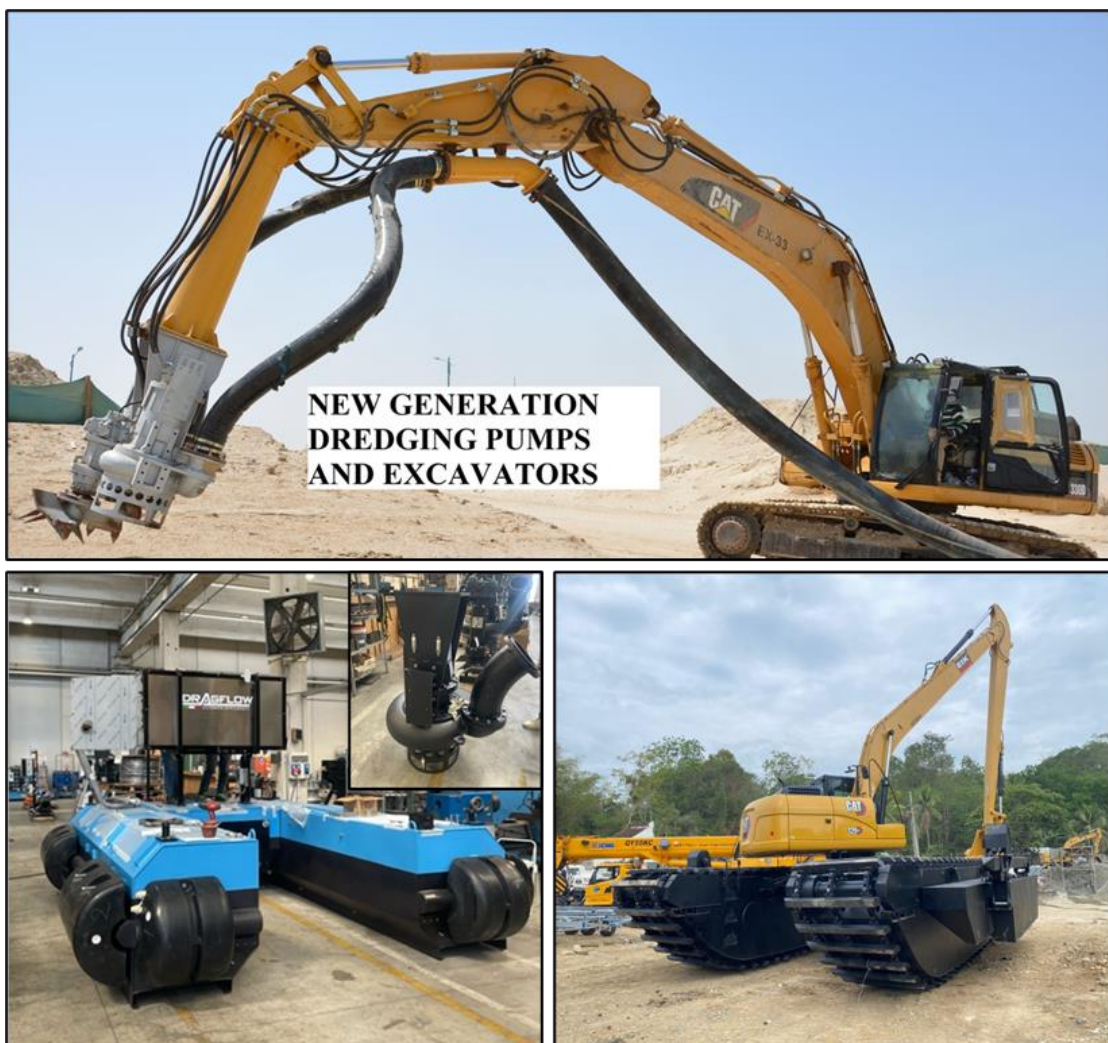
Figure 5.5. Dredge equipment proposed to be used to be dredged the estuary.

Dredging is proposed to utilise the following items of equipment (Figure 5.5)

- 1 x Amphibious 20 tonne Excavator
- 1 x Remote Controlled dredger
- 1 x 350 kVA Diesel generator
- 1 x 23 tonne Excavator
- 1 x 23 tonne Excavator
- 2 x 10 m³ Tipper Truck
- 1 x Tractor Loader Backhoe (TLB)
- 1 x D6 Bulldozer
- 4 x Motor Vehicles (cars)
- 2 x Articulated Dump Trucks
- 1 x 10–20 tonne Roller

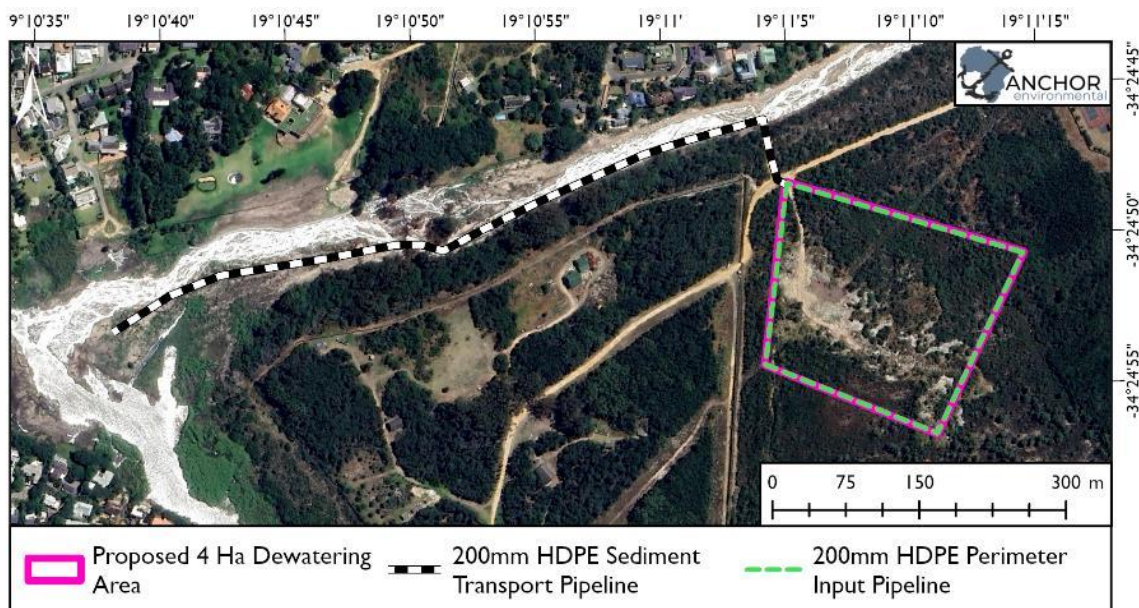
Figure 5.7. Proposed sediment dewatering area and supporting transport/ input pipelines.

Dewatering the proposed sediment volumes is anticipated to require between 4–6 ha of open land. The proposed dewatering site is situated in the western portion of ERF 2834, located just to the east of the neighbouring Habonim Property (Figure 5.7).

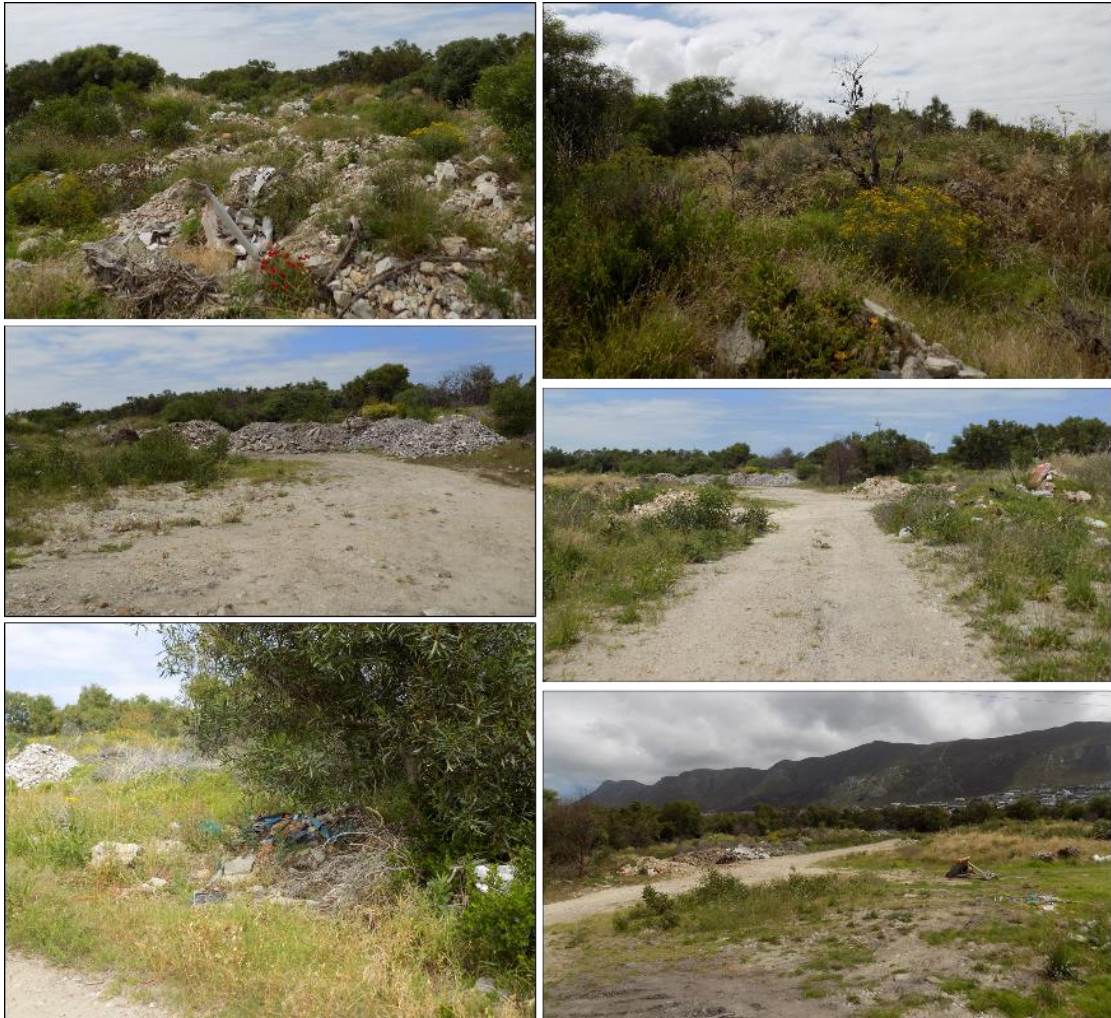
Figure 5.9. Proposed dewatering site on the De Zandt Property. Take note of the extensive infestation of invasive Port Jackson *Acacia saligna*, and signs of illegal dumping.

- There is sufficient space available for all dewatering activities to occur at a single site.
- The site is not located on the estuarine bank/ immediate riparian areas, and does not threaten the integrity of any indigenous fringing vegetation, or pose a threat of bank destabilisation.
- The site is located close enough to the estuarine channel, which reduces complexity associated with sediment transport and minimises impacts associated with depositing sediment and water into the terrestrial environment.
- The selected site, and surrounding area, are heavily disturbed by alien species, and is therefore of little ecological value.
- The site falls within an area slated for a large mixed-use development for which EA has been granted.

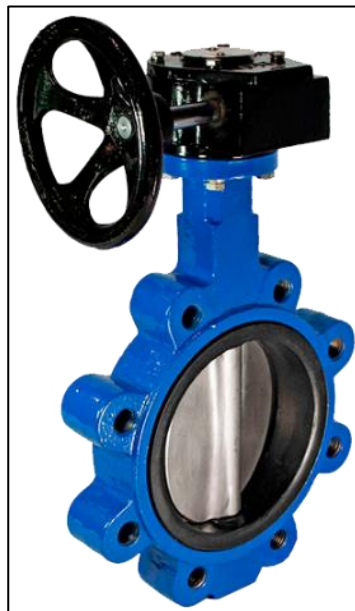
Figure 5.10. Example of a manually operated butterfly valve (Image source: CMO Valves.com 2024).

- Once dredging commences, the sediment will be pumped as a semi-liquid slurry through the ~1.5 km HDPE pipeline from the dredge site to the dewatering area. This pipeline will be placed along recent sediment deposits and will exit the channel at the location of the old bridge—now washed away—and will follow the existing dirt road to the dredge site. By following this route, there will be no need to unnecessarily disturb additional bank area.
- Once at the dewatering site, the sediment will be pumped through an additional length of 200 mm HDPE pipe, which will run along the perimeter of the site. This pipe will have three manually operated butterfly valves, each feeding 110 mm outlets (Figure 5.10). These outlets will be strategically placed around the dewatering area so that sediment inflows can be directed to specific components of the dewatering site.
