Ecological Health Assessment of the Onrus Estuary

November 2024

Citation: Clark B.M, M. Jackson, J. Dawson, M. Armitage, M., A. De Villiers & E. Gammon.
2024. Ecological Health Assessment of the Onrus Estuary. Report no. 2180/3 prepared by
Anchor Environmental Consultants (Pty) Ltd for Overstrand Municipality. 69 pp.

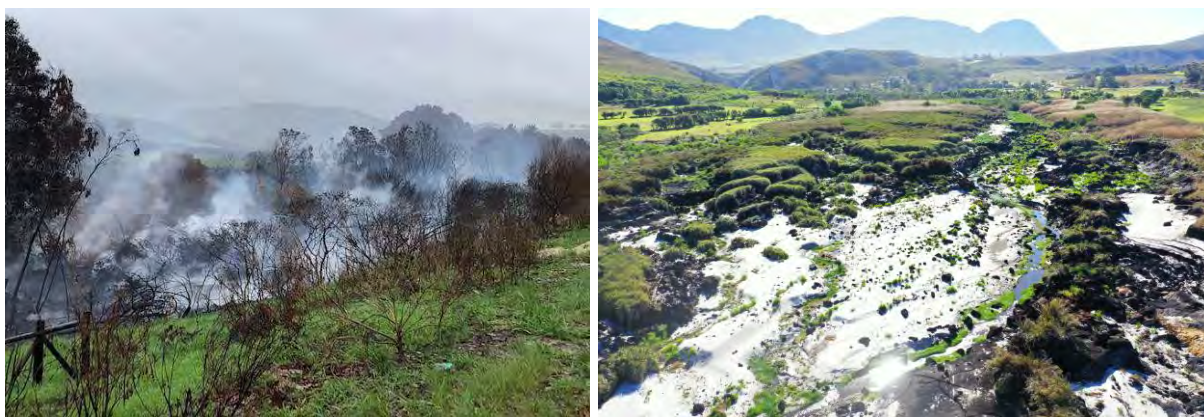
Figure 1-2. Fire in the Onrus wetland (2019) and the wetland after the flood in September 2023.

The Onrus Estuary has recently been severely negatively affected by a 1:100 year flood that occurred in the Onrus catchment in September 2023. This flood resulted in an enormous quantity of sediment being deposited in the estuary which has fundamentally altered hydrodynamic and ecological functioning of the system. Much of the sediment that was deposited in the estuary originated from a major wetland system (the Onrus Wetland) some 4 km upstream of the estuary. This wetland system is in a poor state of health having been subject to a long history of abuse. It has been drained for agricultural purposes for the past 70 years, and has experienced significant sediment losses and geomorphological changes as a result of natural and accelerated erosion (Grundling et al. 2019). The peat which underlies the wetland has become desiccated, and alien invasive plant species have started to colonise degraded parts of the wetlands. An uncontrolled veld fire ignited the desiccated peat in the wetland in 2019 which further destabilised the system, laying the ground for the massive loss of sediment, peat and vegetation from the wetland in 2023 (Figure 1-2).

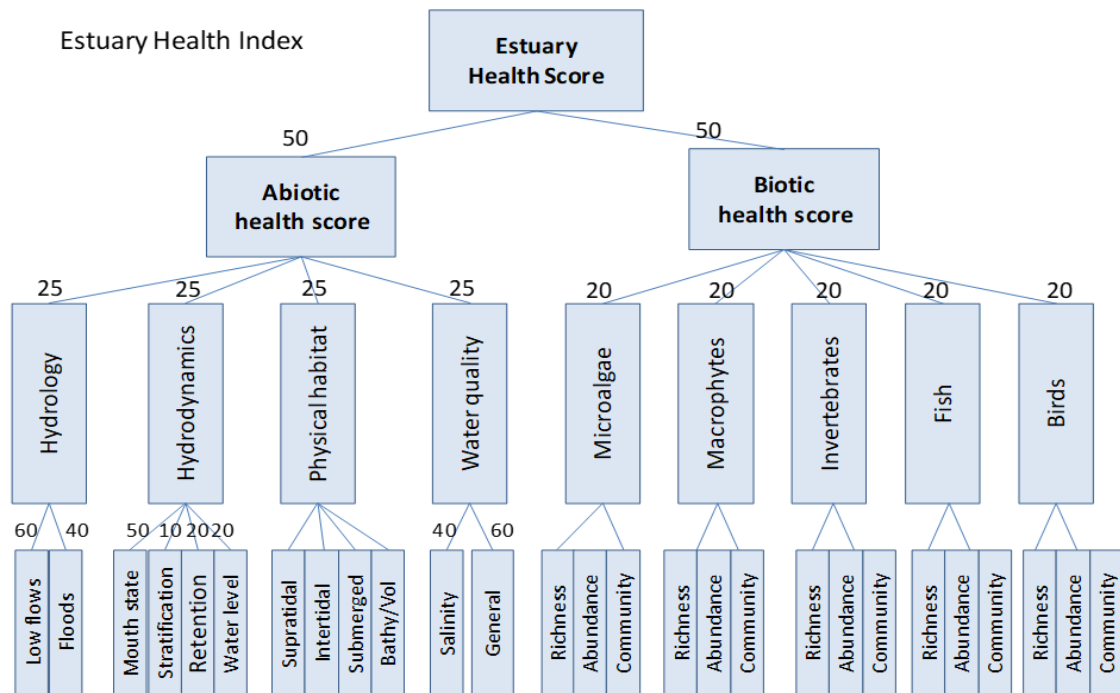
Figure 2-1. Contribution of abiotic and biotic parameters to the Estuary Health Index. Numbers indicate weighting. (Source: Turpie et al. 2012).

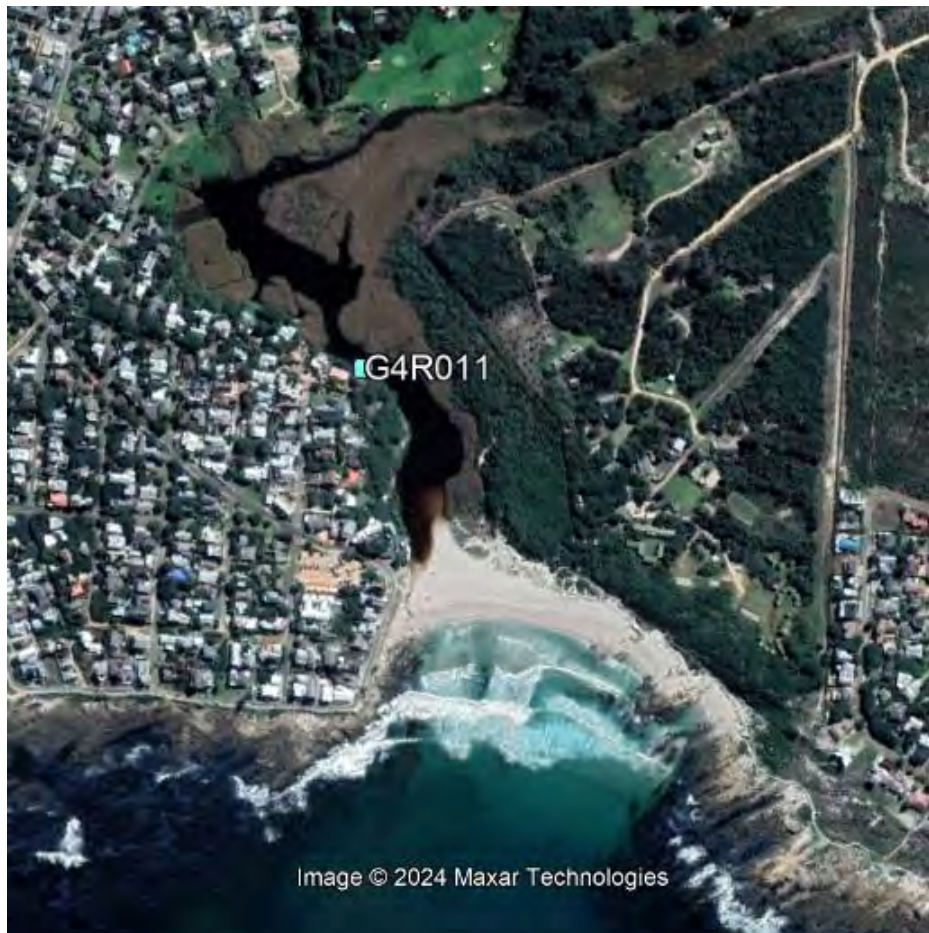
Figure 3-3. Location of the water level gauge (G4R011) in the Onrus Estuary.

There is some historic data on water level variation in the Onrus Estuary for the period 1994 - 2011 (Figure 3-2). The estuary drained at least a dozen times over this period which suggests that the sandbar at the estuary mouth was still regularly breached when floods were large enough. These open mouth periods tended to last for a few weeks to months based on data from the flow gauging station located within the estuary (Figure 3-2 and Figure 3-3).

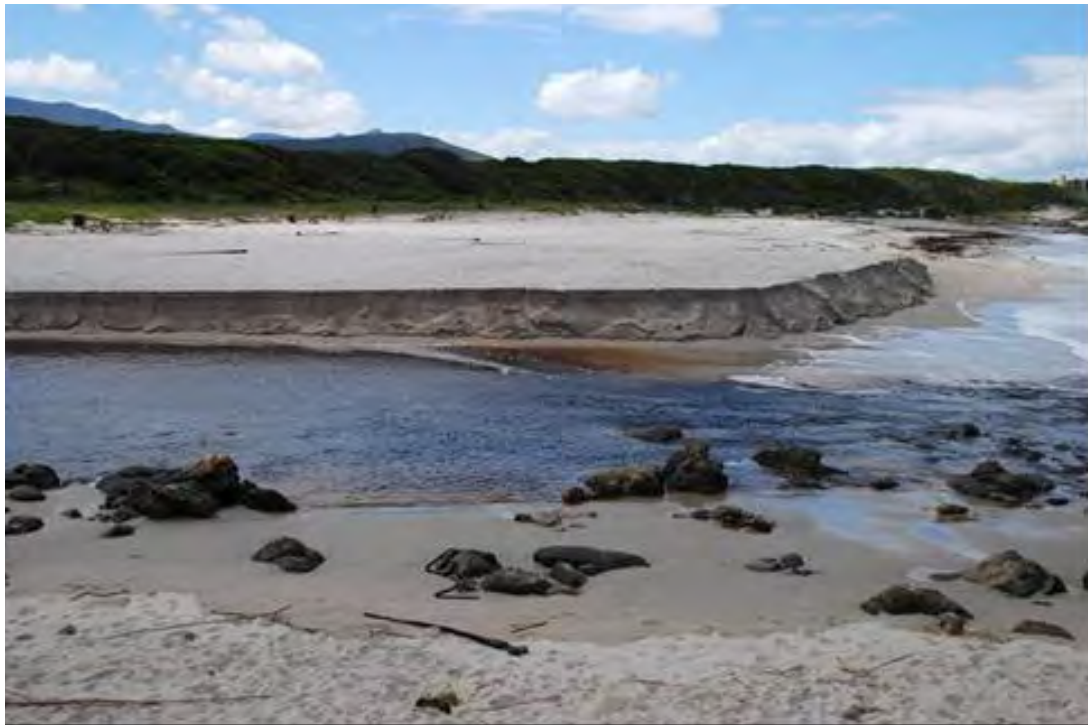
Figure 3-5. The estuary mouth on 23 October 2012, following the natural breaching on 19 October.

It is likely though that De Bos Dam has attenuated flood flows to some extent and also the frequency at which the sandbar (berm) is breached. Lower flows are also likely to have resulted in the mouth closing sooner after breaching than prior to the commissioning of the dam (Van Niekerk & Turpie 2012). This is evident when considering the natural mouth breach that occurred on 19 October 2012 following heavy rainfalls. First the water level increased, then the lagoon drained, after which tidal fluctuations were evident for a short period (three weeks) before the mouth closed once more (Figure 3-4and Figure 3-5).

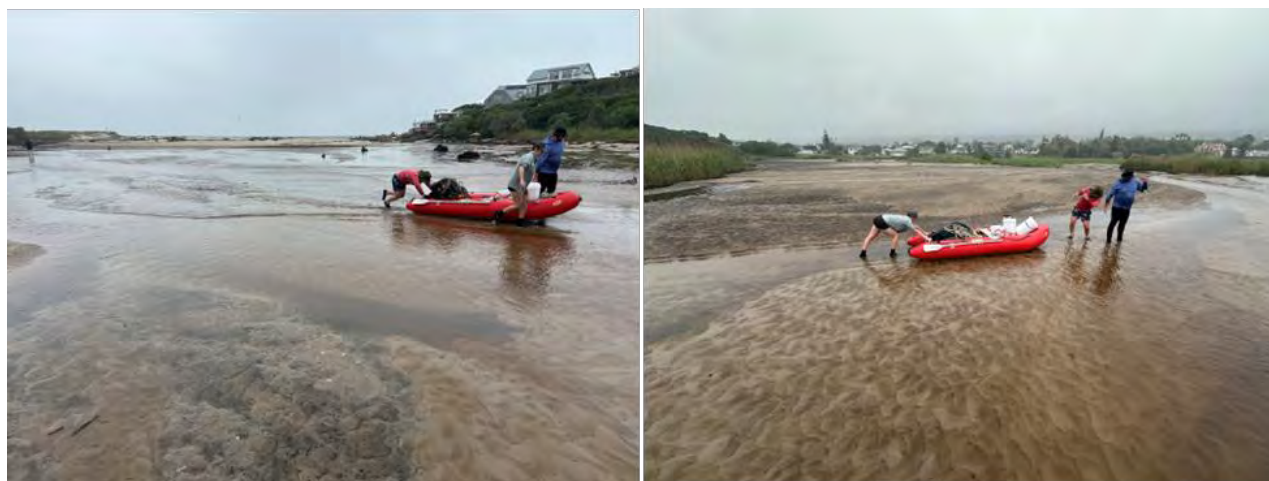
Figure 3-9. Extensive sedimentation in the Onrus Estuary following the floods in September 2023 have all but eliminated open water and deeper channel habitat in the estuary to the extent that it is no longer even possible to navigate with a small inflatable boat on the estuary.

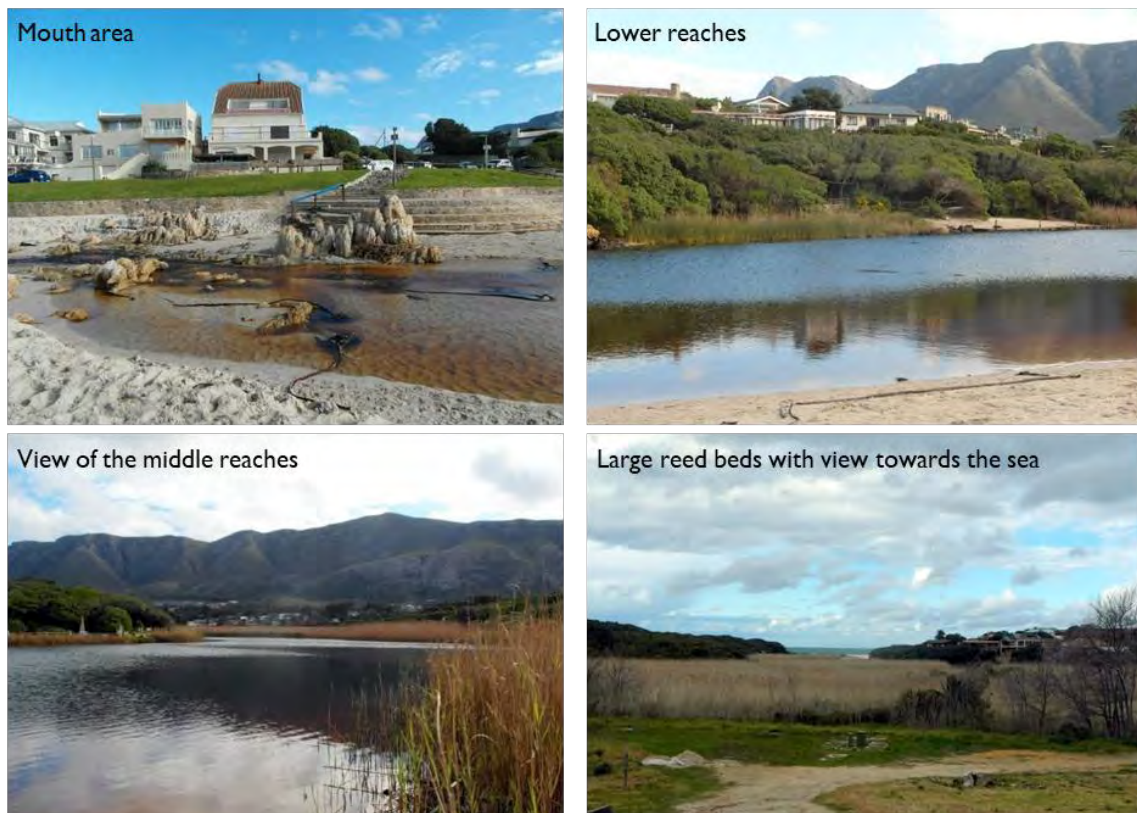
Figure 4-3. Photographs of the Onrus Estuary (July 2016). (Source: DWS (2017)).

Heineken & Damstra (1983) identified pondweed *Potamogeton pectinatus* and the algae *Chara* growing together in the bottom sediments of the shallower upper northern part of the lagoon. According to Massie & Clark (2016) red water fern *Azolla filliculoides* has been occasionally recorded in the estuary. The indigenous blue water lily, *Nymphaea nouchali*, was noted in the estuary in the summer of 2011. In July 2016 the estuary was accessed by foot and no submerged macrophytes were noted (Figure 4-3).

appearance to young Phragmites, possibly *Ficinia nodosa* (previously *Scirpus nodosus*), fringed the open water in front of the coastal forest (Figure 4-3).

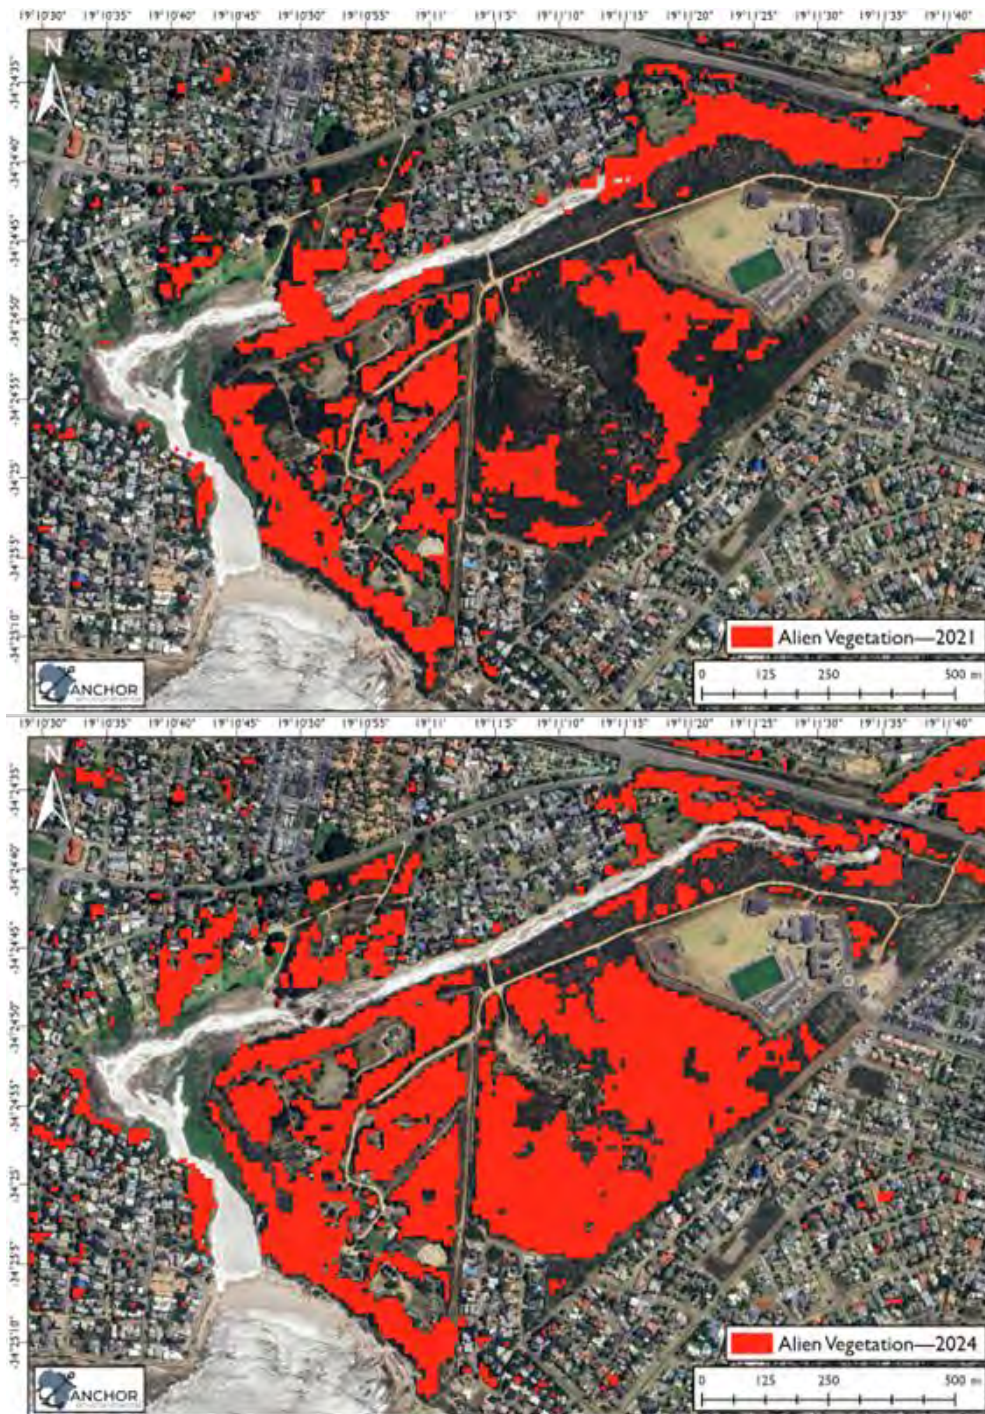
Figure 4-4. Change in the extent of alien invasive vegetation since 2021—as delineated by satellite analysis.

Concerningly, Figure 4-4, which shows the delineated areas of vegetations classified as “alien invasive” according to a recent satellite imagery analysis, has shown that the extent of this alien infestation has increased dramatically since 2021. Whilst it was not possible to fully ascertain the extent of indigenous vegetation remaining in-and-around these alien stands, it is presumed that since much of these invasions are from acacia species, which are known to alter the surrounding soil chemistry and rendering it unsuitable for indigenous plants, little indigenous vegetation likely persists in these areas. Indigenous and alien species identified by the 2018 NBA, and likely to constitute the majority of the present invasions, are listed in Table 4-5.

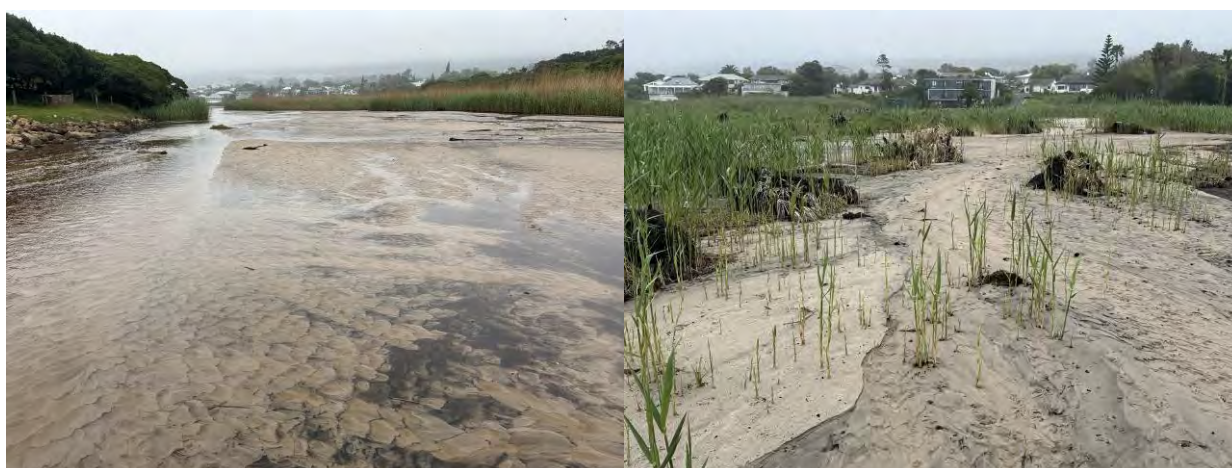
Figure 4-5. Extensive infilling of the Onrus estuary channel and other open water areas means that it is now ripe for invasion by *Phragmites australis*.

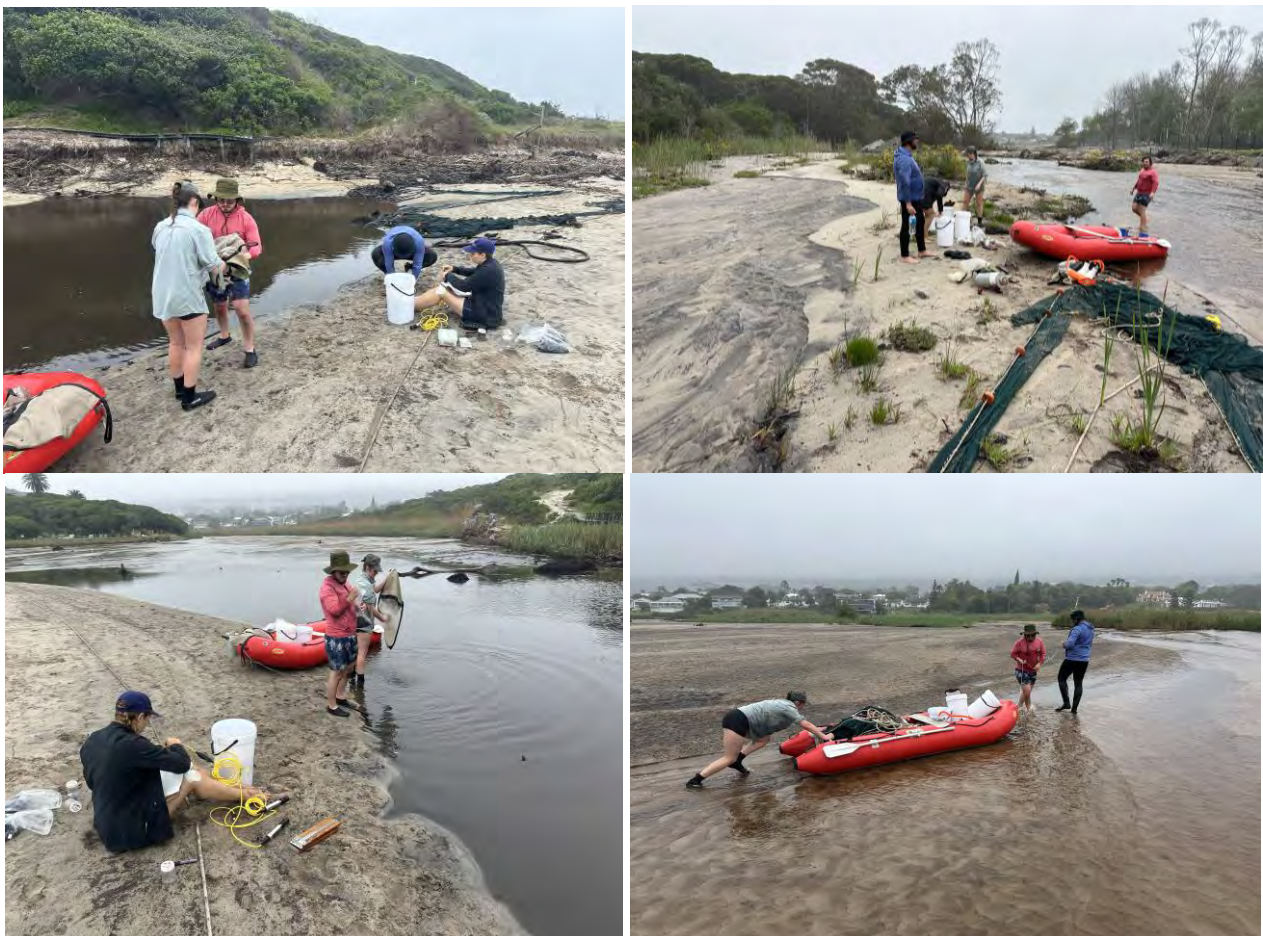
Figure 4-6. Sampling the Onrus Estuary in 2024.

As part of this study, we sampled invertebrates at six stations up the length of the estuary in October 2024 (Figure 3-10 and Figure 4-6). Sampling was conducted with a hand corer which samples an area of 0.025 m² and volume of 0.76 m³. Three replicate cores were collected at each site. Numbers of invertebrate taxa and their abundance in the estuary was extremely low. A total of only nine taxa and 31 individuals were recorded, with more than half of the samples (11 out of 18) being completely empty (Table 4-13). Most of the taxa recorded were freshwater species which is consistent with very low salinity levels recorded in the estuary (Table 3-8). The absence of sandprawns *Callichirus kraussi* is noteworthy. This represents a very dramatic reduction in health status of the invertebrate community in the estuary relative to that recorded by Heineken & Damstra (1983). The recent flood and resultant deposition of sediment in the system has all but eliminated benthic invertebrate fauna from the estuary. Species that remain are mostly of freshwater origin.

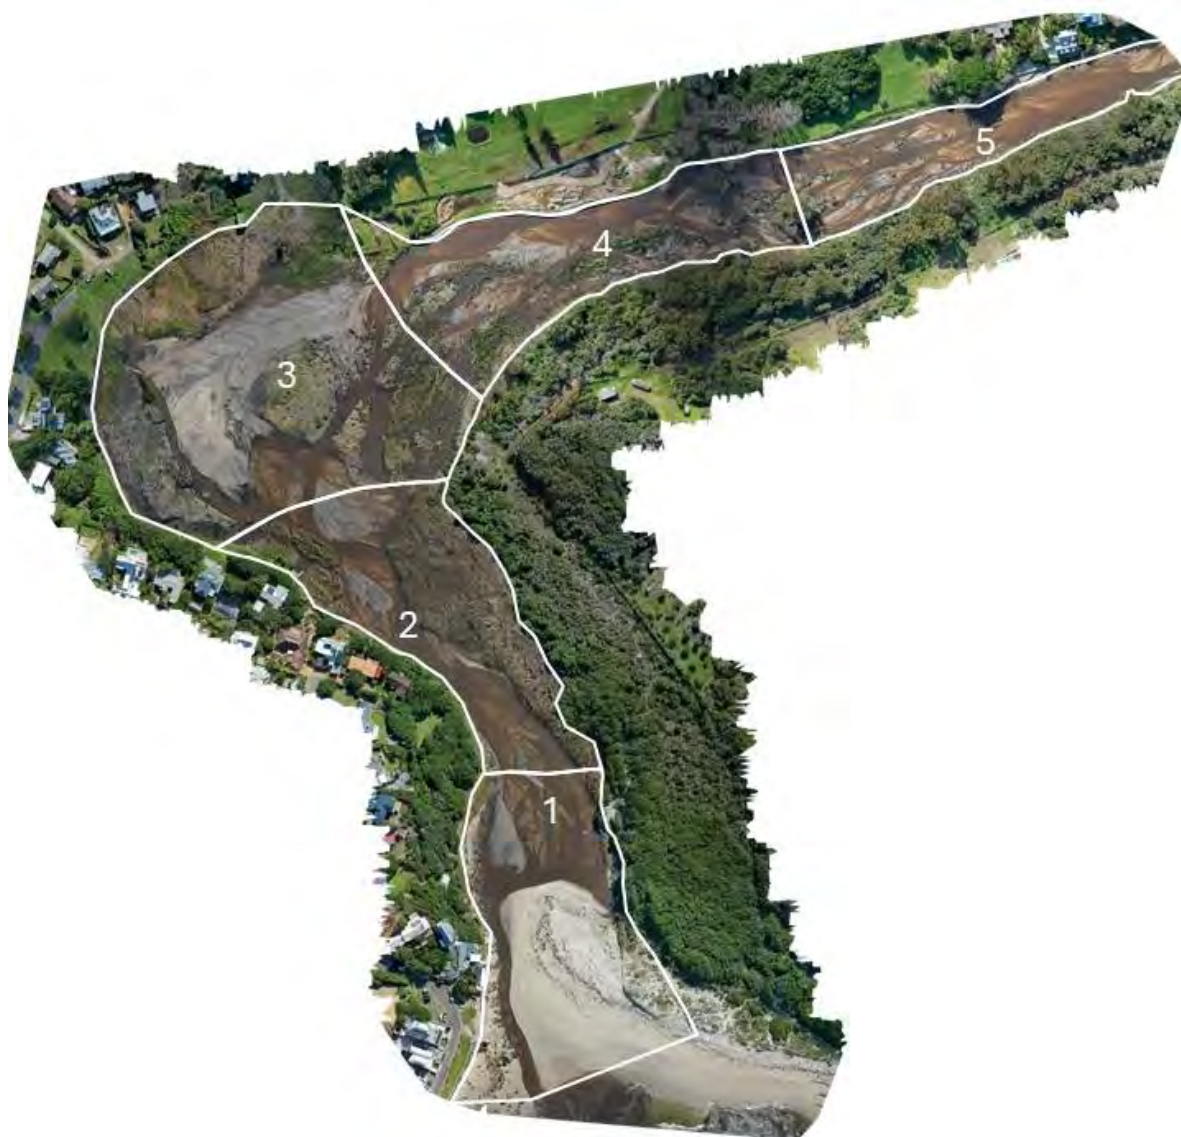
Figure 4-9. Waterbird counting areas on the Onrus Estuary.
