ONRUS RIVER WETLAND STABILIZATION

DESIGN REPORT

(INCLUDING METHOD STATEMENT)

Final - 2025 10 27

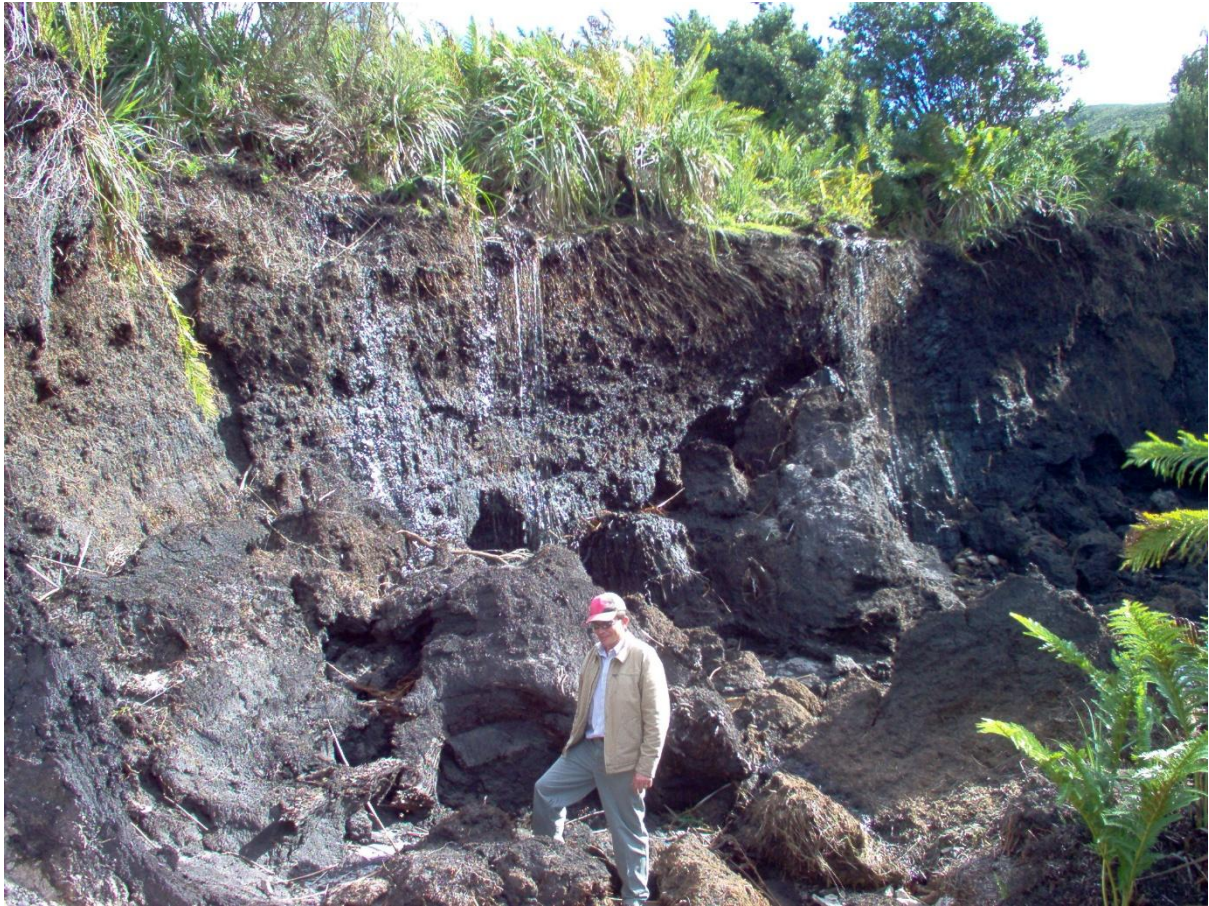
Figure 3 Erosion headcut in the Tierkloof wetland - Goukou River (2004). This wetland has now disappeared completely.

When the high water table which led to the formation of the peatland are removed, the wetland (soil plus vegetation) which has formed over many thousands of years, can become extremely degraded, or disappear completely within a few years. An example of this is the Tierkloof wetland (tributary of the Goukou River) which seems to have completely disappeared post erosion starting in 2003.

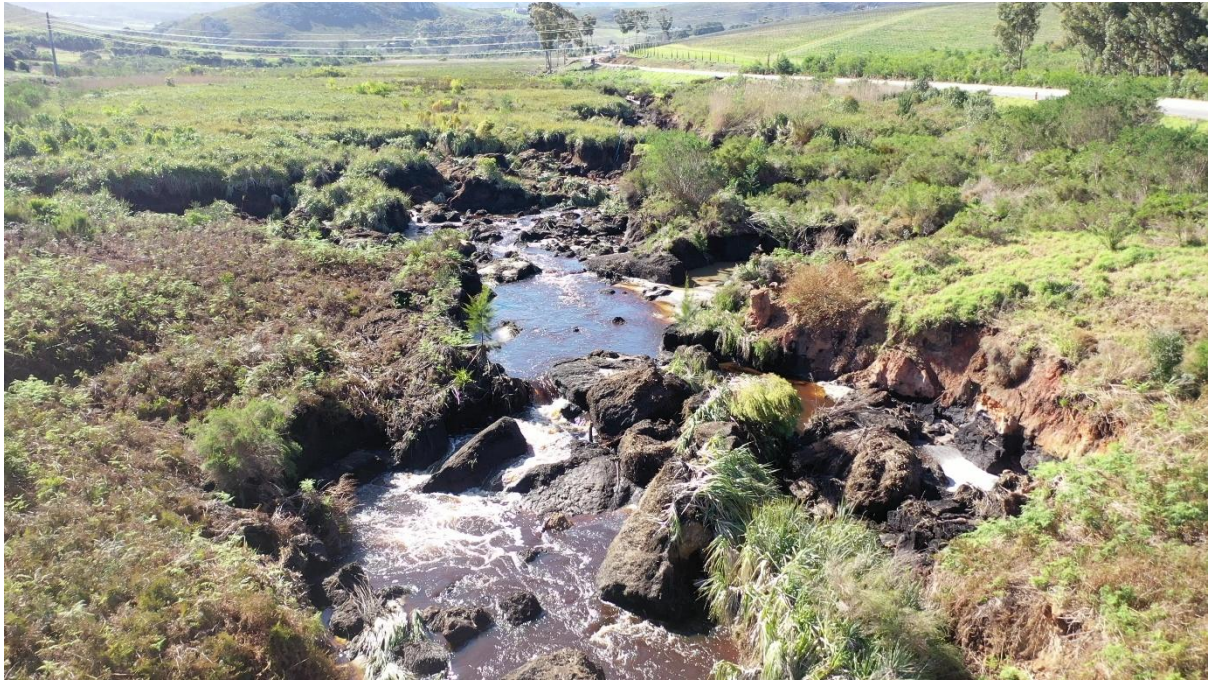
Figure 4 Looking upstream to the headcut in the wetland just before the flood 2023

The erosion of the Onrus wetland began sometime before 2020. The exact cause of the initiation of the erosion is uncertain, but man-made disturbances like the drying out of the wetland post the construction of the De Bos Dam upstream (on the Karwyderskraal Road), and the proliferation of alien vegetation (mainly black wattle *Acacia mearansii*) played significant roles. After the erosion had begun, a fire started in the wetland by cable thieves ignited the dried-out peat which burned underground for many months before finally being extinguished. The underground burning of the peat most likely created underground chambers which collapsed during the flooding of 2023 and exposed the wetland to the severe erosion which took place later in 2023 and 2024.

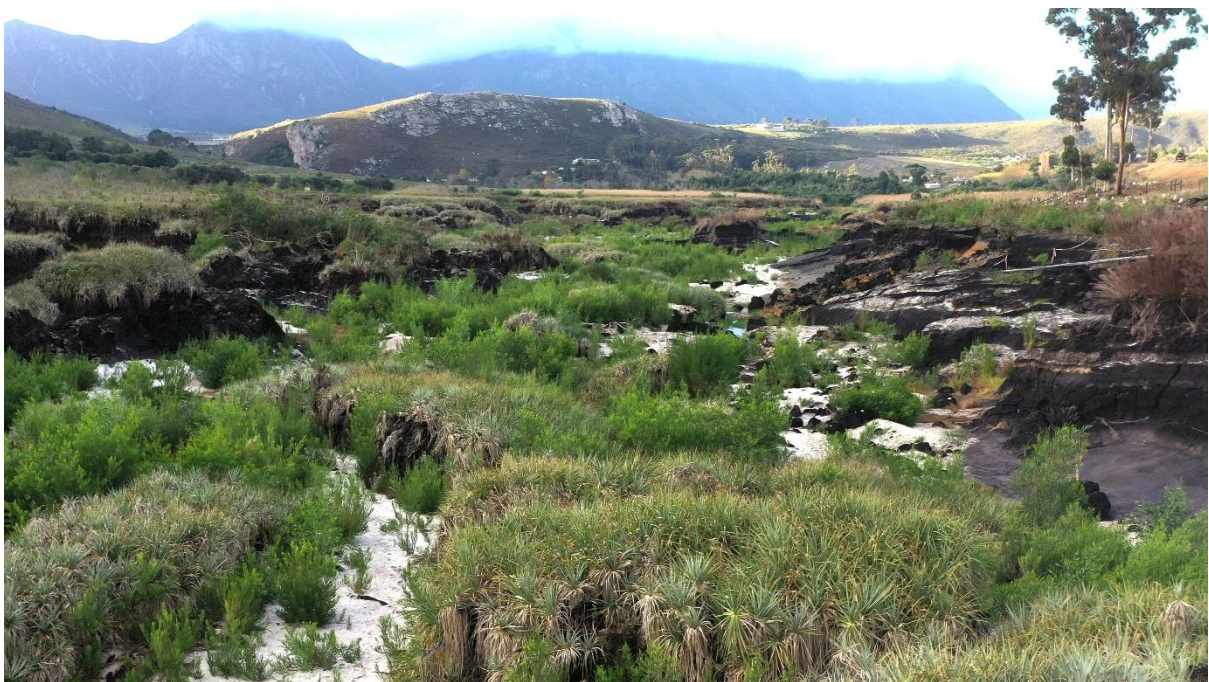
Figure 5 Looking upstream over where the headcut had been in August 2023. The gully is now about five times wider and several meters deeper.

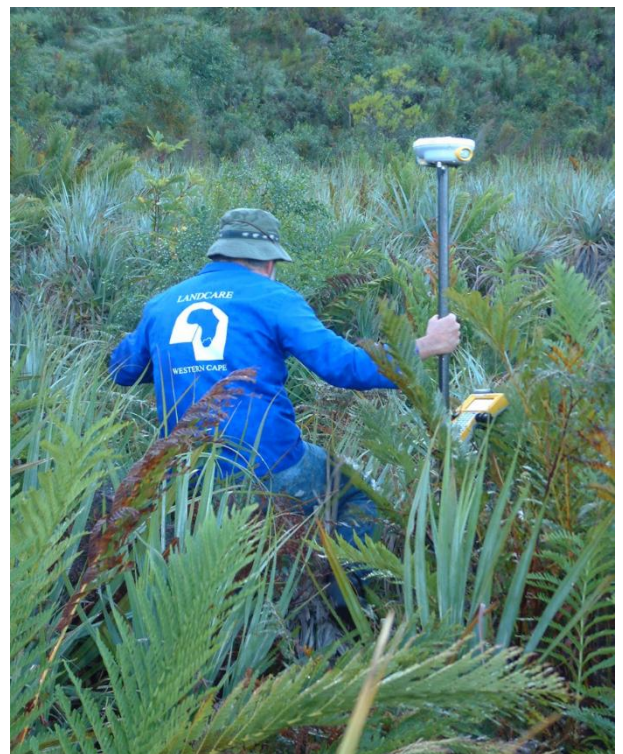
Figure 7 Access to palmiet wetlands make them extremely challenging to survey

Surveying ground heights in palmiet-wetlands has always been challenging. It is most reliably measured with a hand-held gps but walking through a palmiet wetland to do this is practically impossible. With the density of foliage in palmiet wetlands, both photogrammetry and lidar can only measure the top of the palmiet.

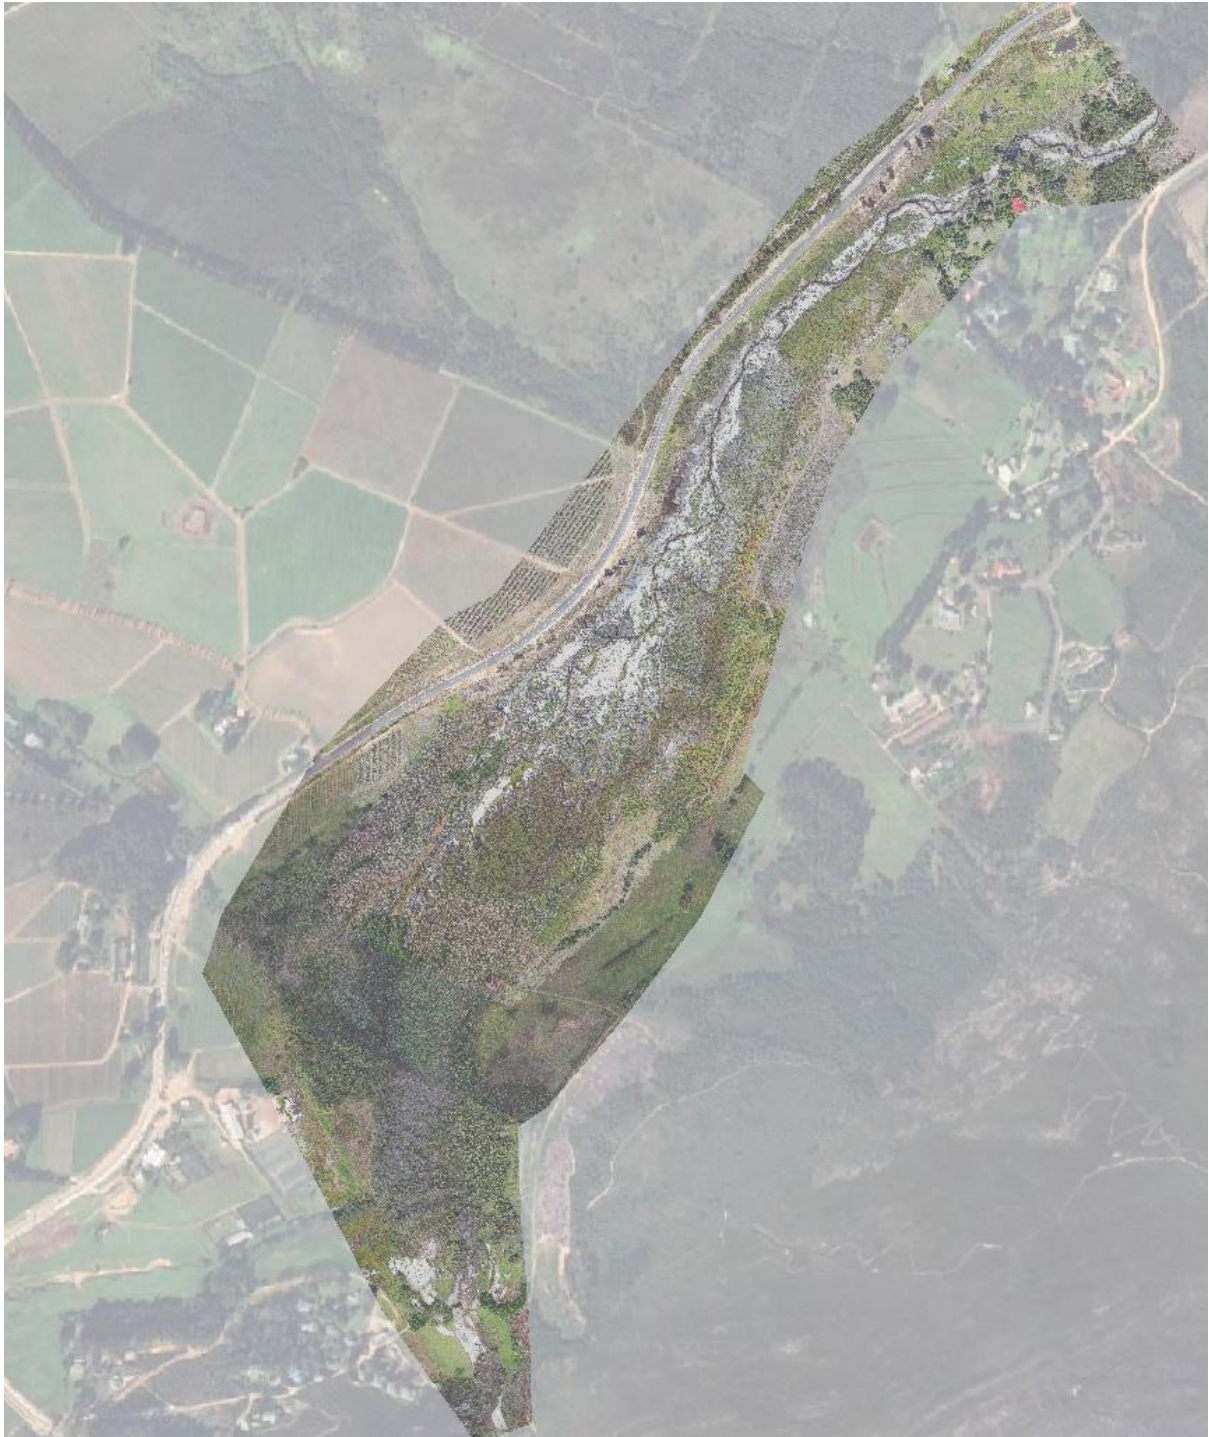
Figure 19 The orthophoto produced with drone-based photogrammetry on a Google Earth background. This shows the extent of the area surveyed for the construction of the hydraulic simulation models.

After the hydraulic modelling of the 5 weir concept had been completed, a Lidar survey became available. The Lidar survey was used to model the 6 weir option because at the time when the Lidar was flown, a lot of the alien trees in the wetland had been removed. The Lidar also has superior penetration through the remaining alien trees. This dataset was kindly made available by Mr Nardus Bosman¹.

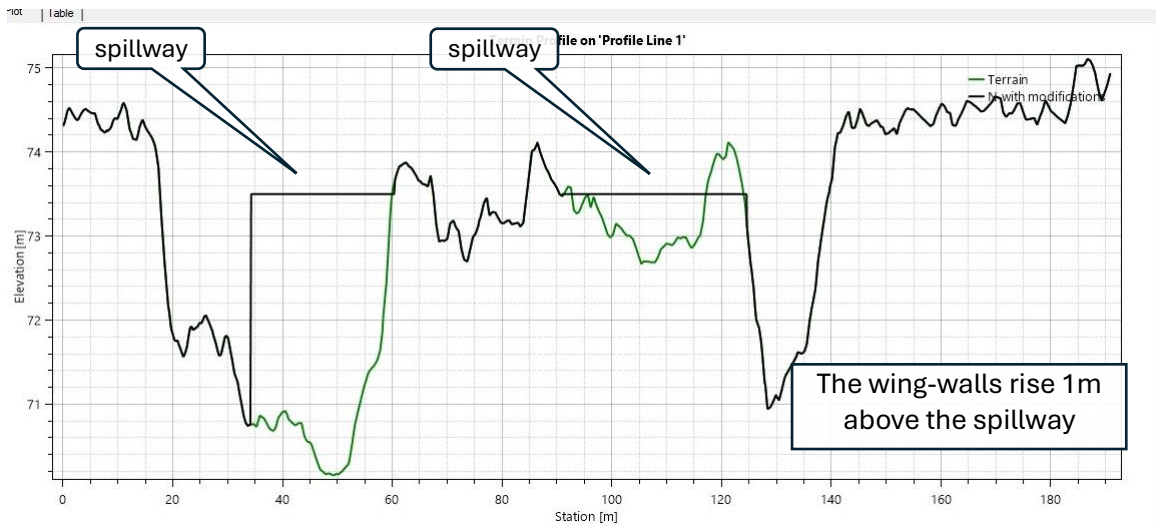
Figure 26 Section through weir 1 (looking downstream)

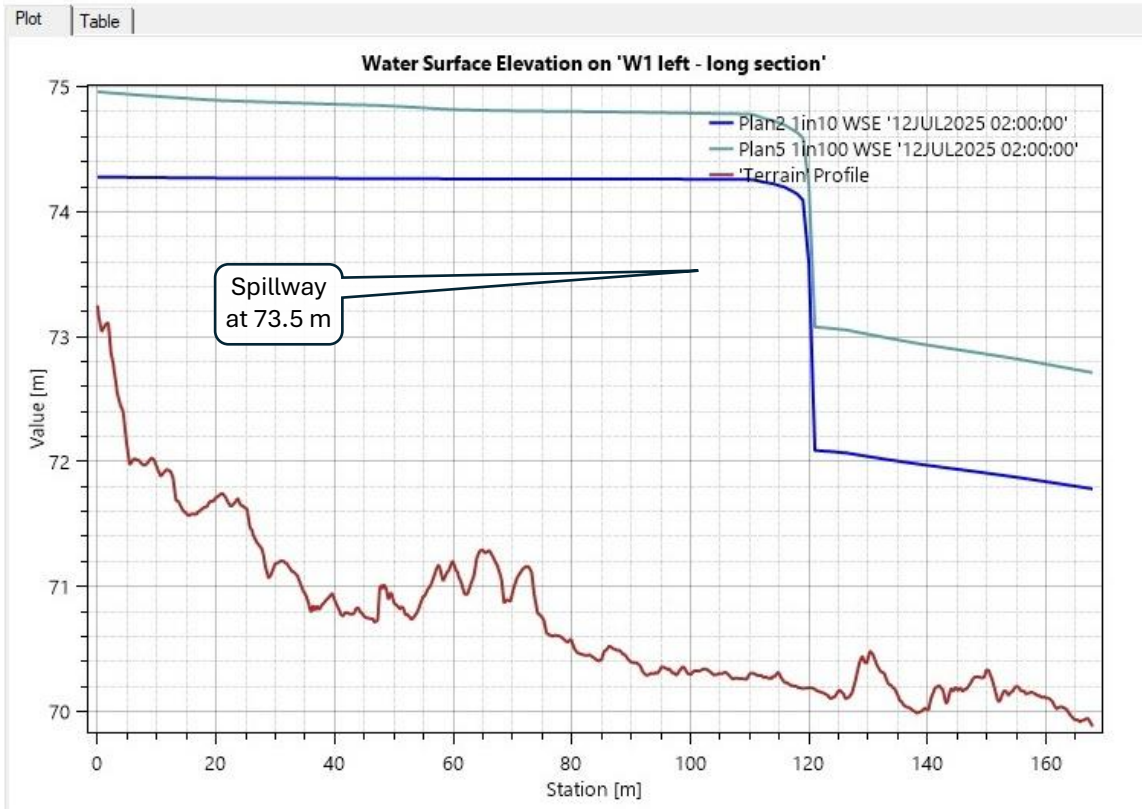
Figure 27 Long section through Weir1 showing 1:10 as well as 1:100 year peak flow levels

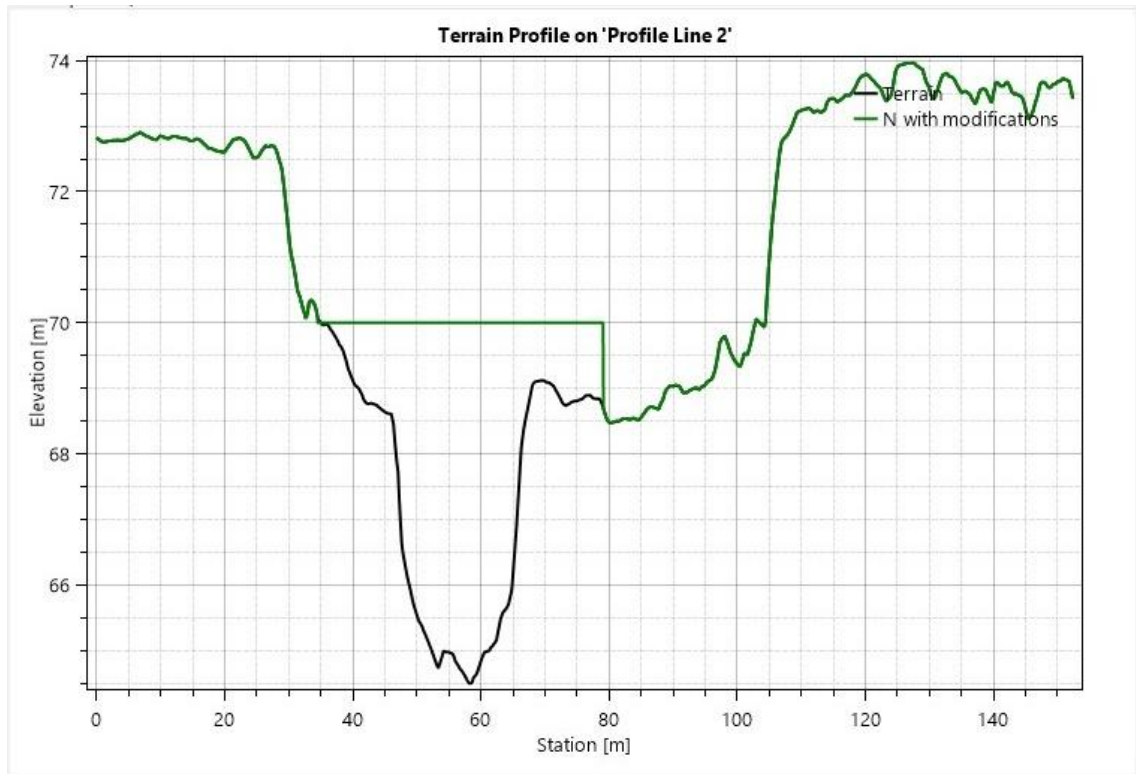
Figure 29 Section through weir 2 (looking downstream)

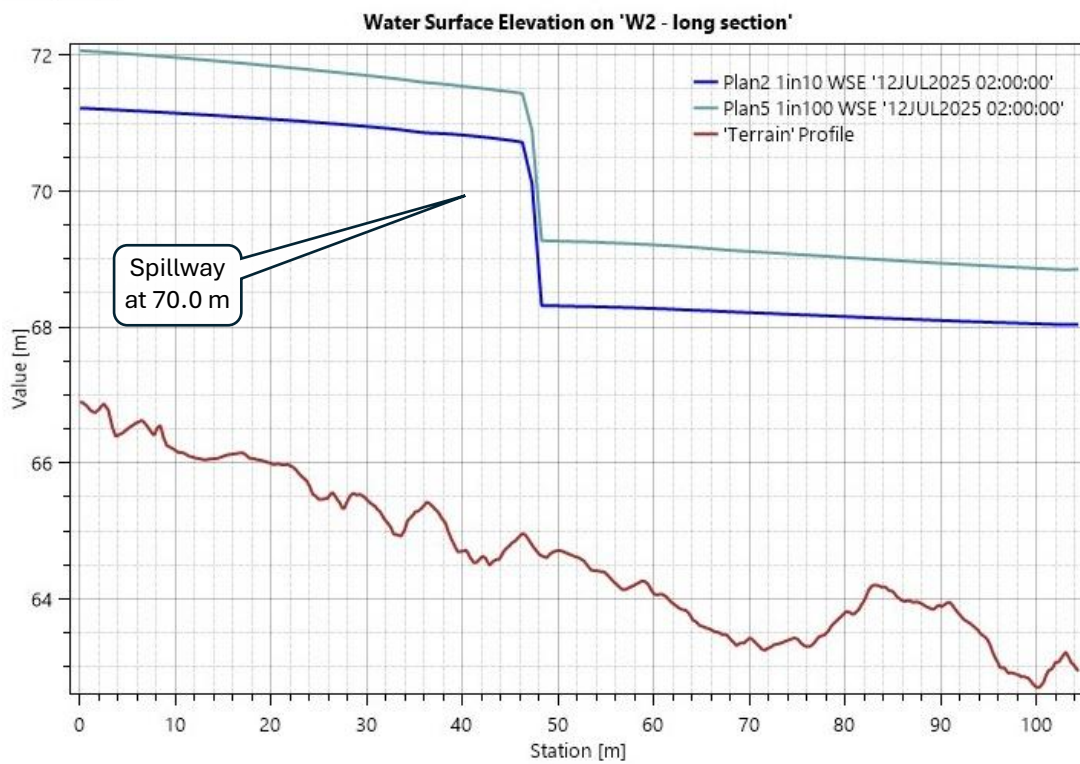
Figure 30 Figure 31 Long section through Weir2 showing 1:10 as well as 1:100 year peak flow levels

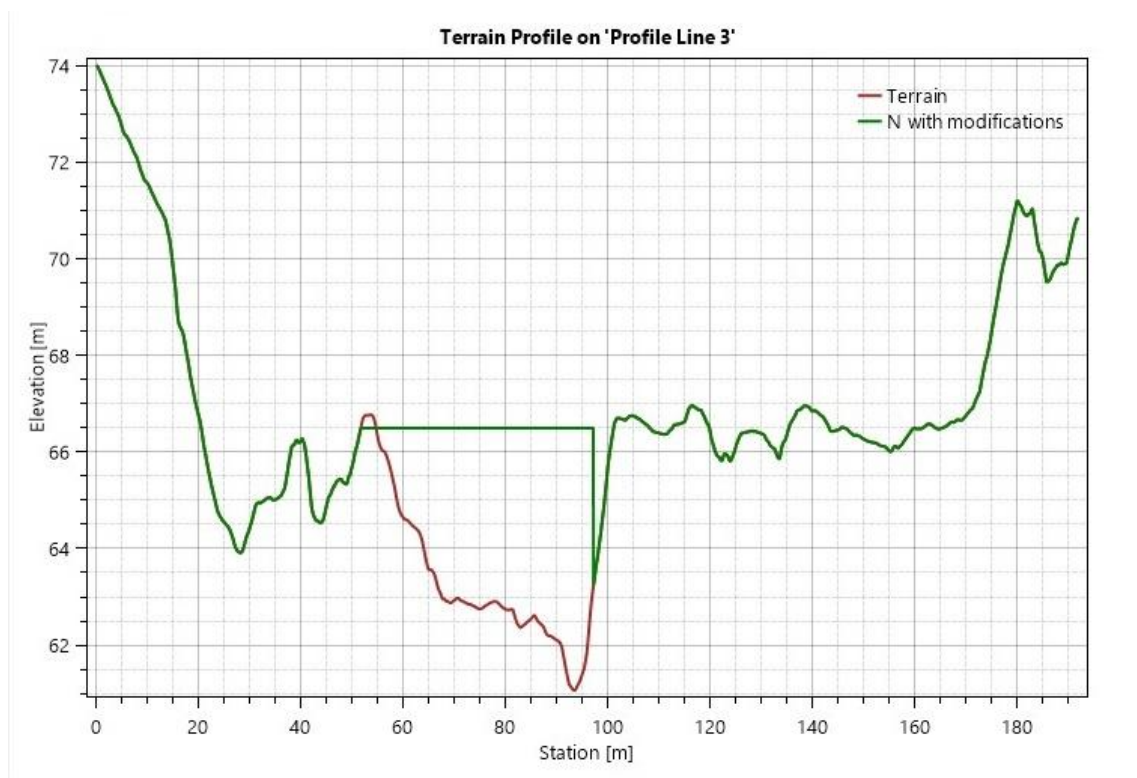
Figure 33 Section through weir 3 (looking downstream)

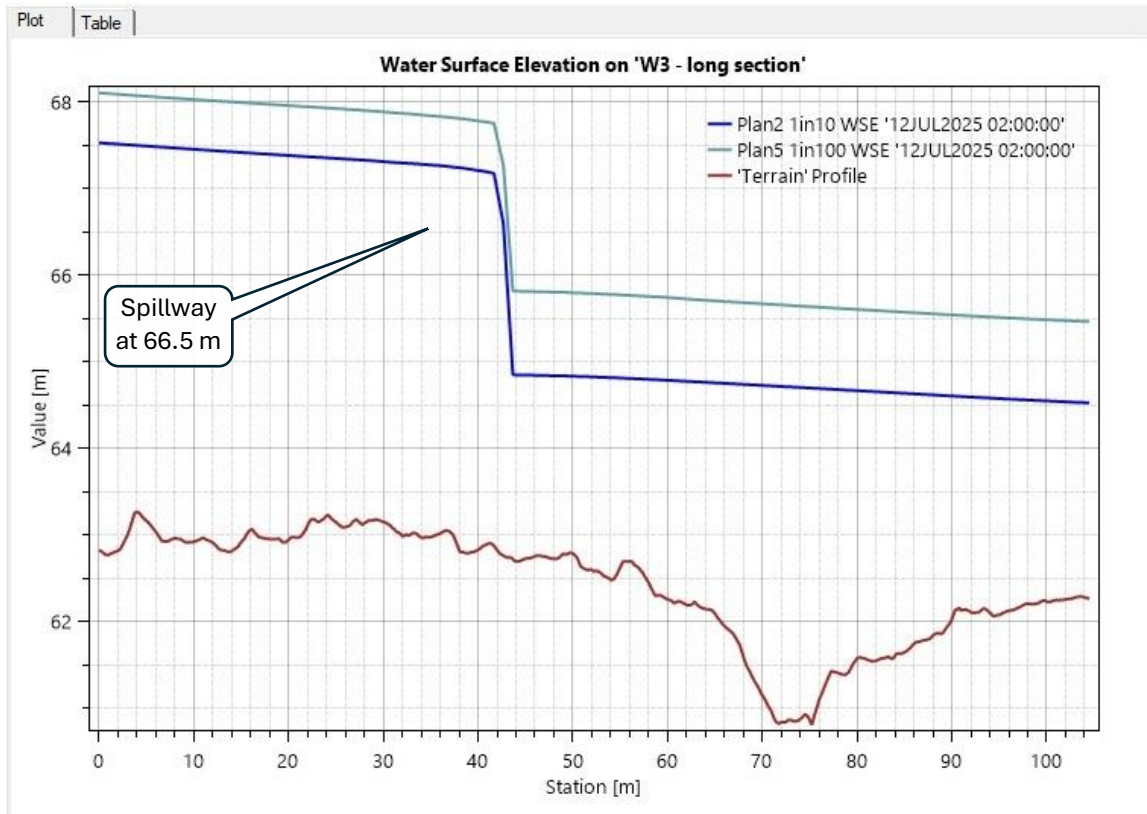
Figure 34 Figure 35 Long section through Weir3 showing 1:10 as well as 1:100 year peak flow levels

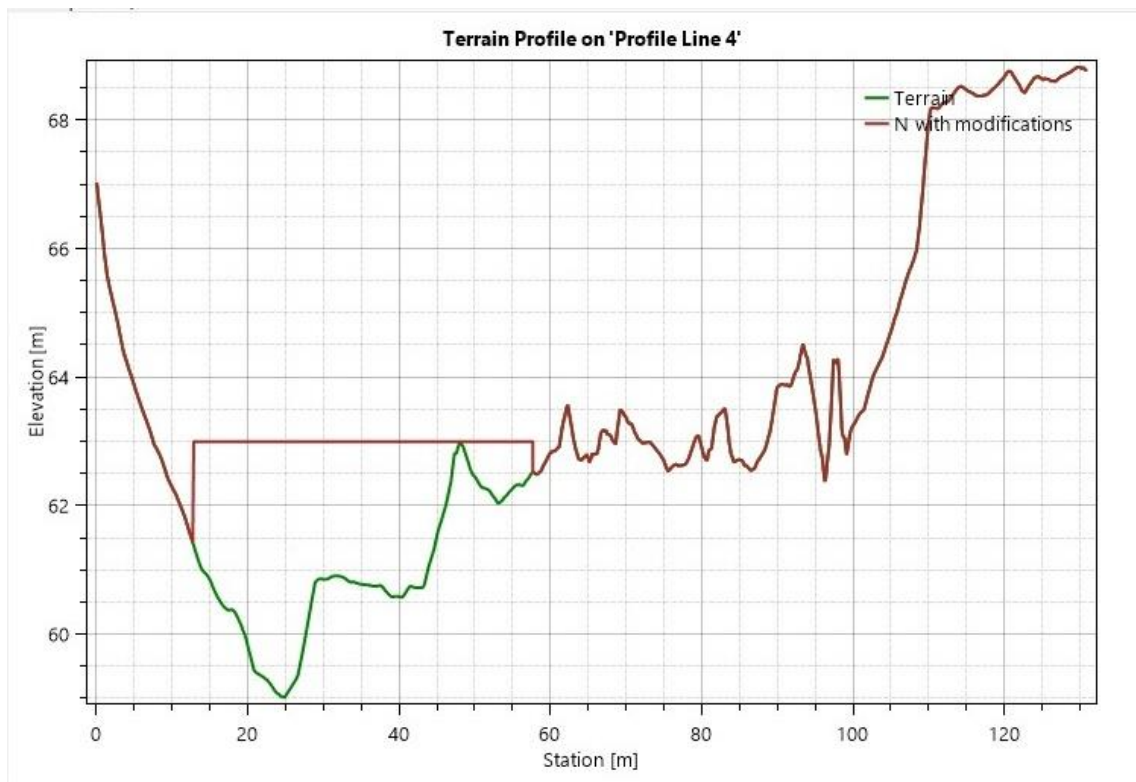
Figure 37 Section through weir 4 (looking downstream)

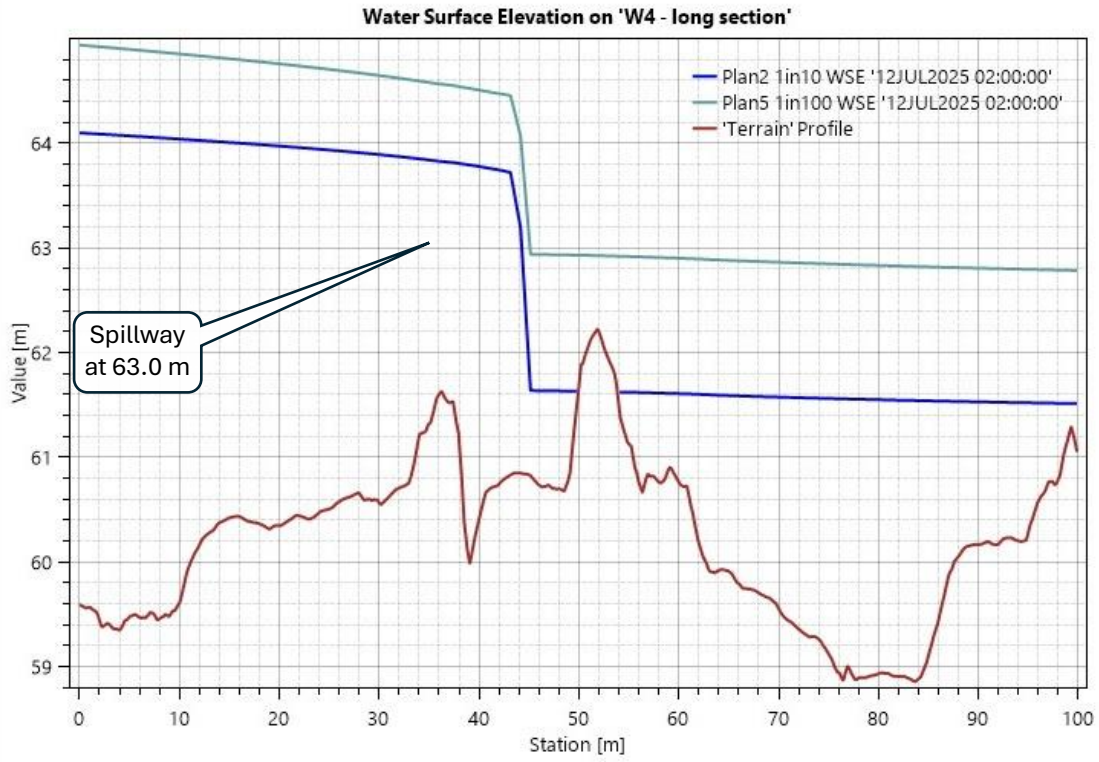
Figure 38 Figure 39 Long section through Weir4 showing 1:10 as well as 1:100 year peak flow levels

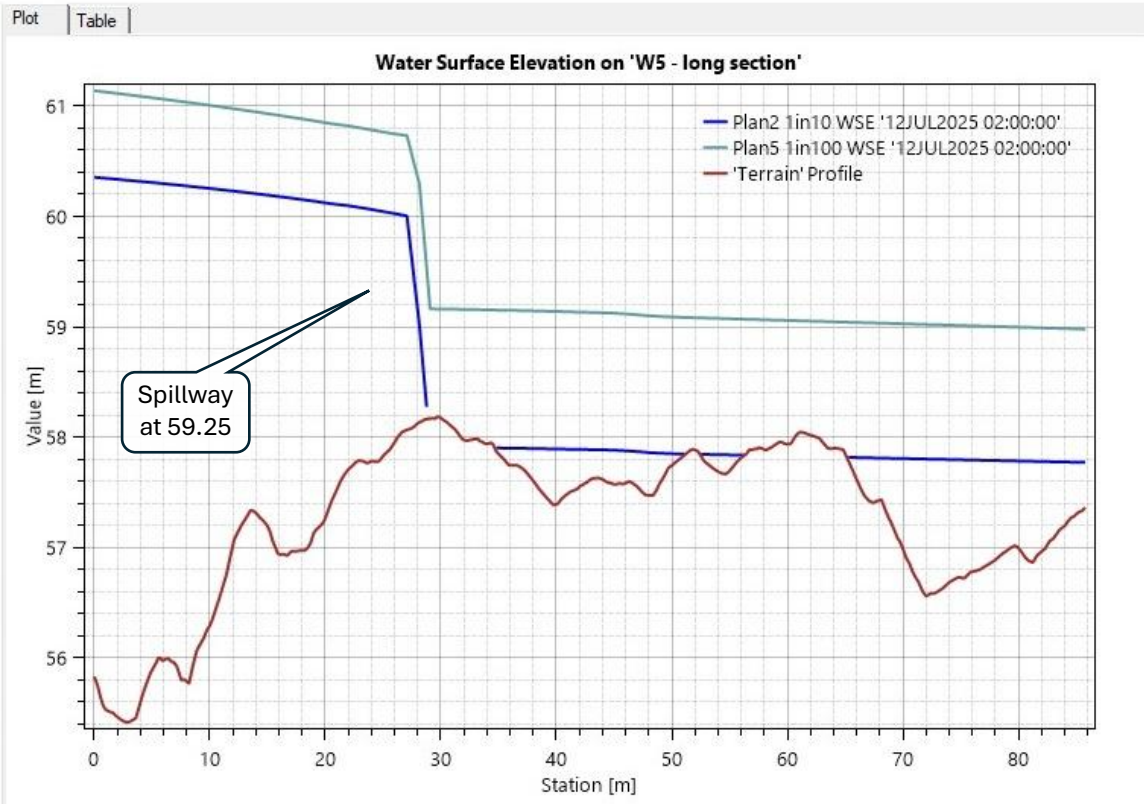
Figure 42 Long section through Weir5 showing 1:10 as well as 1:100 year peak flow levels

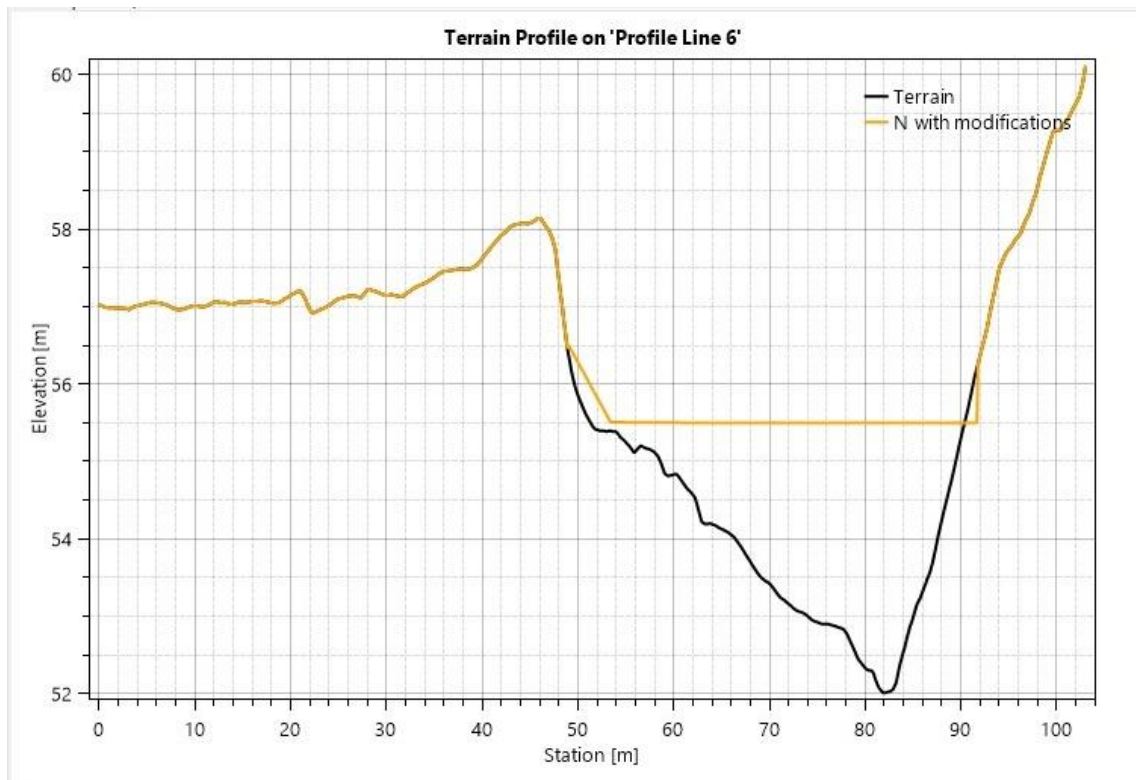
Figure 44 Section through weir 6 (looking downstream)

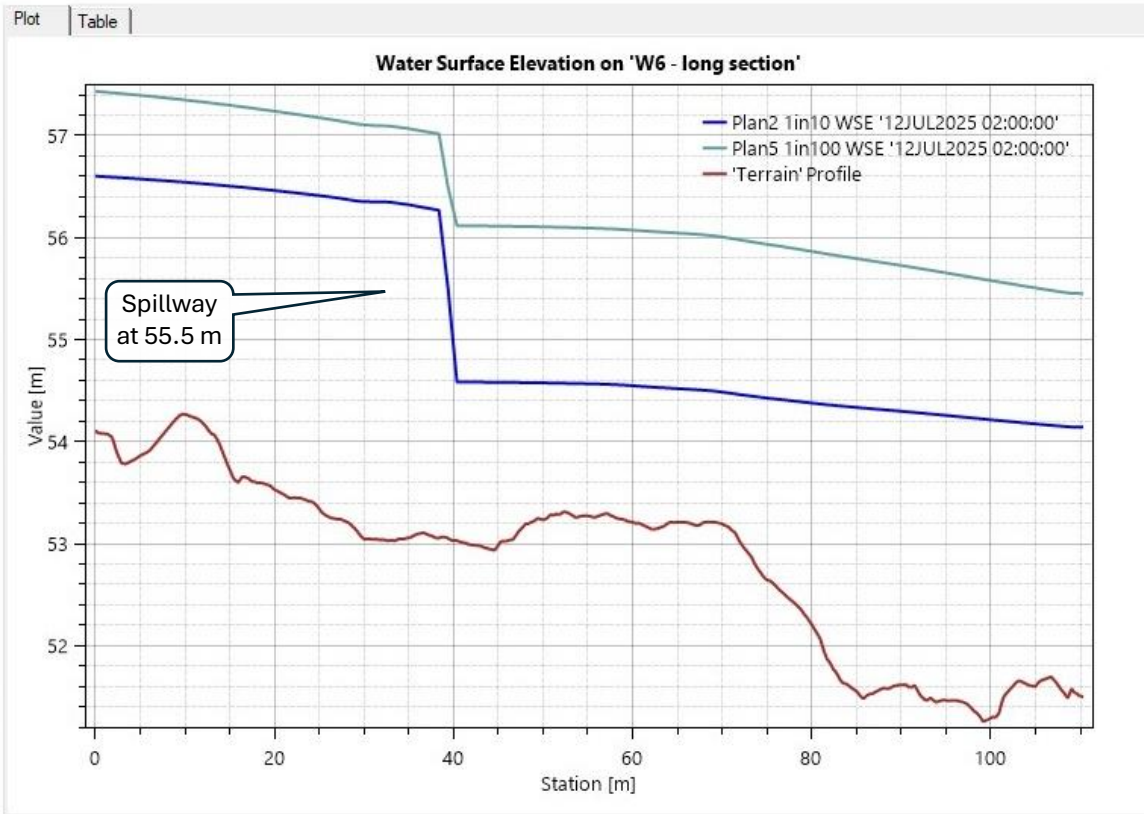
Figure 45 Long section through Weir6 showing 1:10 as well as 1:100 year peak flow levels

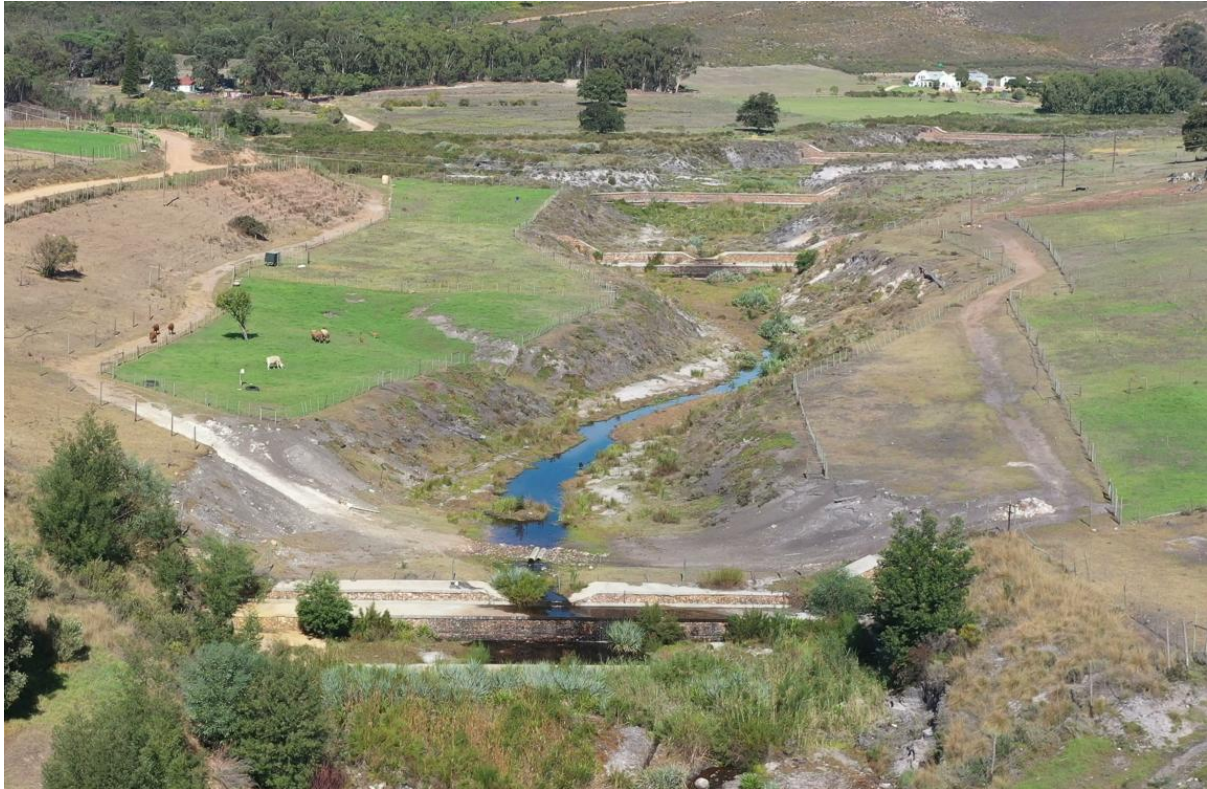
Figure 57 The gulley with a cascade of 5 weirs today

The gulley at Tesselaarsdal (between Hermanus and Caledon) washed out rapidly over 9 years. The gulley was up to 13 m deep and fell 21 m over 600 m. If not stopped it would have spread wider and higher up the valley as well. Once funding was found, it required 5 weirs to be constructed to halt the erosion.

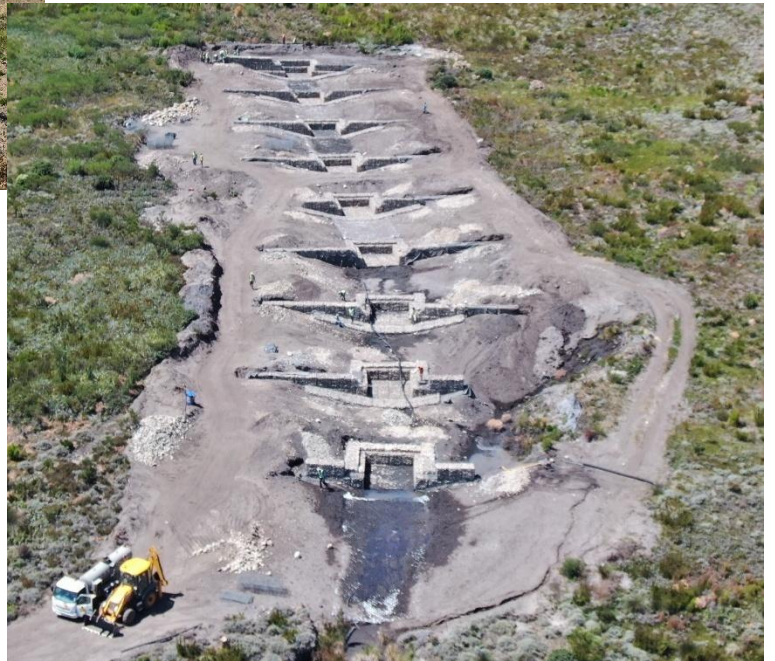
Figure 58 The weirs being constructed in 2021

During the heavy rain of 2018 several gulleys washed out on the farm Vergelegen. One (Site 1) was in a palmiet wetland. The slope of the land was steep and once the erosion started it was difficult to stop it. A cascade of weirs was constructed in 2021.

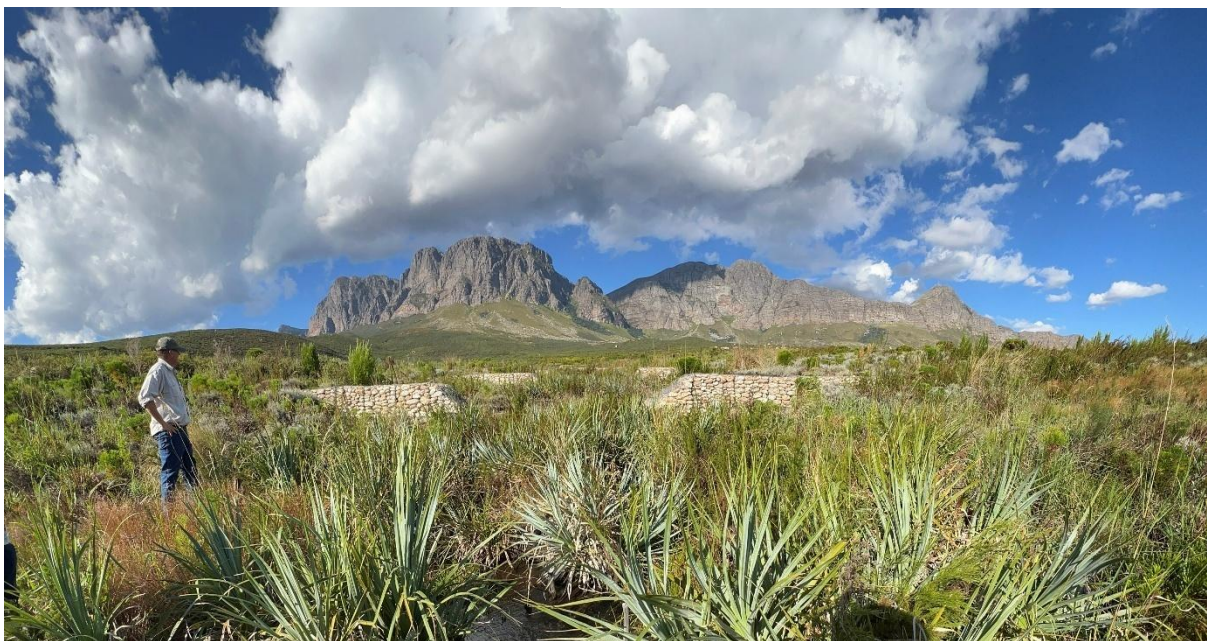
Figure 60 Looking up the rehabilitated gully in 2025 (same view as Figure 599)
