# Updated Management Plan for the Pringle Bay beach and adjacent dune area

Prepared for:  
**OVERSTRAND MUNICIPALITY**  
and the  
Pringle Bay Ratepayers' Association  
by  
**LAURIE BARWELL & ASSOCIATES**

**OCTOBER 2015**

*(This report is an update/revision of the 1988 CSIR REPORT: Pringle Bay Beachfront Management Plan. (C/SEA 8842) and should be seen as complementary)*

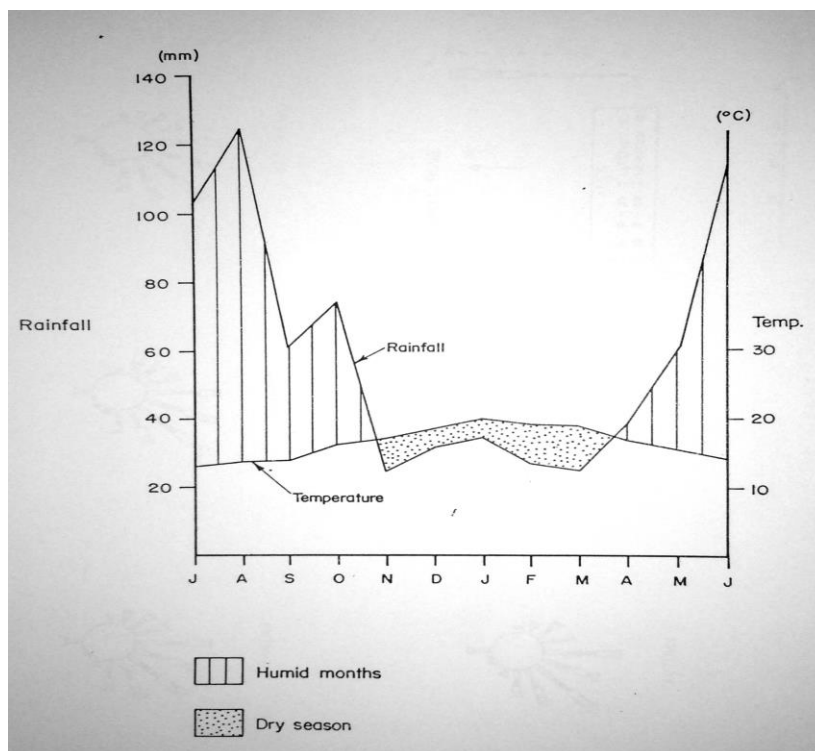
Figure 2: Climate diagramme for Pringle Bay (Heydorn & Tinley, 1980)

Combining the monthly average temperature and rainfall data results in a so-called climate diagramme (Figure 2). A humid period extends from April to October (where the rainfall line is above the temperature line). The arid period extends from November to March each year.

The implication of this information is that planting of vegetation in the dry period (November to April) should be avoided if no irrigation system is available. When relying on rain-fed gardening, it is clear from Figure 2 that the best time to establish dune vegetation is typically in August and September when the temperature is increasing and some 'follow-up' rainfall is still possible during October.

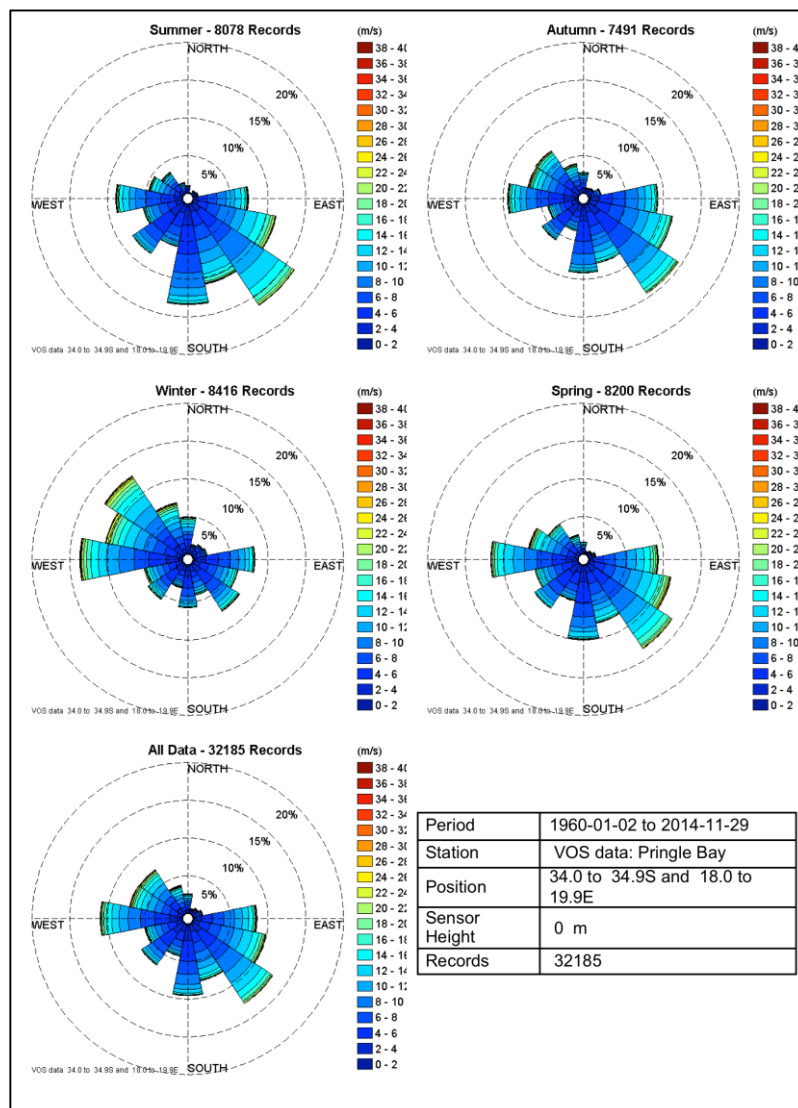
Figure 3: Seasonal wind roses for the offshore area

Southerly to south-easterly winds dominate in frequency of occurrence and velocity throughout the year, but are more significant during summer, spring and autumn. Westerly (onshore) winds occur throughout the year and the velocity range remains relatively constant for all seasons. The data used to compile the wind-roses originate from voluntary observing shipping (VOS) and provide a good first estimate of the long-term wind climate in the area. However, possible wind funnelling or sheltering effects by the local mountainous topography is not taken into consideration. The VOS data can only be improved upon by continuous on-site wind measurements over a period of at least three years.

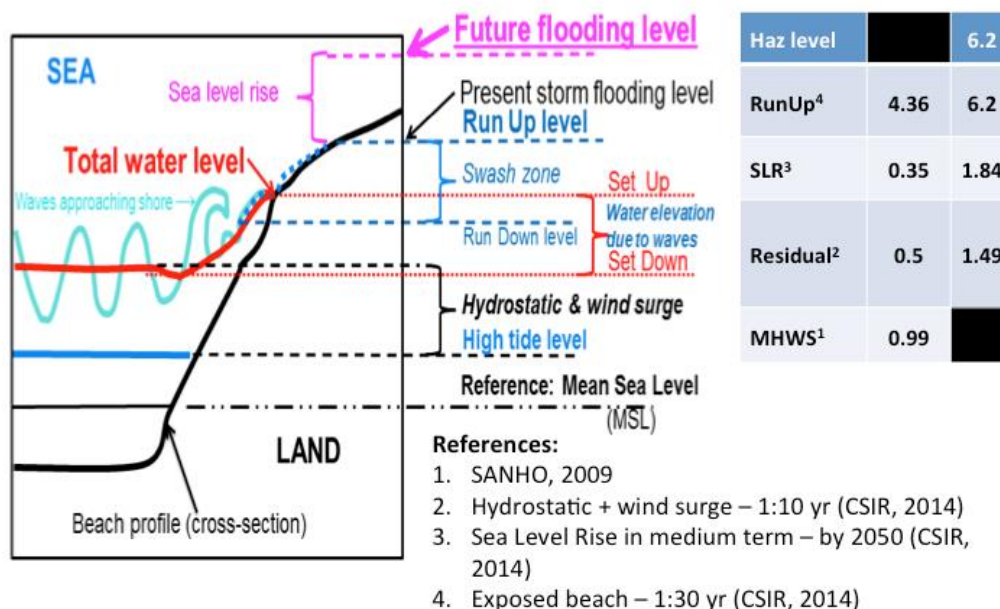
Figure 6: Estimated hazard level for 2050 at Pringle Bay

Thus, the total elevation (including the effect of climate change) that may be reached by storm waves during the passing of a low pressure system at spring high tide could be in the order of  $1.84 \text{ m} + 4.36 \text{ m} = +6.2 \text{ m MSL}$ . This level is also known as the Hazard Level.

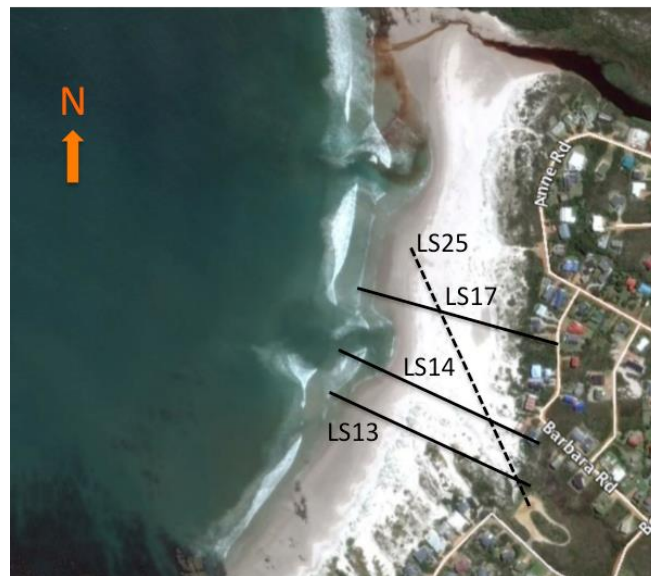
Figure 10: Position of survey lines (on the October 2014 Google Earth™ image)

More recent topographical surveys of the management area at Pringle Bay are available for 2008 and 2015. This allows for the comparison of cross-sectional data and provides the opportunity for calculating actual volumetric changes over the period between the surveys. The 2015 survey also provides an excellent baseline for future post-management comparative studies. The positions of the selected survey lines are shown in Figures 10 and 11. The spot heights surveyed in February 2015 and the contours taken from the 2008 aerial survey are shown in Figure 11. The contour and topographical spot heights are given to MSL (Mean Sea Level).

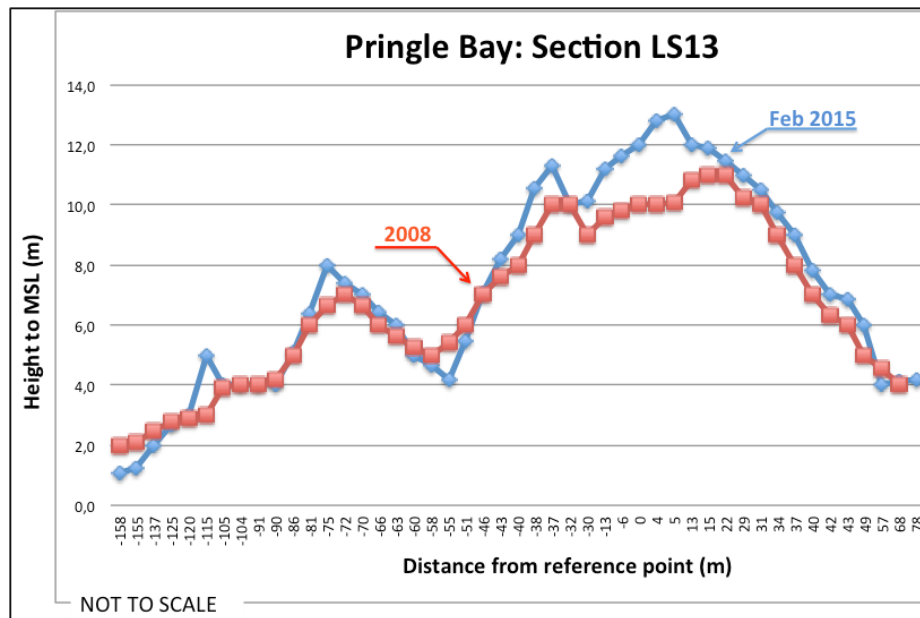
**Figure 12:** Comparative cross section of beach and dunes (Section LS13)

In Figure 12 the topographical heights as surveyed in 2008 and those from the 2015 survey are plotted along Section LS13 (Figure 11). The zero point along the x-axis is taken as the point where Section LS13 crosses Section LS25.

The frontal dune system showed little change as the area is partially vegetated and the Life Savers' hut is placed on the foredune and thus benefits from active management to prevent damage to the area around the facility.

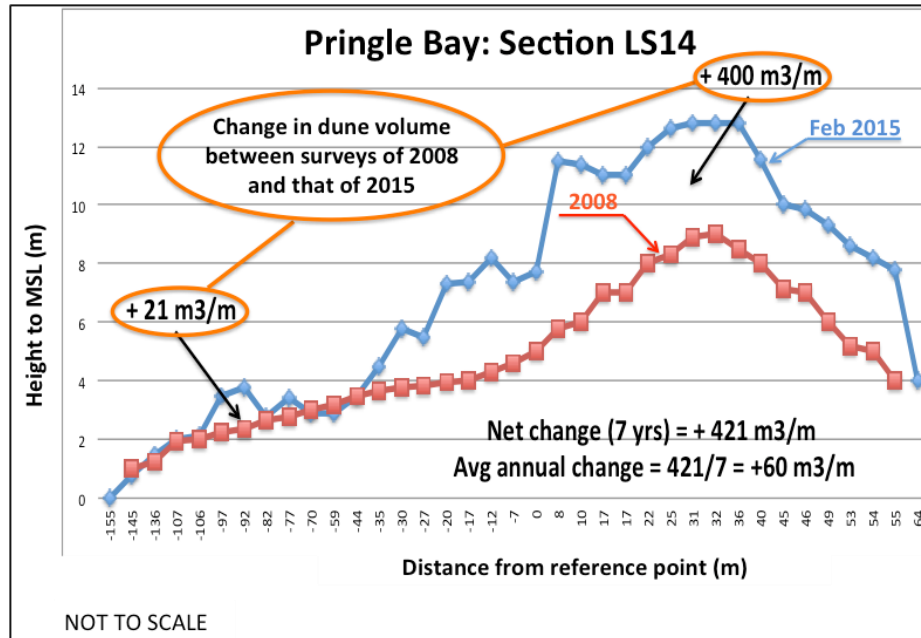
Figure 13: Comparative cross section of beach and dunes (Section LS14)

Shown in Figure 13, Section LS14 (Figure 11) is located in the area where a significant volume of wind-blown sand has accumulated due to an influx of sand removed from the deflation area located west along Section LS14 and north-west along Section LS25 (Figure 15). This principle is illustrated in Figures 13 and 15. The calculated average rate of accumulation is around  $60 \text{ m}^3/\text{m}/\text{yr}$ . (Figure 13) to  $16 \text{ m}^3/\text{m}/\text{yr}$ . (Figure 15) over the period between surveys.

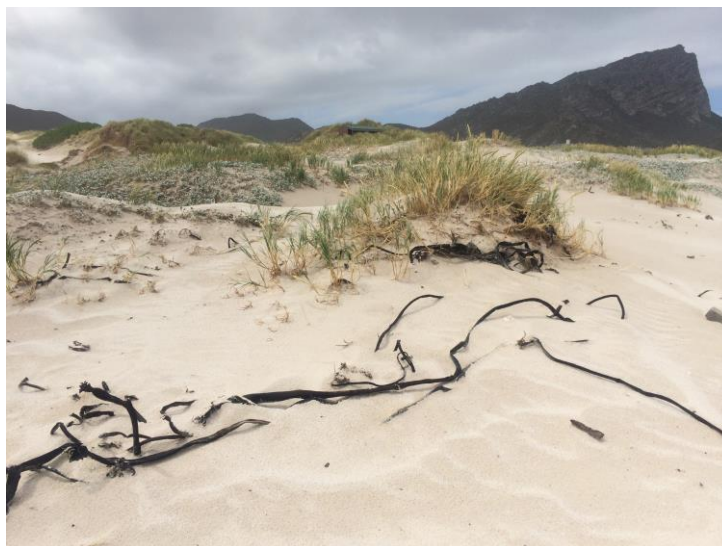
**Kelp traps sand and provides natural fertilizer thus creating suitable environment for pioneer dune vegetation to grow and form the core of the foredune system.**

The reduction of foredune integrity can occur as a result of vegetation removal, trampling or die-off, often due to poor management. Naturally occurring kelp washed up onto the beach forms the core of a natural windblown sand management mechanism. Sand and seeds are trapped amongst the kelp, thereby forming a sheltered micro-climate where pioneer dune vegetation can establish. Nutrients are released as the kelp naturally decays thereby assisting the vegetation to grow and trap more wind-blown sand until a series of hummock dunes are formed. More kelp washed into the gaps between the hummocks and the process repeats until a foredune is formed. The removal of washed up kelp should therefore be discouraged within the dune management area.

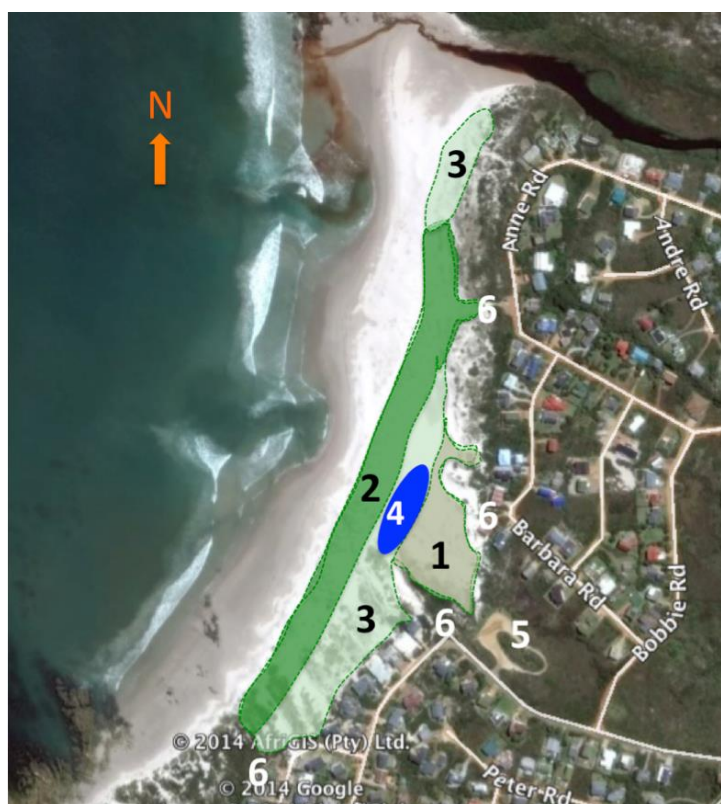
Figure 17: Details of the managed areas within the beach and dune areas

With reference to Figure 17 the following approach to implementing the management plan is recommended:

- Move the 'lost' sand from the high dunes (1) back onto the beach and to form a new foredune (2);
- Maintain a vegetated foredune (2) through effective and ongoing management;
- Establish suitable dune vegetation in Areas 1 and 3;
- Maintain the integrity of the vegetated dune to prevent exposed areas from forming as this causes 'blow-outs' and a subsequent loss of sand from the buffer dune;
- Landscape Area 4 to allow for the accumulation / detention of storm water draining off the public parking area (5) and adjacent wetland via the existing storm water drainage pipe;
- Formalize the walkway access to the beach at the position marked as 6;
- Prevent informal paths from forming within the rehabilitated area;
- Implement a structured seasonal management and maintenance programme; and
- Implement a public information and progress feedback programme.

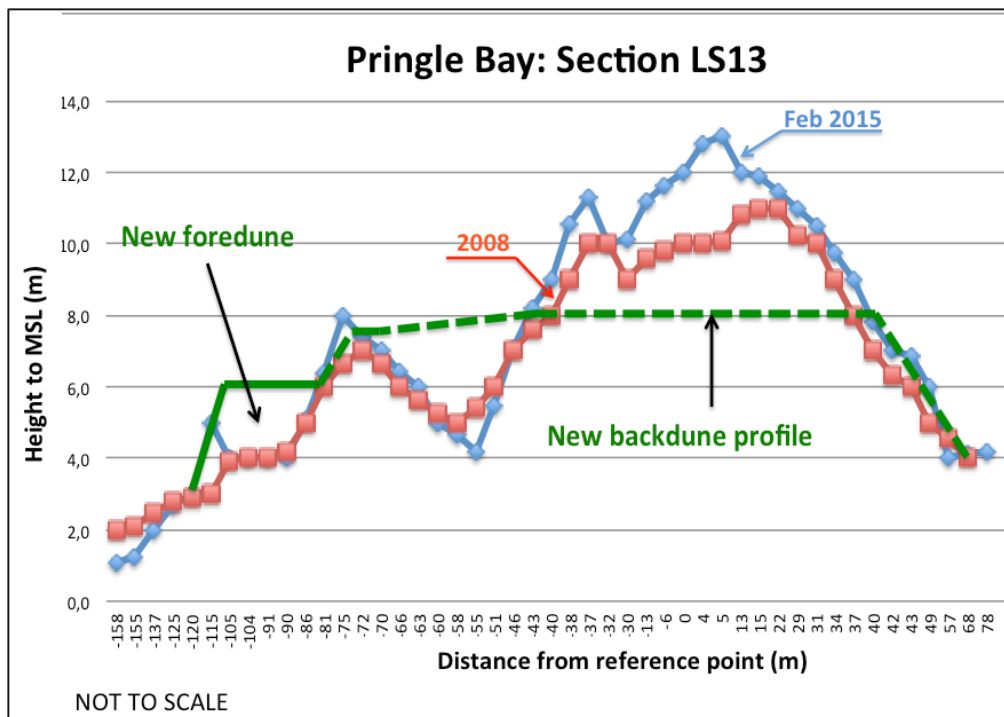
**Figure 18:** The new backdune profile along Section LS13 (refer to Figure 10)

The existing Life Savers' Facility is located behind and above the new foredune at Section LS13 (Figure 18). The backdune area is reshaped to still form the highest point (at +8.0 m MSL) thereby creating a wind-free area on the southern side to allow the establishment of a new boardwalk and pathway from the parking area to the beach. This is discussed in Section 7.6 below. All exposed areas are to be stabilized as soon as possible after the bulldozing has taken place. This is discussed in Section 7.5 below.

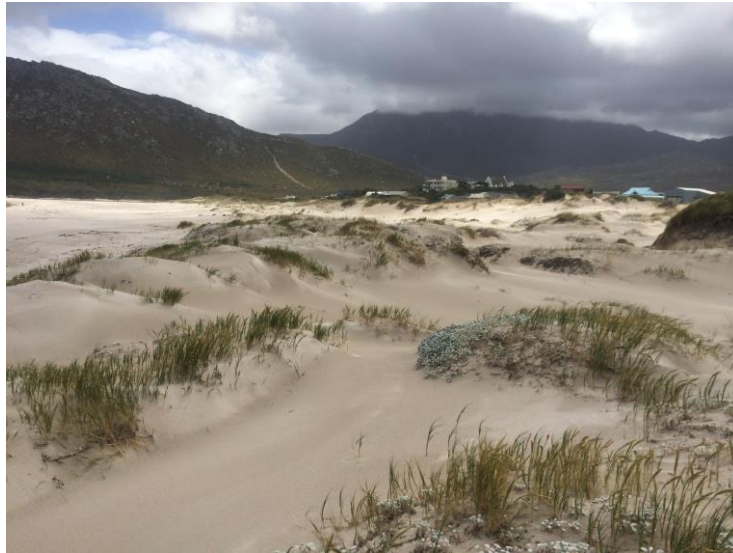
The volume and shape of the existing foredune can be enhanced by packing branches in a well planned manner  
Photo: L Barwell (November 2014)

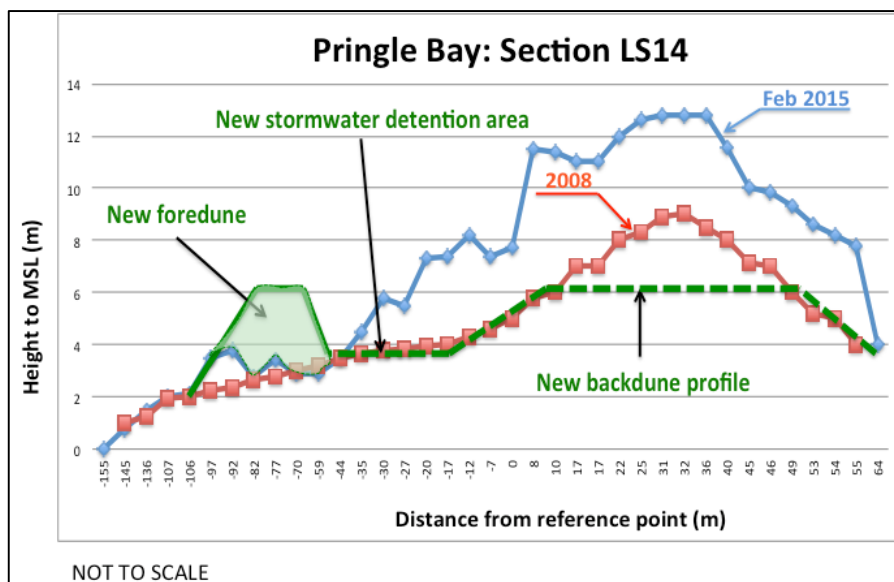
**Figure 19:** The new backdune profile along Section LS14 (refer to Figure 10)

For the area represented by Section LSA14 (Figure 19), sand from the backdune area is bulldozed all the way onto the beach and the backdune area is contoured to a level of +6.0 m MSL. The natural stormwater detention area is reinstated at a level low enough to allow the stormwater to drain into it from the existing stormwater drainpipe outlet. This level is estimated at +3.0 m MSL but can only be established once the pipe is exposed during the reshaping exercise. The area between the detention pond area and the beach is reshaped to form a new foredune with a top level of +6.0 m MSL.

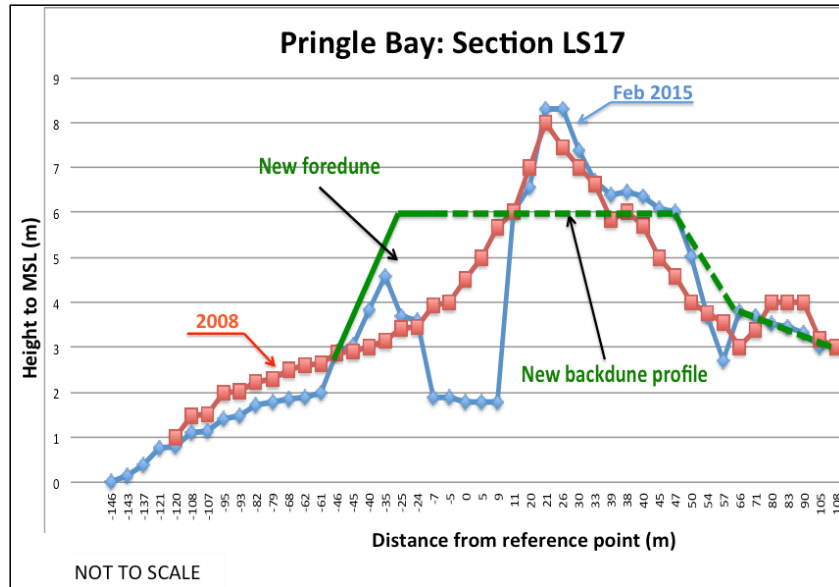
**Figure 20:** The new backdune profile along Section LS17 (refer to Figure 10)

At Section LS17 (Figure 20) sand from the backdune area is used to fill in and reform the foredune to a top level of +6.0 m MSL. This forms the northern edge of the reinstated stormwater detention pond. Figure 21 reflects the reshaped Section LS25 showing the new foredune, the stormwater detention area and the reprofiled backdune area.

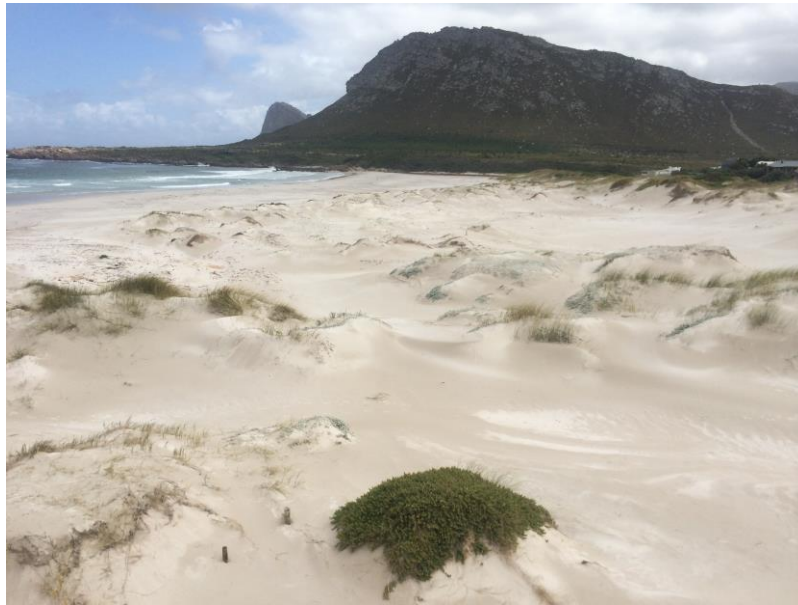
**The backdune area needs to be reshaped to allow for an effective storm water detention area**

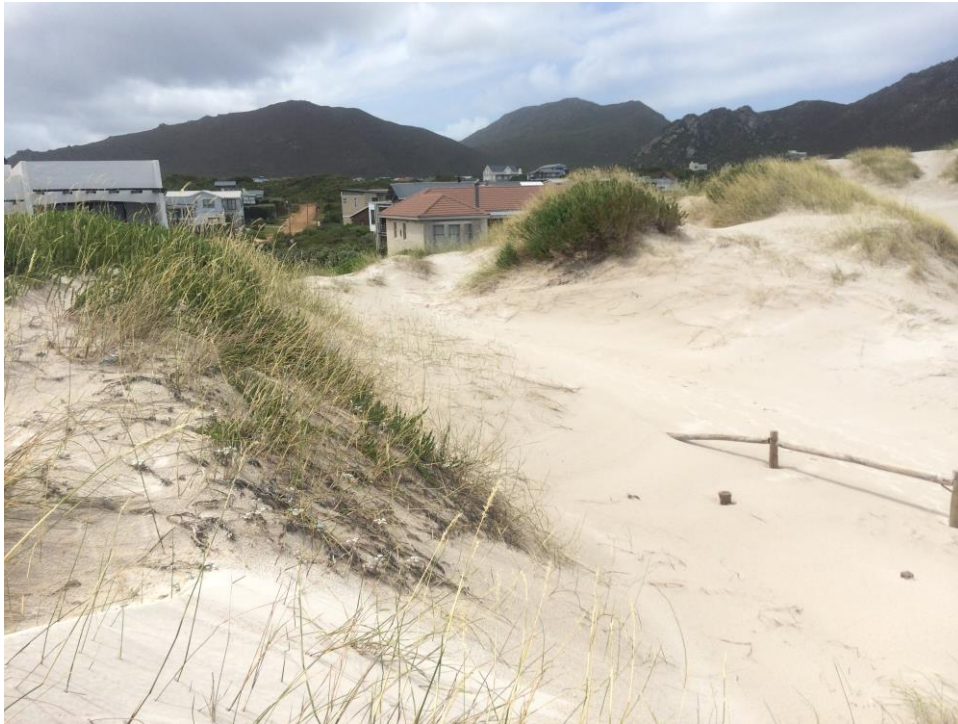
**Wind-blown sand has overwhelmed access pathways installed as part of the 1988 Management Plan**

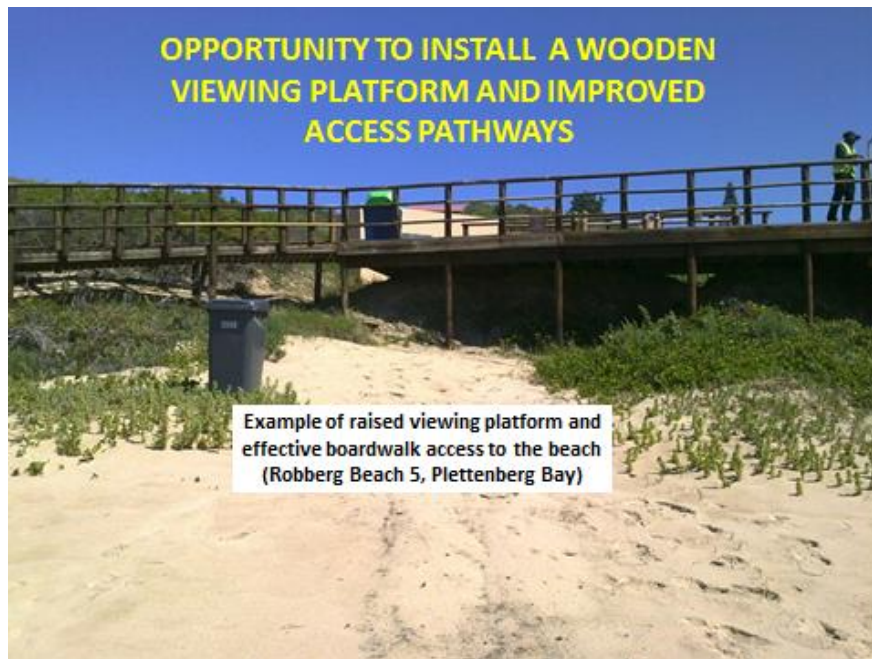
Figure A2.1: An example of a functional raised viewing deck and beach access walkway. The floor levels allow sand to move freely beneath the structure and enough sunlight allows for vegetation growth.

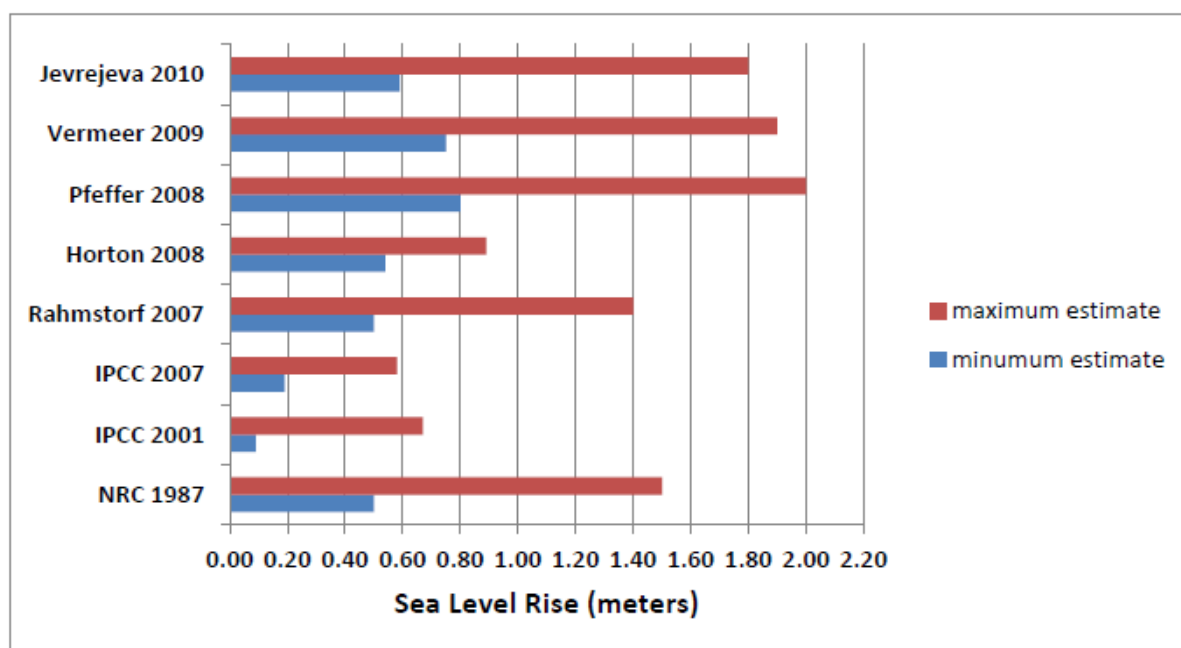
Figure A6.1: Comparison of minimum and maximum estimates of global SLR by year 2100 (USACE, 2011)

The probability of sudden large rises in sea level (possibly several metres) due to catastrophic failure of large ice-shelves (e.g. Church and White 2006) is still considered unlikely this century, but events in Greenland (e.g. Gregory 2004, Overland, 2011) and Antarctica (e.g. Bentley 1997; Thomas *et al.* 2004) may soon force a re-evaluation of that assessment. In the longer term the large-scale melting of large ice masses is inevitable. Recent literature (since IPCC 2007) gives a wide range of SLR scenarios, as indicated in Figure A6.1.
