WARD 13 - SITE VISIT

26 March 2026

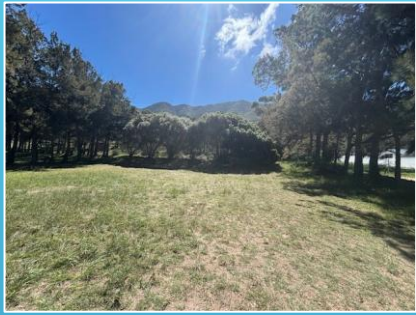
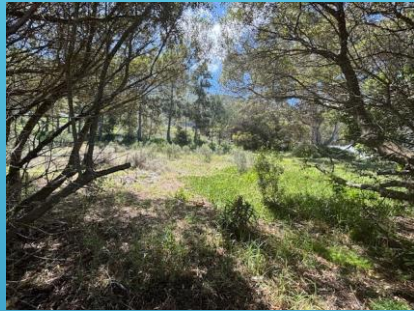
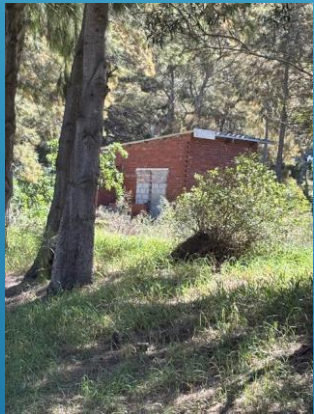
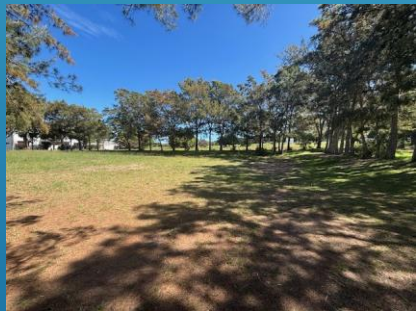
1. DOG PARK

Molteno Street (old Jukskei Club) (next to Electrical Department)

Area was identified for the establishment of a dog park.

- Meeting to be arranged with Mr D Heard regarding which plants can be kept and which must be removed.
- Fencing to be erected (especially along the R43) due to safety concerns.
- A water tank can be installed at the small building to collect rain water.

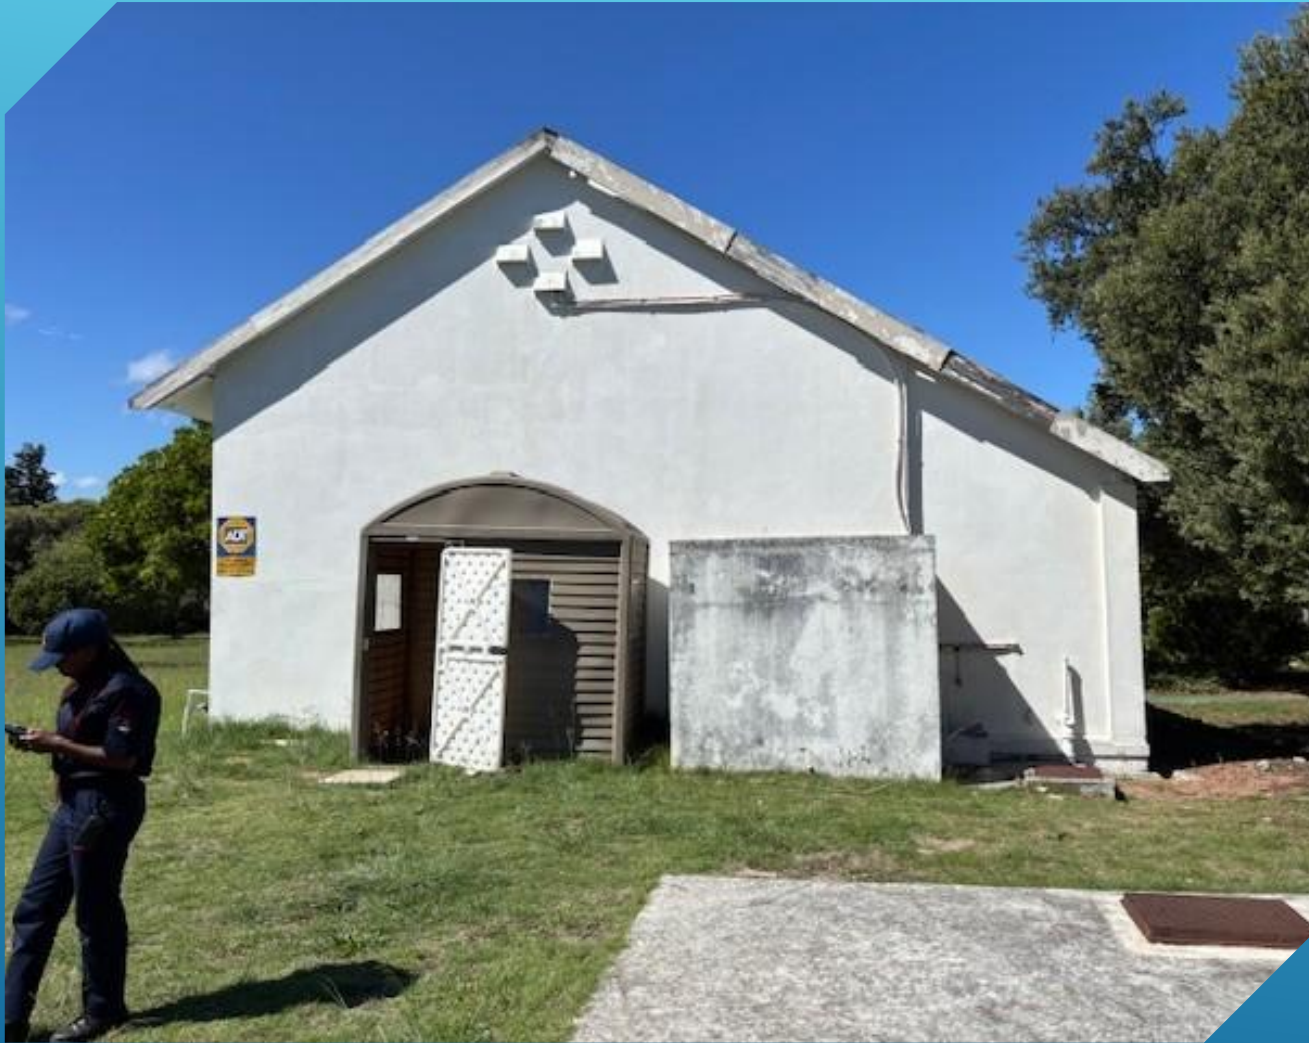
2. HERITAGE HUB / OLD CLINIC SITE

- Ward 13 listed the establishment of a Heritage Hub on the IDP at this property.
- Hermanus Country Kids are pursuing this property for a day care, and submitted a proposal to Parliament.
- Ms Bronkhorst, Ms Thornton & Ms Gabb applied for an NPO and drafted a Constitution.
- An application will not be considered if its not from an NPO.
- If the property is transferred from WC Province to the municipality, interested parties will be able to submit applications and it will trigger a public participation process.
- The idea is to propose a multi-use centre where performances (concerts), meetings, etc can be held.
- The proposal will include for example a Hub, offices, museum, etc.
- A business plan will be drafted to submit with a formal application.

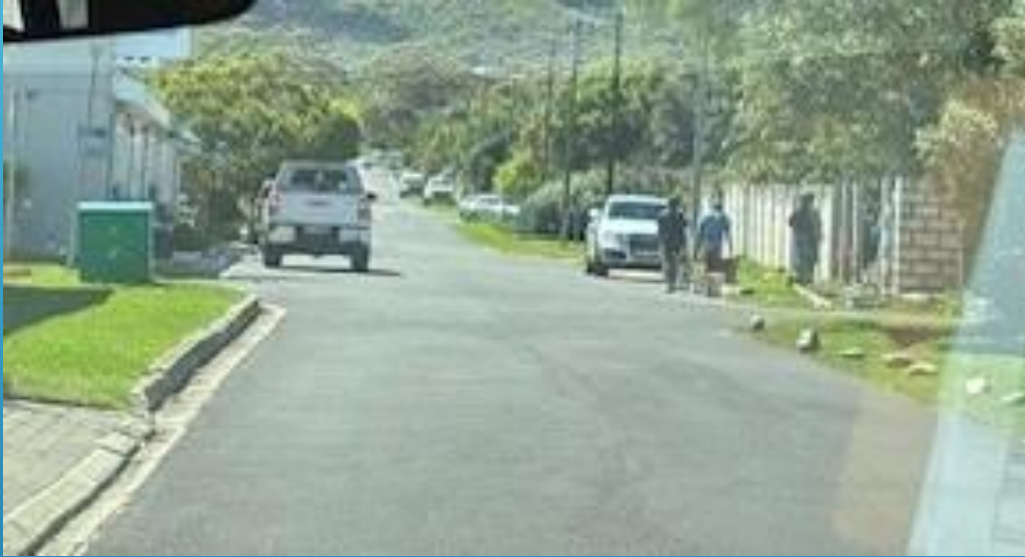
3. MOLTENO STREET - SIGNAGE

Ms Thornton reported that traffic are speeding in this section and the road is very busy, especially on Saturdays with the markets, etc.

People park on the side of the road and pedestrians have to walk in the streets, which make it more dangerous.

- Signage indicating either slow down or pedestrians.
- OR – 4 Way stop at Molteno & Roos Street.
- Long Term – Parking must be formalized in the business areas.

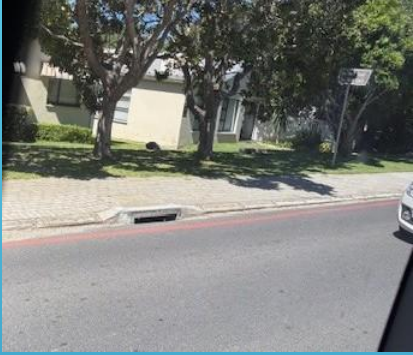
Van Blommestein

Ms Thornton reported that during heavy rain fall, the water flow underneath the houses due to only two small drains.

- Water must be diverted to the river. Feed down Petersen Street on the right hand to the river.
- Mr T Marx to attend next ward committee meeting with maps of roads and stormwater

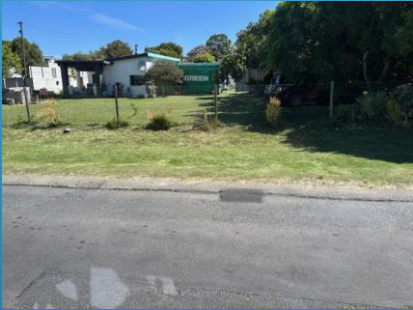
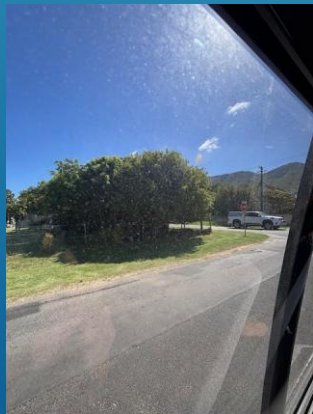
Douglas Street

Houses overflow during heavy rain fall which causes erosion and other issues.

- Kerb/paving stones & gutters to be installed.
- Mr S Müller to attend site meeting regarding stormwater issues.

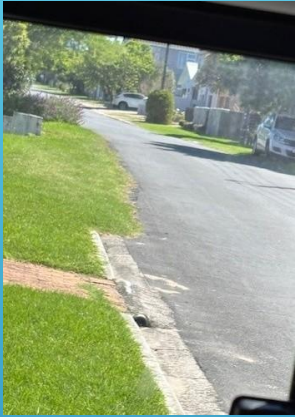
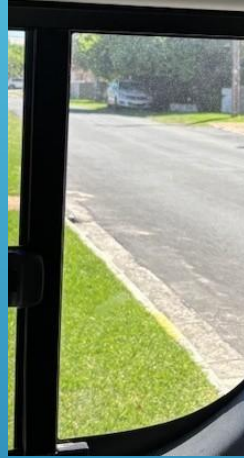
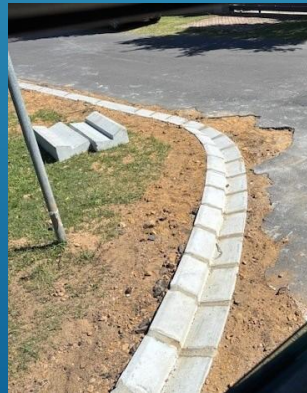
5. CHIAPPINI STREET

- Tarred road breaking up and road very narrow.
- New kerb stones installed but tarred road was not fixed.

- Kerb stones must be installed on all roads and thereafter tarr roads must be fixed.

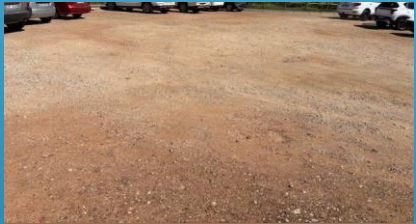
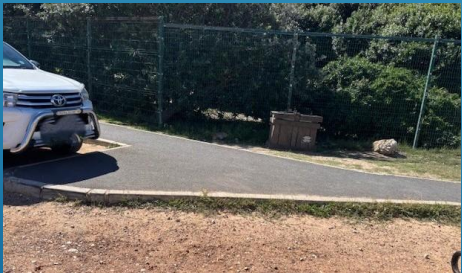
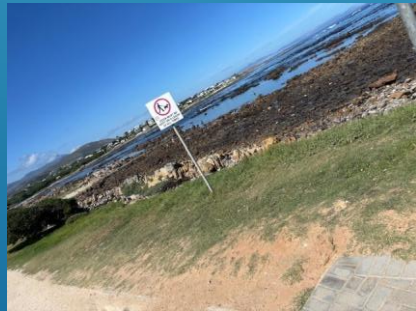
6. DAVIES POOL – PARKING AREA

- Ms Bronkhorst reported that they are busy obtaining quotations for paving of the parking area (which will last longer than tarring the area).

- Cllr Resandt indicating that if there is a saving on the dog park project from the WSP funding, it can be allocated to this project.
- One or two bays must be converted to a disabled parking (not on the left as you enter the parking area – not a safe area).
- The wings (tarred areas) must be removed and changed to proper sidewalks.
- As you exit the parking area, the 1st section must be changed to 2 way and then to 1 way.
- Better lighting must be installed – the cameras cannot pick up any thing beyond the 1st part of the road.
- Meeting to be scheduled with the Electrical Department regarding lighting.
- Wheel chair access must be provided down to Davies Pool.

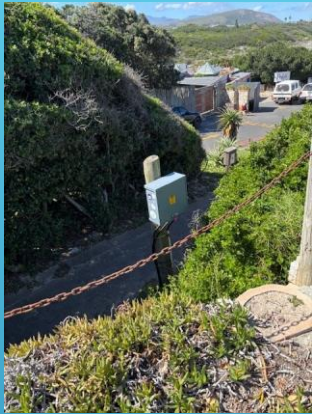
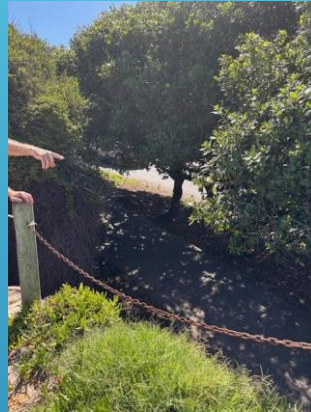
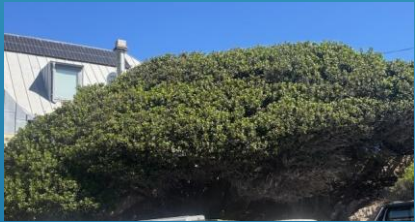
7. ONRUS BEACH PARKING AREA

- As customers exit the restaurant, it's pitch dark and causes safety issues.

- Extra lighting must be installed near restaurant and in parking area – round lights with cage covers or low lights.
- Lights to be installed in big tree as exit the parking area.
- Light on wooden pole to be changed to low light – currently blinding the camera.

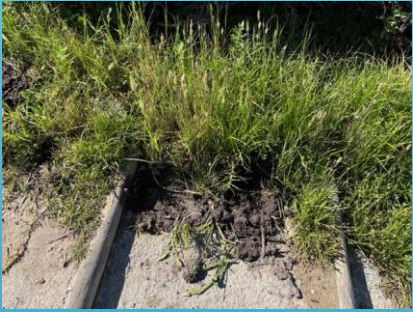
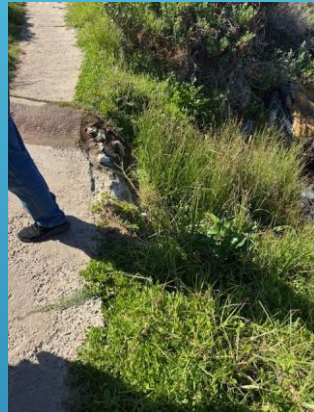
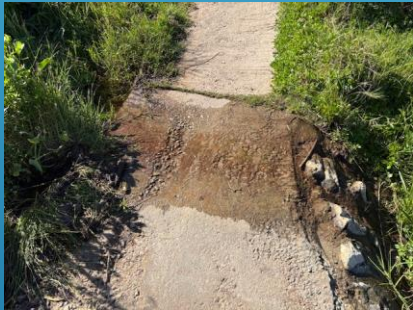
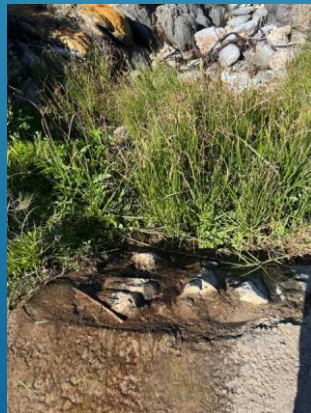
7. VERMONT COASTAL PATHS

- Concrete bench & base eroded – must be stabilized.
- Erosion on and next to path due to heavy rain fall.

- Pipe underneath walk way – water pooling during rain & rubbish flow down pipe with water – trench to be dug to catch the water & bigger pipe to be installed.
- Slats can also be layed over the path or a wooden walk way.
- Water to be directed to the channel at the end near the wooden bridge.
- Municipality to clarify which department is responsible for this area – either Community Services or Environmental Department.
