Ward 9

Ward Committee Site Visit

12 March 2026

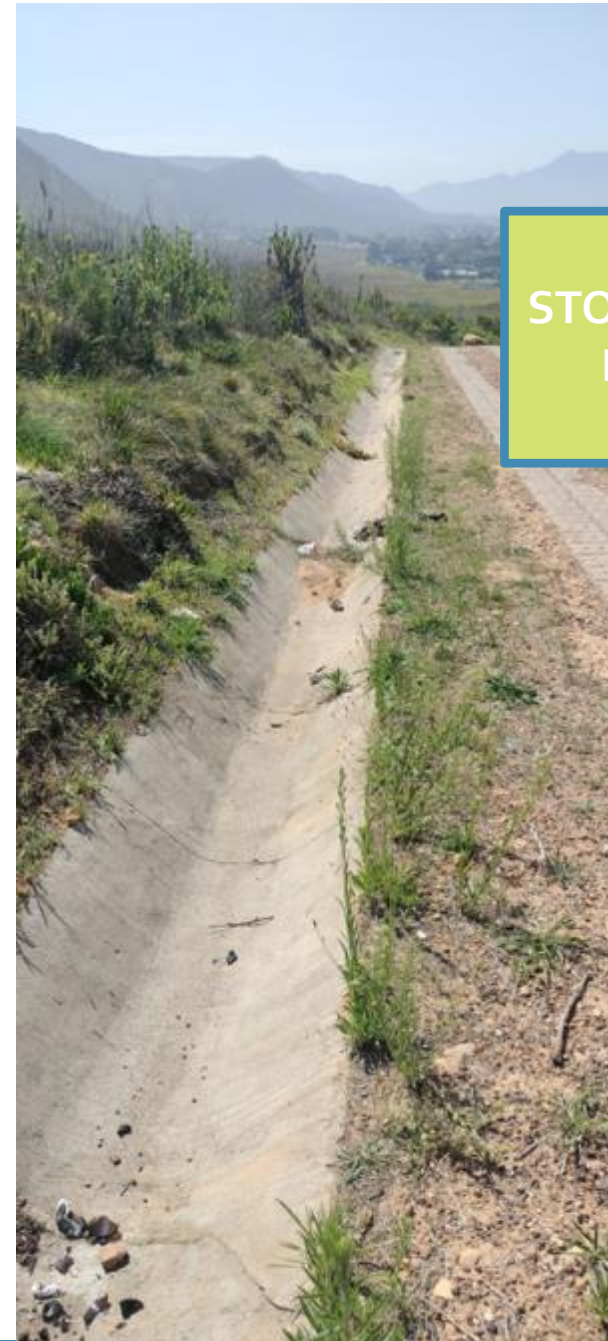
STORMWATER CHANNEL
RESERVOIR ROAD

- ❑ The stormwater channel cannot handle excessive amounts of rainwater

- ❑ That the newly appointed cleaning crew be tasked with clearing all debris and obstructions from the stormwater channel in Reservoir Road, Kleinmond
- ❑ That maintenance be done on the section of Reservoir Road in Kleinmond between the gate to the circle. Environmental Department to address

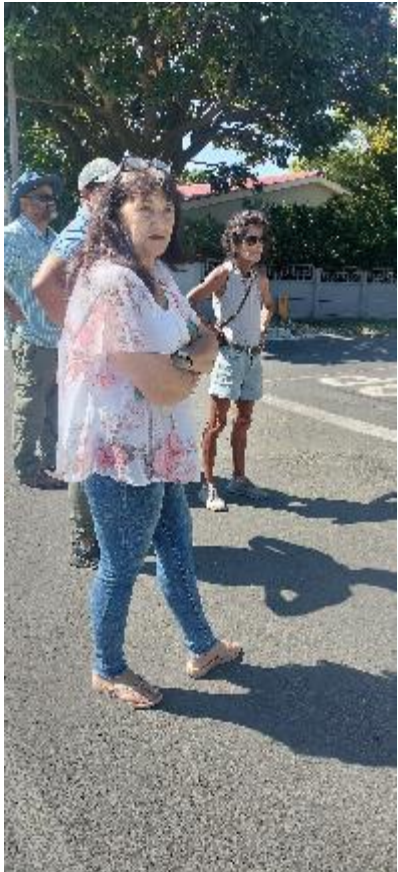
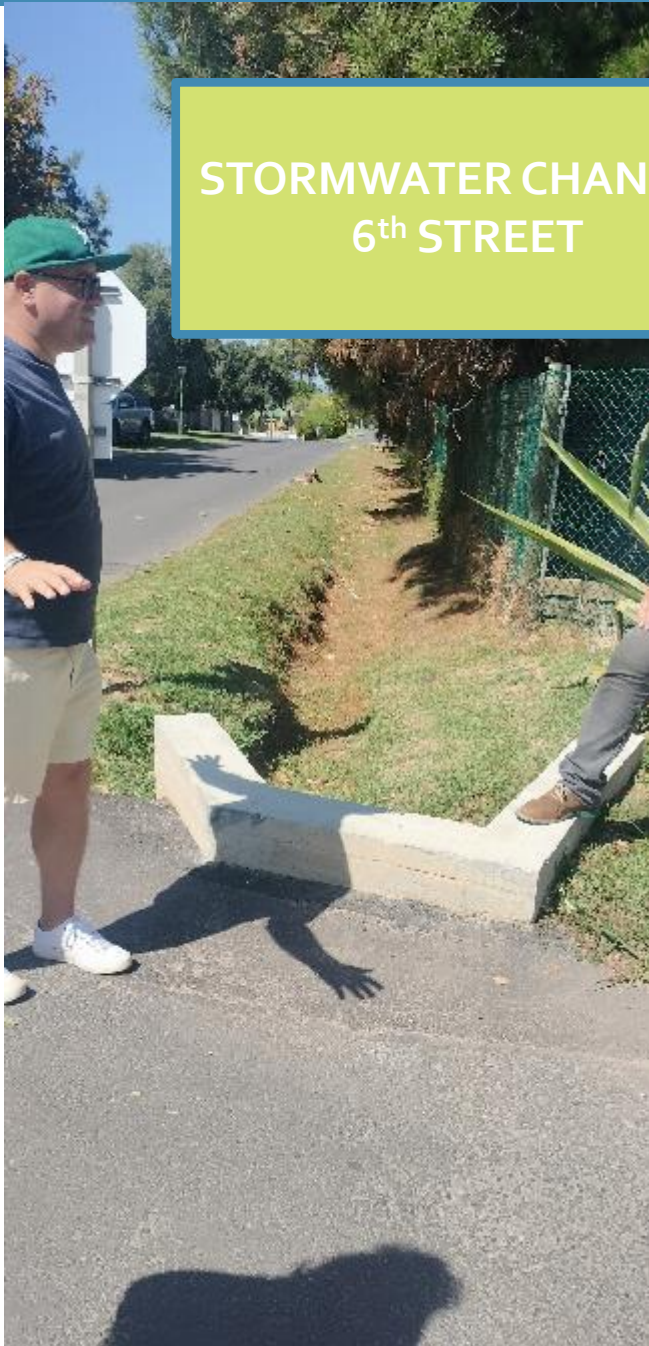
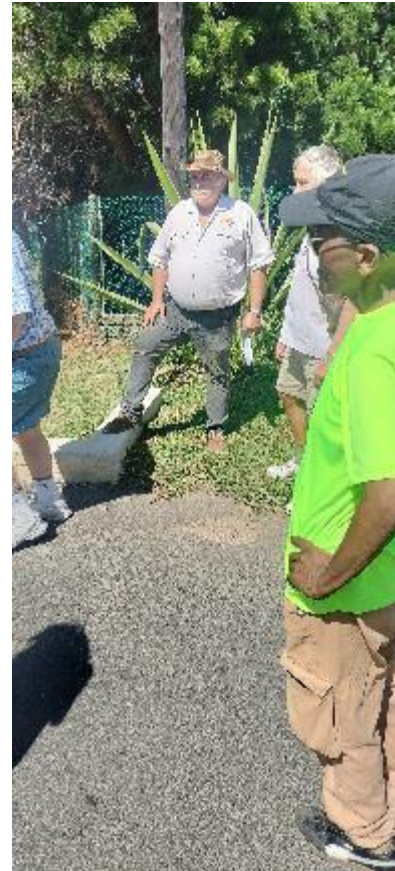
STORMWATER CHANNEL
6th STREET

- ❑ This man-made footpath had caused surplus water to overflow into homes

- ❑ The stormwater channel in 6th Street is similarly unable to handle significant volumes of water

- ❑ That rocks, or a berm, or stairs be placed or built to stop water from the stormwater channel in Reservoir Road in Kleinmond from flooding homes in the vicinity

- ❑ Mr. van Rhodie indicated that the stormwater infrastructure in the areas of 6th Street, 4th Street, and Botrivier Road should be assessed to determine whether the existing system can adequately handle current water volumes, and to establish if any upgrades are required
- ❑ He noted the rehabilitation of sections of 6th Street will be addressed in the next financial year and the associated stormwater infrastructure of these sections will also be addressed

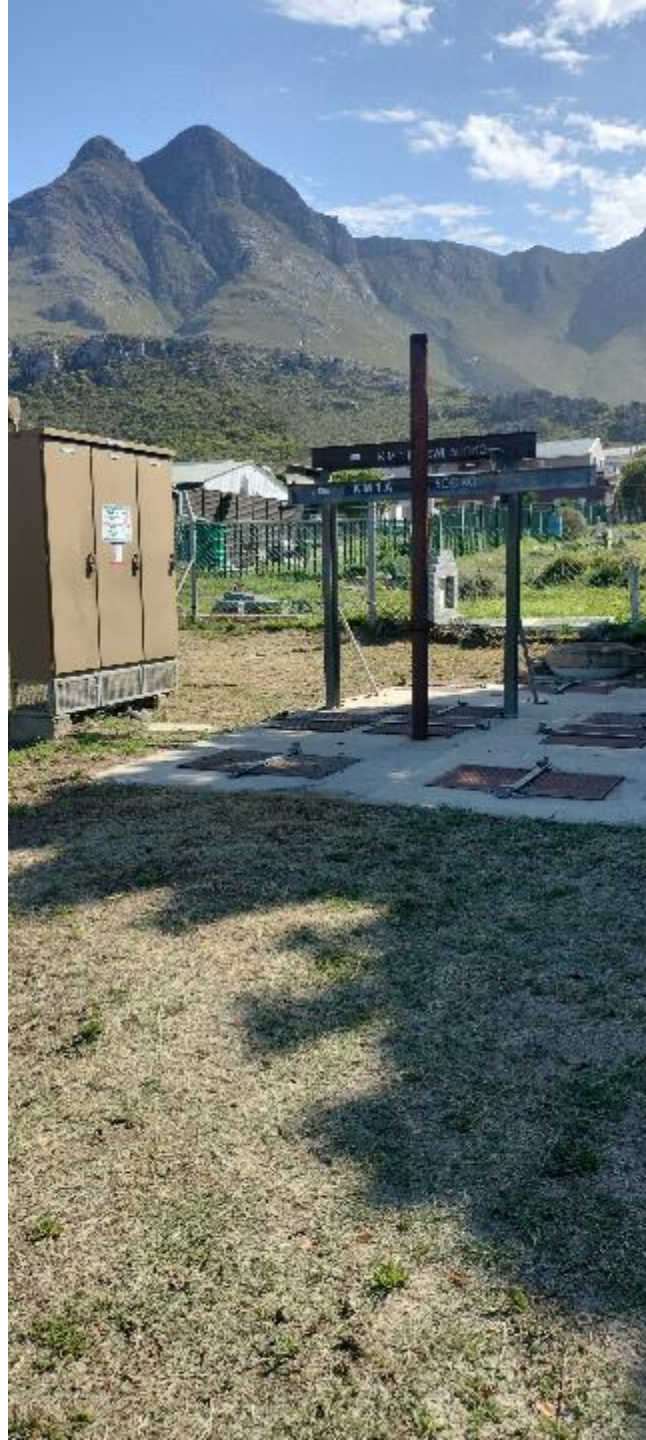
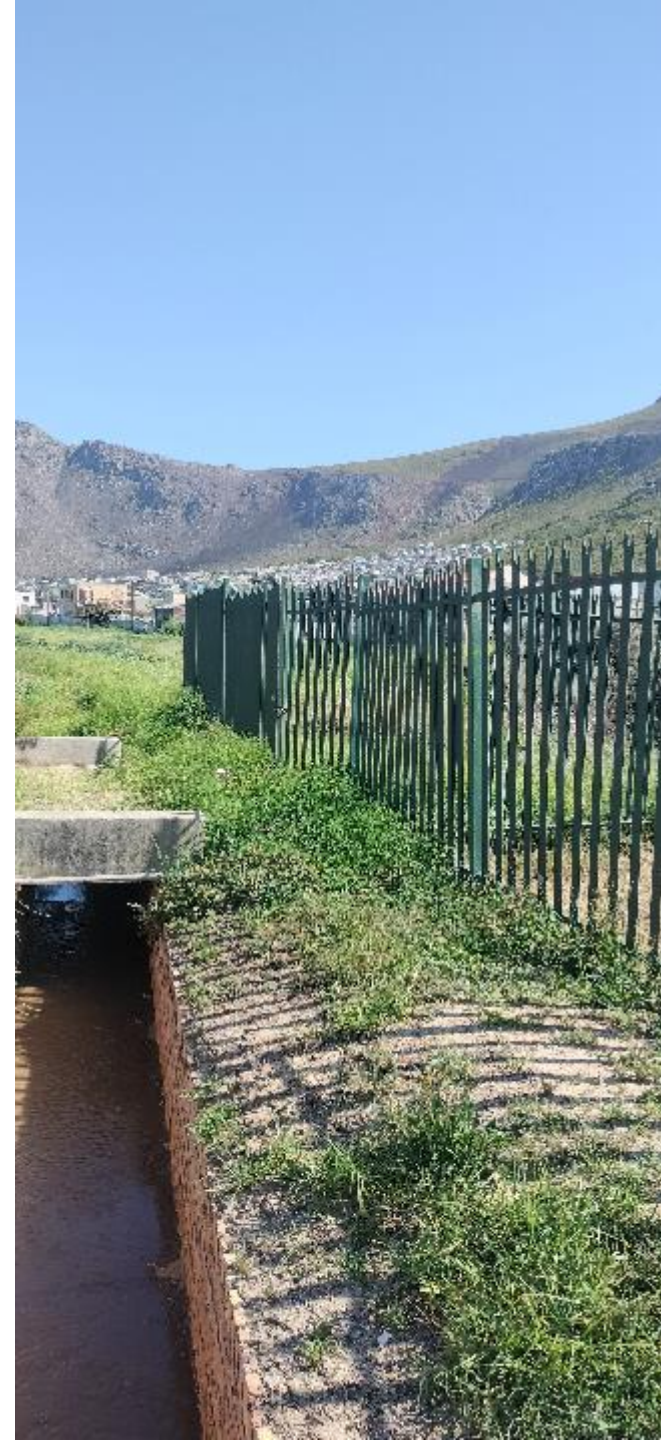
SEWER PUMPSTATION
MAIN ROAD

- ❑ Mr. Denovan van Rhodie explained that the sewage pump station at the cemetery services the area west of Protea Avenue, including sections of Mountain View through to Overhills (Poppedorp). However, the Overhills informal settlement was excluded from this system and was instead served by a gravity-fed sewer line to the Palmiet sewer pump station

- ❑ The cemetery sewer pump station transferred sewage to the Palmiet pump station, from where it was pumped to the wastewater treatment plant
- ❑ In the event of spillages or blockages, the service charter stipulates a response time of 24 hours. However, plumbing teams endeavour to address such incidents as soon as resources become available

- ❑ The costs associated with cleaning blockages or spillages are derived from the man-hours required to unblock sewer networks, as well as the use of specialized equipment. Sewer tankers are unable to suck solid waste, whereas Juno super sucker tankers are capable of doing so; however, the cost of hiring Juno tankers was higher

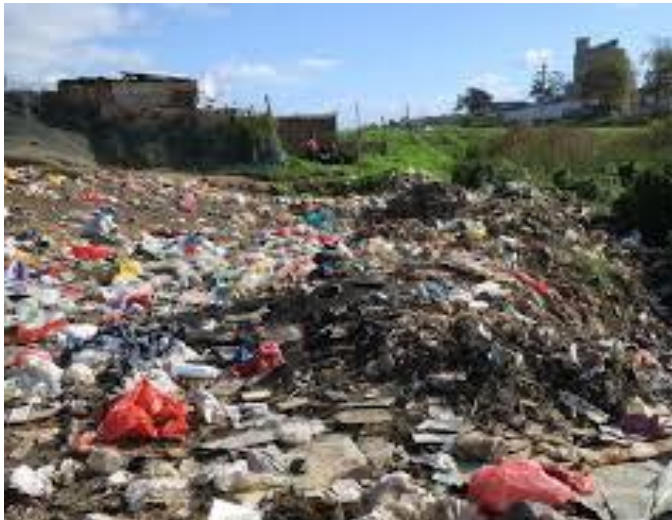
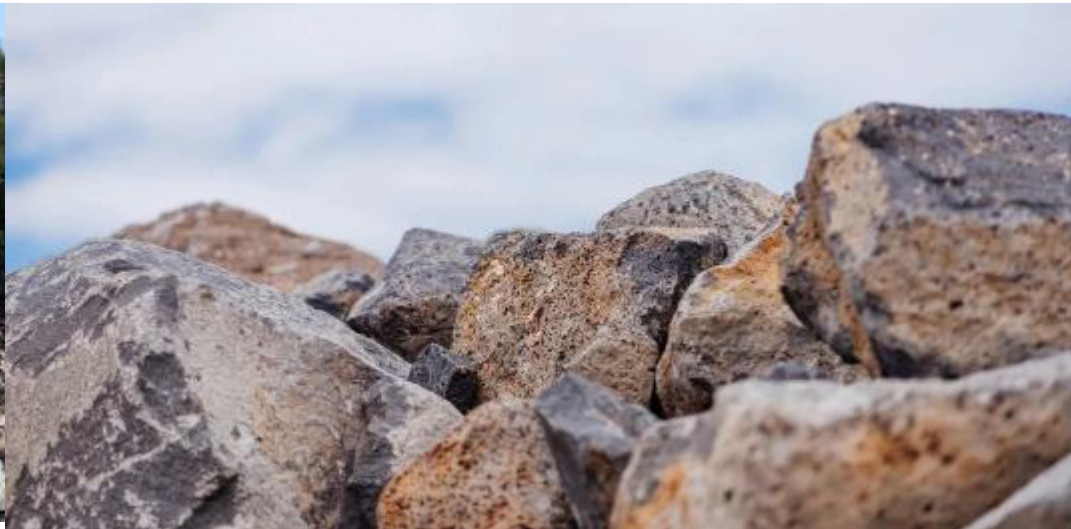
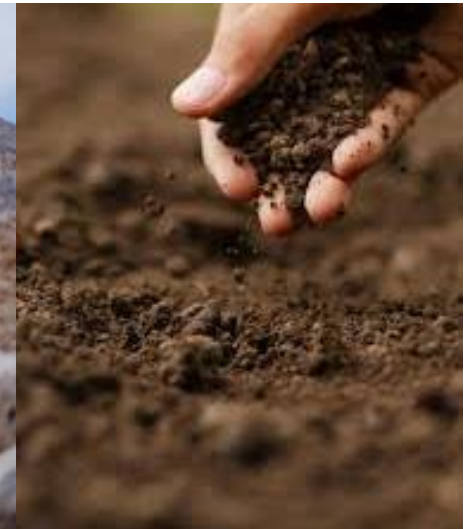
- ❑ Sewer blockages chiefly consisted of unwanted material discarded in the network:

Garbage

Rocks

Soil

The most efficient solution to mitigate sewer blockages was to block what was going into the line

- ❑ Future plans included converting sewer manholes into sand/dirt traps, which would help reduce sewer spillages. However, this would not eliminate the cost of hiring Juno super sucker tankers, which would still be required to service and clean the sand and debris collected in these traps
- ❑ Educating the public through for example the use of puppets to warn about the dangers when children play in sewerage water
- ❑ Locking sewer lids

- ❑ That a survey be done to determine how many sewer lids there were in Kleinmond with a view to installing locks

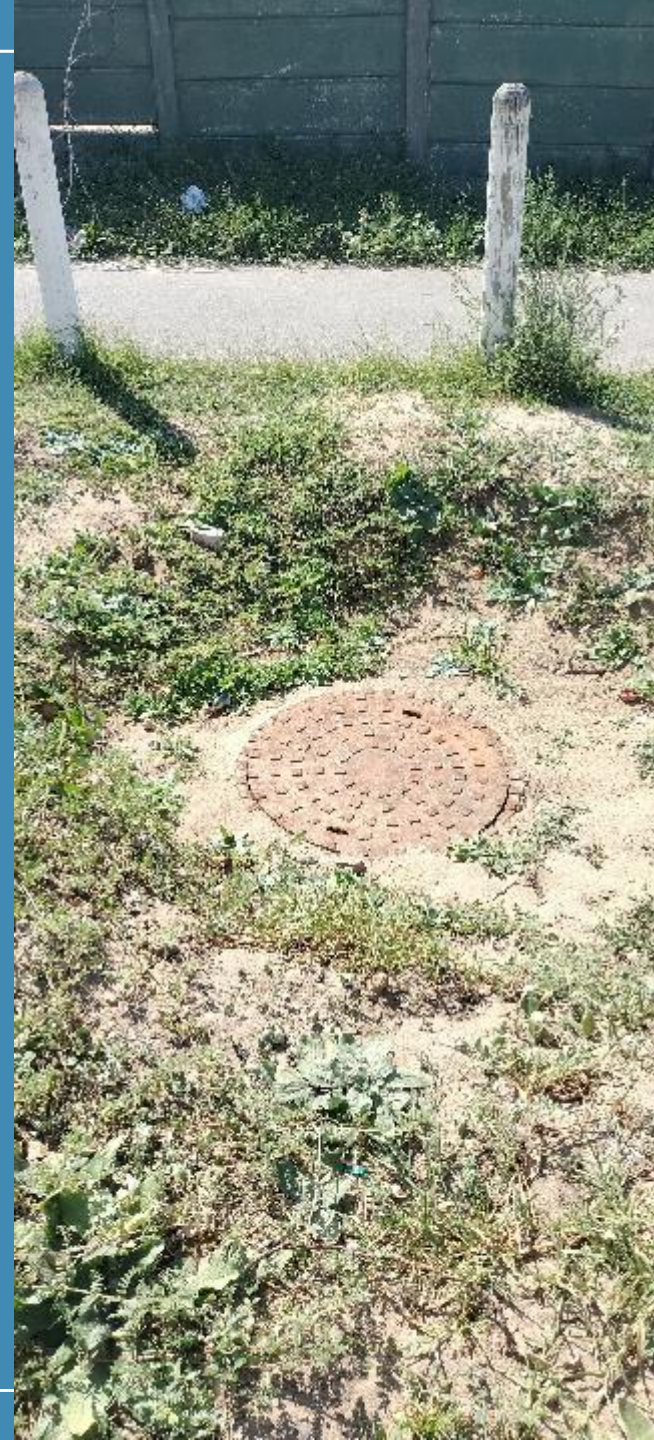
MANHOLE: ENTRANCE TO THE RUGBY FIELD

- ❑ Mr. van Rhodie explained that this sewer line flows to Main Road, then to the tennis courts pump station, from where it was pumped to the Palmiet pump station and ultimately conveyed to the wastewater treatment plant
- ❑ He informed that blockages primarily occur as a result of the disposal of rags and other refuse into manholes
- ❑ There are plans to add 2 new sand traps on this particular sewer line in the next financial year

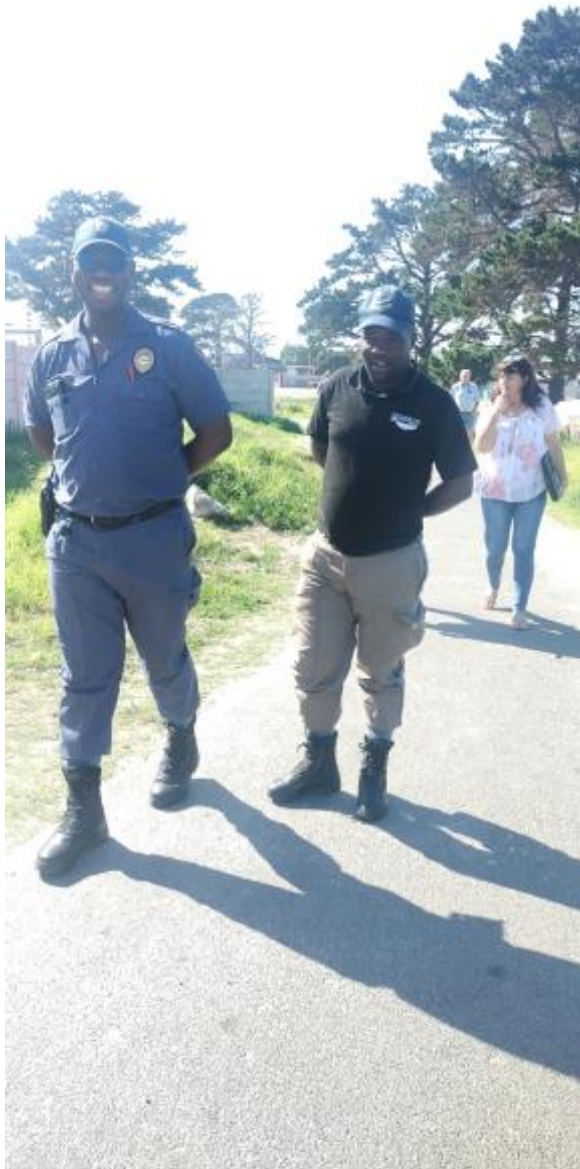
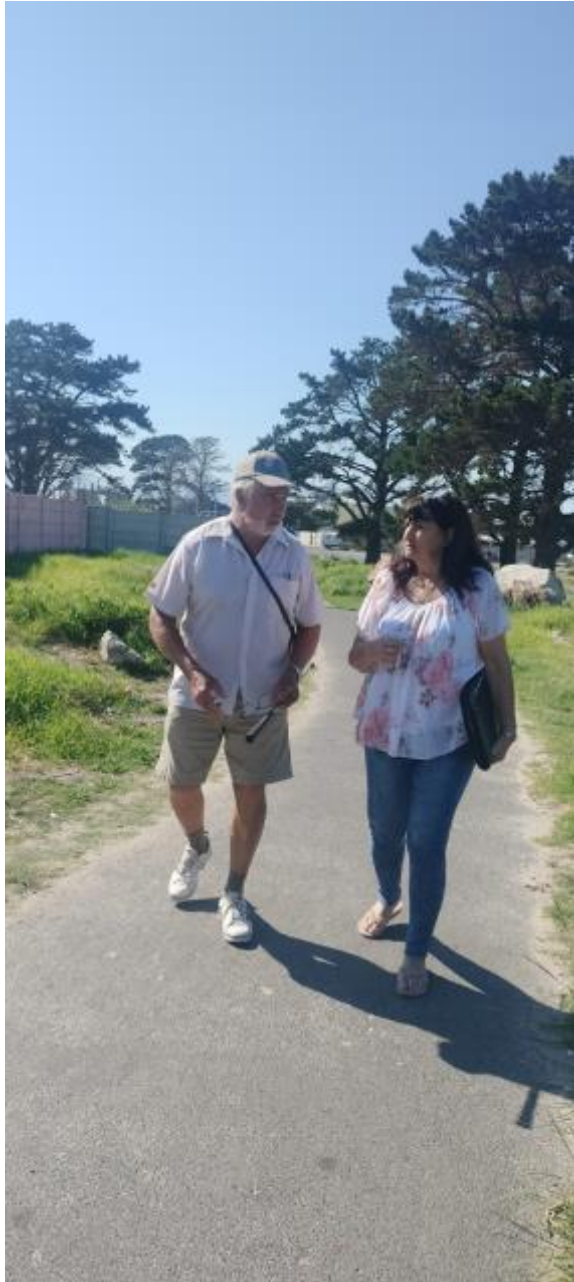
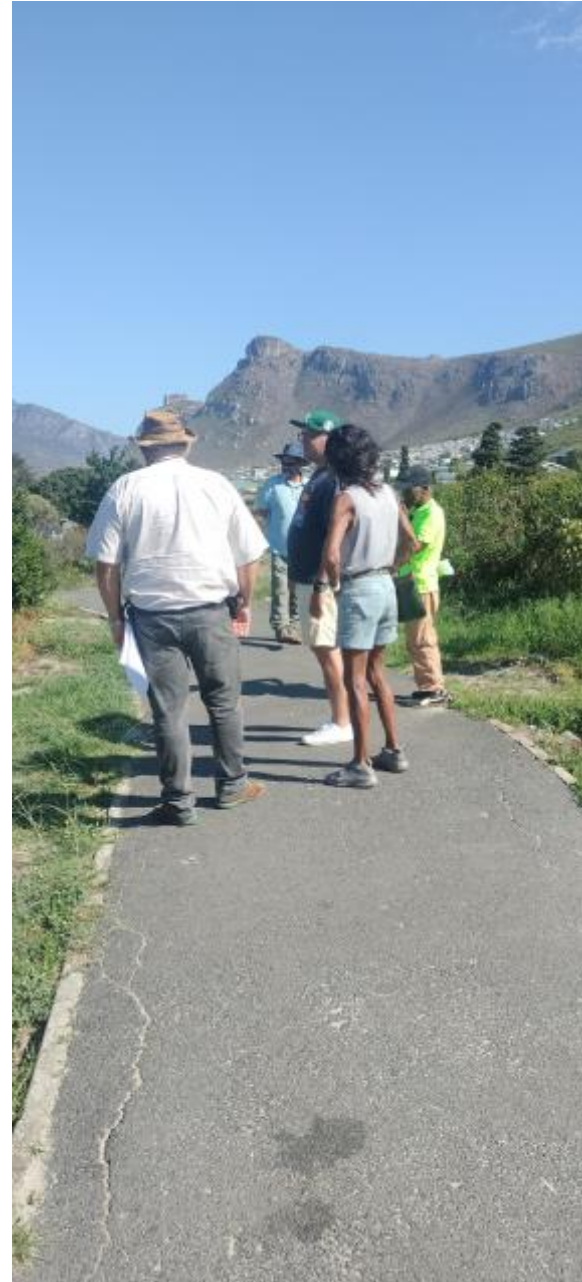
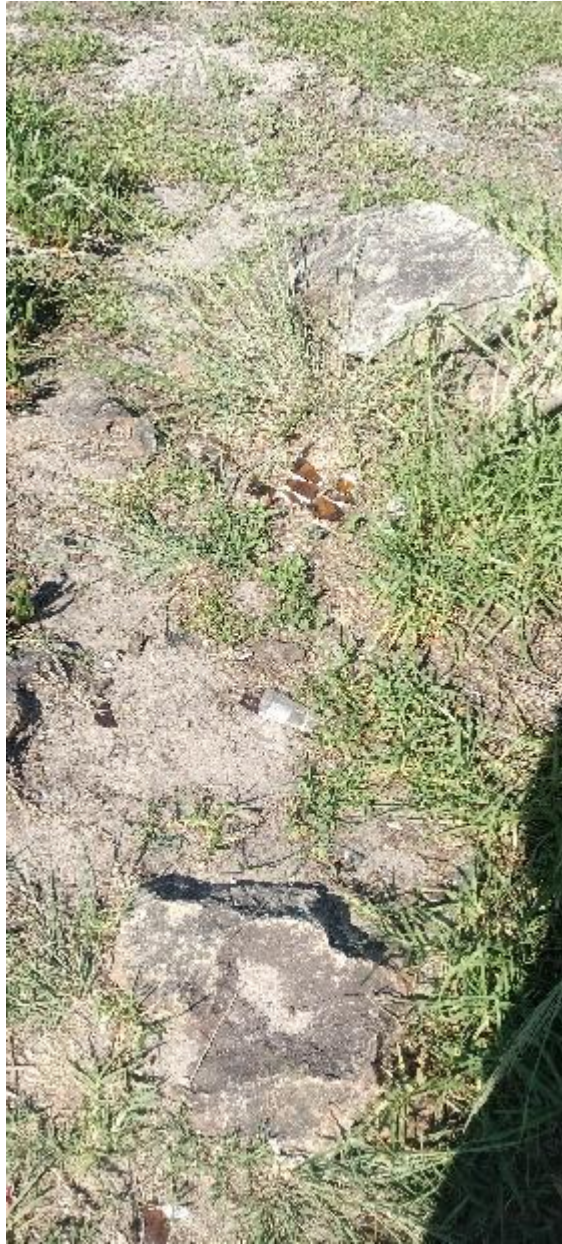
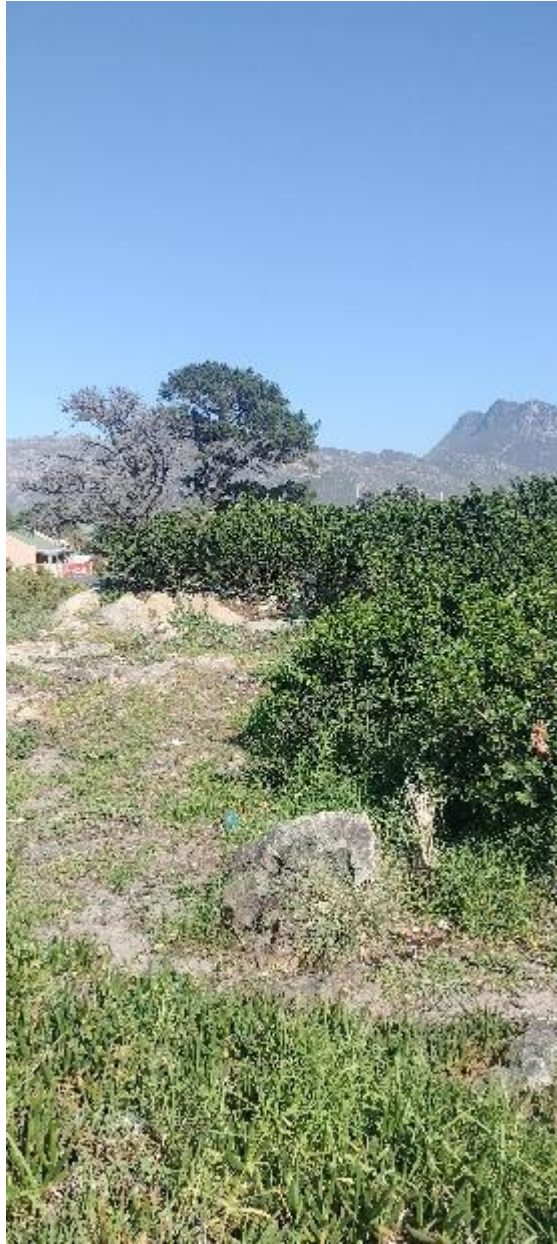
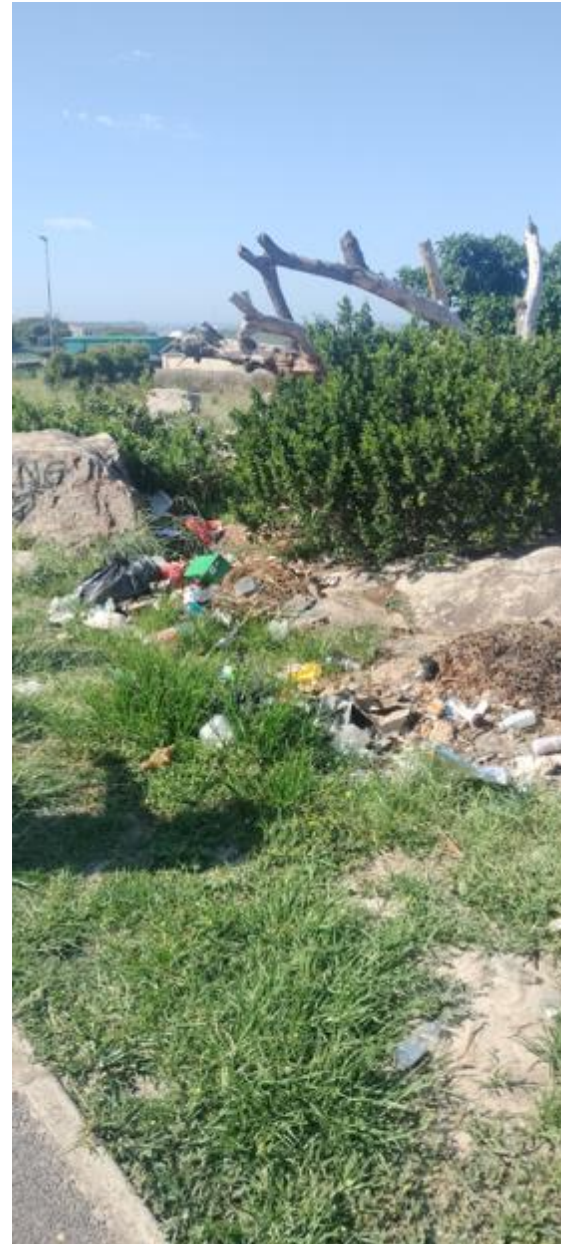
- ❑ The area was severely overrun by accumulated refuse, discarded abalone shells, and hazardous glass shards
- ❑ Cleaning and street sweeping staff had been appointed and would begin working on Monday 16 March 2026
- ❑ Expansion of the area was discussed; solutions put forth included:
 - ❑ Creating a dog park,
 - ❑ Fencing the area, and
 - ❑ Building a designated footpath

- ❑ That the newly appointed cleaning staff began their contract by cleaning the area between the graveyard and KAWS in Kleinmond first
- ❑ That there was a need to educate officials from Parks, Recreation, Cemeteries & Refuse Removal to avoid clearing an area in a manner that destroyed native plants such as fynbos and proteas

- ❑ That Law Enforcement conducts regular, high-visibility patrols day and night within the corridor between the graveyard and KAWS in Kleinmond, acting as a proactive measure to discourage criminal activity such as :
 - 1) members of the public who dump waste in this veld,
 - 2) poachers who discard abalone shells in the drains,
 - 3) homeless people who build shelters to sleep in, and
 - 4) members of the public who drink in public and discard glass bottles in the veld

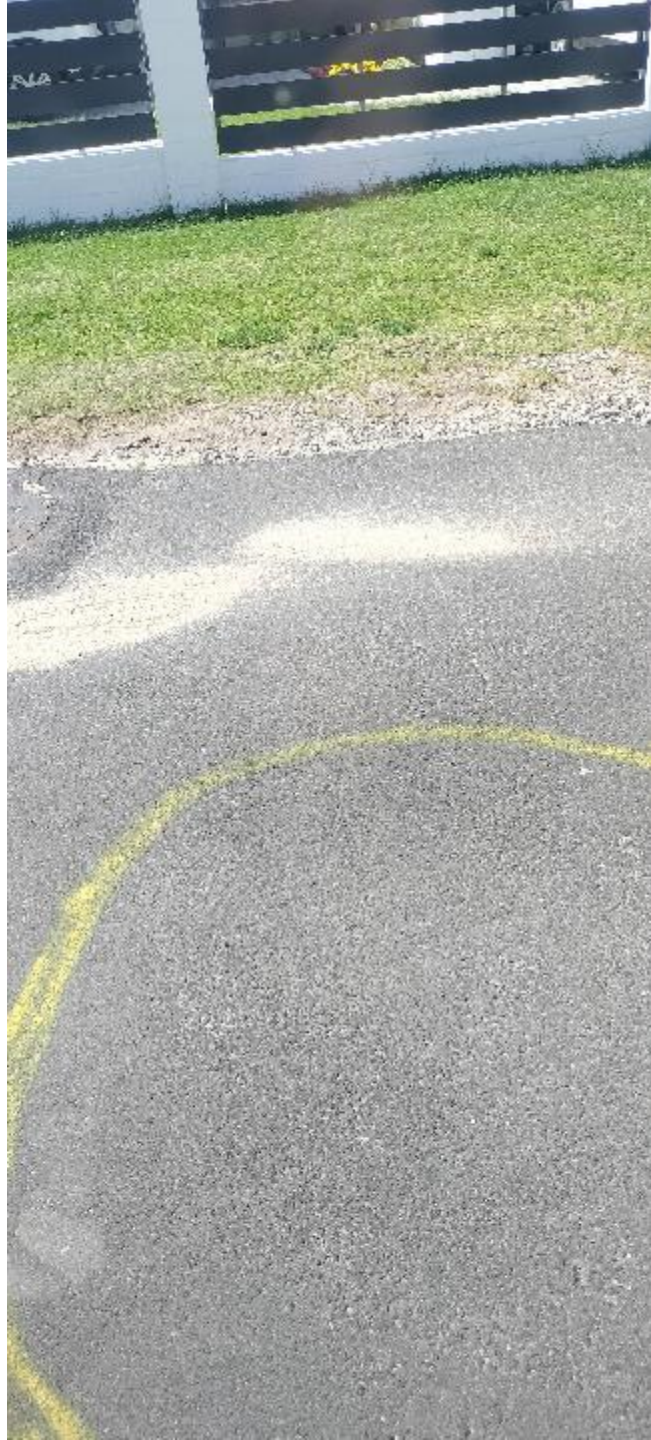
SINKHOLE IN 4th STREET

- ❑ Mr. van Rhodie informed that specific projects had been completed
- ❑ Boekenhout Street had been repaired, whereafter work would commence on 1st Avenue
- ❑ Pipes will then be bought
- ❑ Mr. van Rhodie noted pipelines from 4th Street onwards required maintenance
- ❑ 11th Avenue as well as 9th Avenue had to be rehabilitated due to the abundance of groundwater
- ❑ Similarly, the sinkhole in 4th Street was a result of the groundwater
- ❑ He informed that a considerable sum of money had been spent on repairs

- That officials from Streets & Stormwater repair the sinkhole in 4th Street, Kleinmond

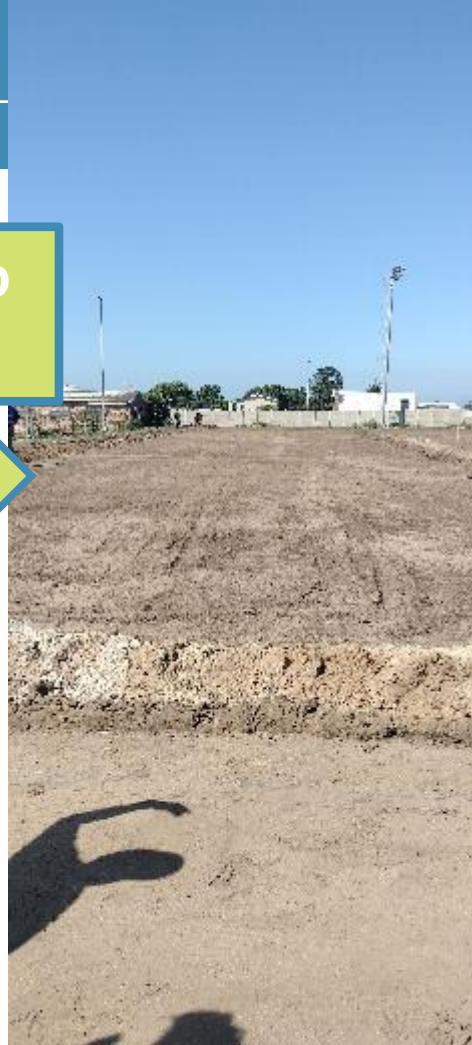
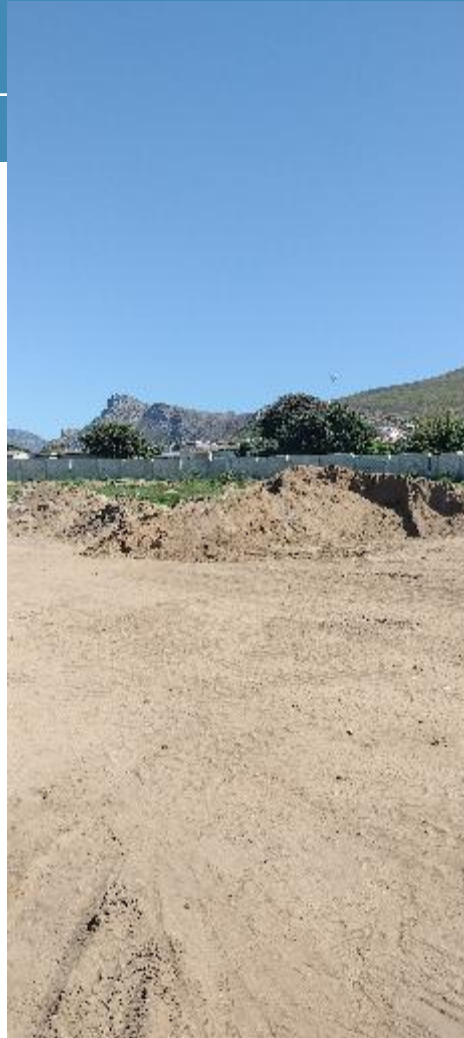
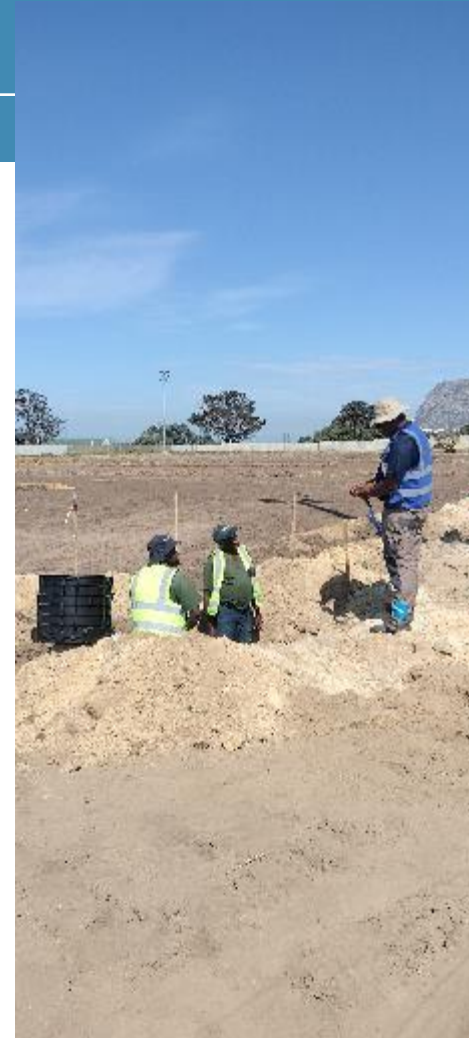
KLEINMOND RUGBY FIELD

Field for warm-up purposes

- ❑ Work done at the rugby field totalled in excess of R12m
- ❑ Newly installed floodlights had LED globes which used less electricity
- ❑ The field had been compacted and irrigation was being installed
- ❑ The irrigation system would be timer-operated
- ❑ Once the grass was planted, the field would not be used for 3 months during which time the contractor would oversee the field and train Municipal role-players including Mr. Dudley du Bruin in maintenance and upkeep
